Camdenville Park

PLAN OF MANAGEMENT

July 2014

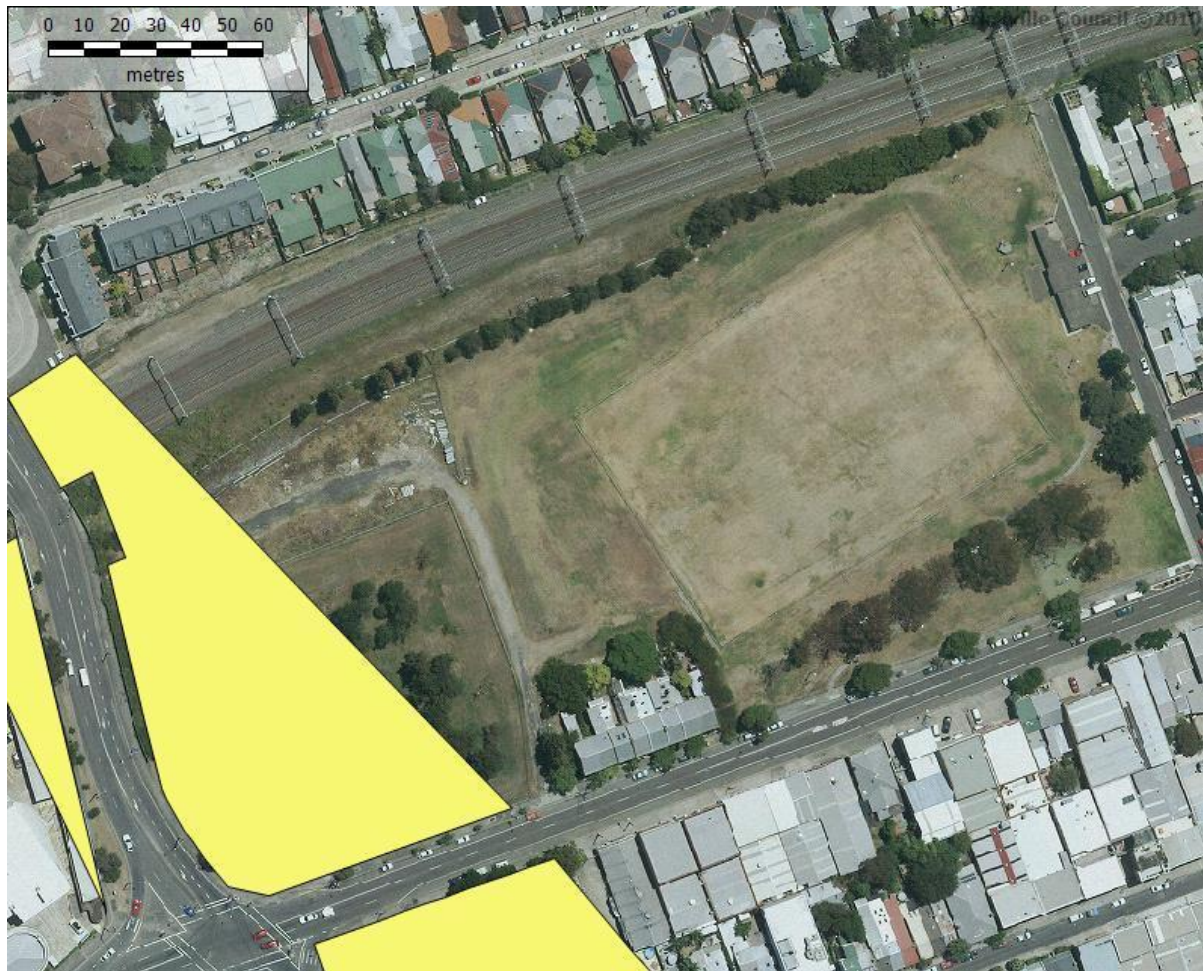
There is a Roads and Maritime Services (RMS) reservation for acquisition across the western portion of the park. While RMS does not own any part of Camdenville Park, this land is noted on Council's LEP as land reserved for acquisition.

RMS reservation for acquisition across Camdenville Park

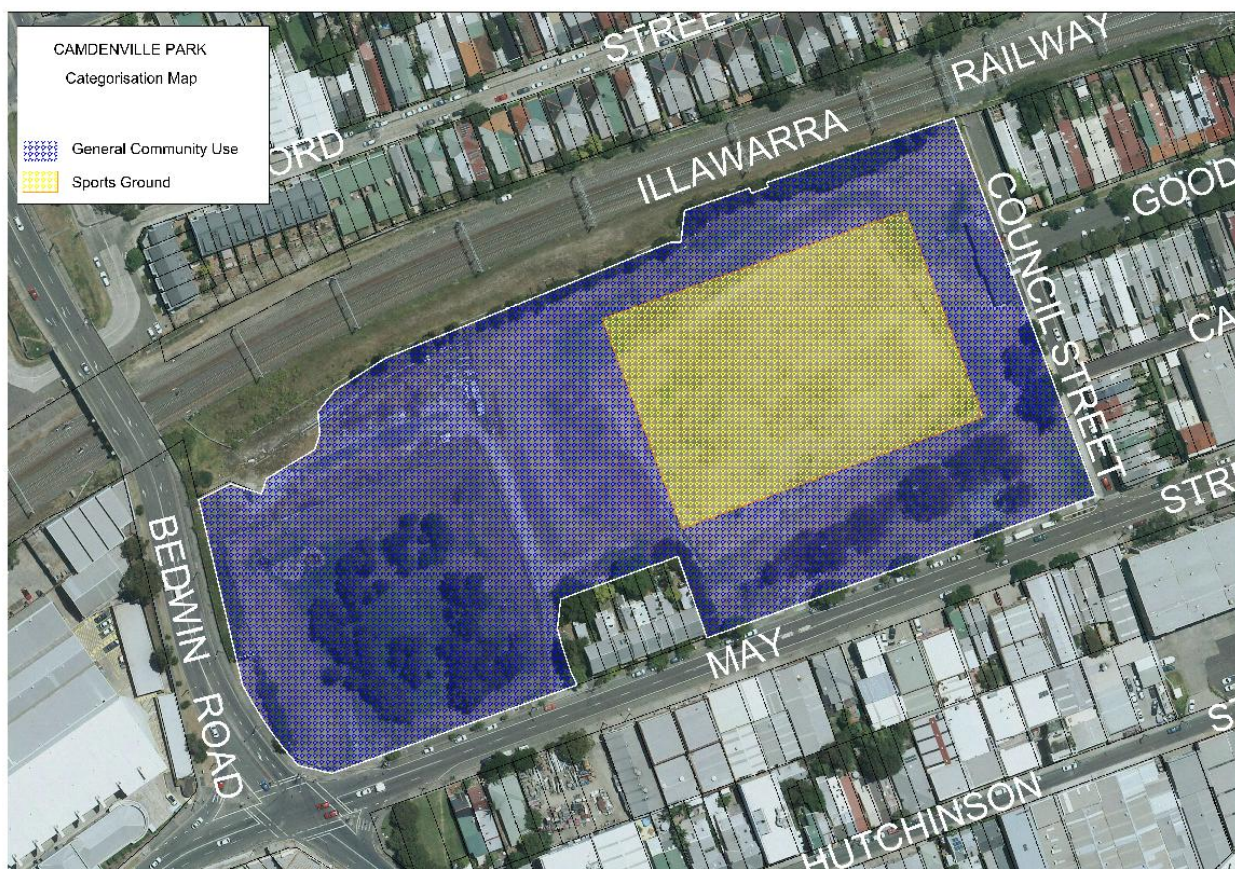
Camdenville Park - Categorisation Map

Note the Plan of Management proposes the realignment of the playing field as shown above. Use of the facility in the current configuration will continue until the proposed works are completed.

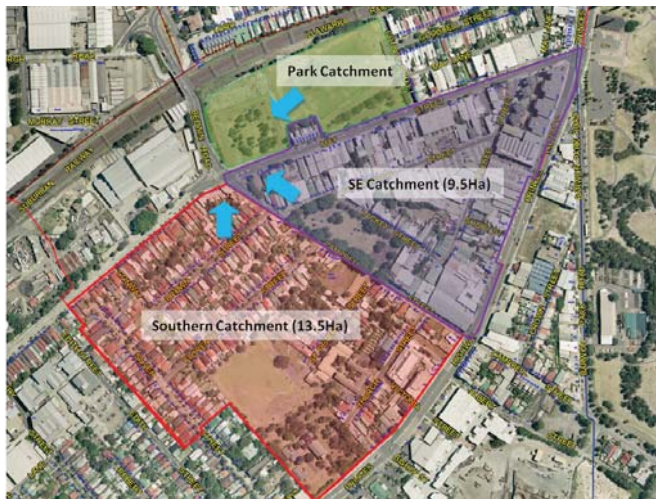
Detention Basin catchment diagram, Storm Consulting

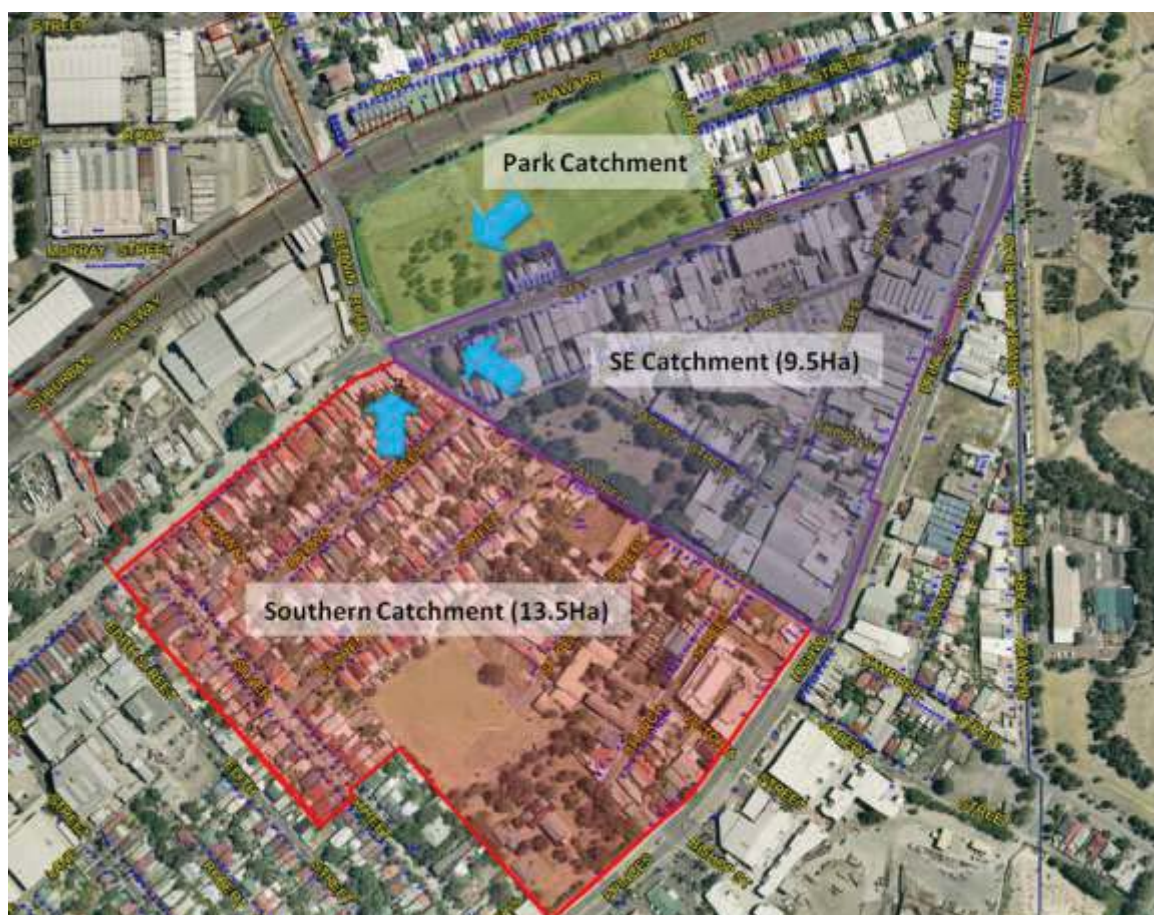
Figure 1: Catchment Plan

Table 1: Catchment Summary

Catchment ID	May St - Campbell St (9.5Ha)	Southern Catchment (13.5Ha)	Camdenville Oval + Units (1.54Ha)	May St – road catchment (0.7Ha)
Node Type	UrbanSourceNode	UrbanSourceNode	UrbanSourceNode	UrbanSourceNode
Total Area (ha)	9.5	13.5	1.5	0.7
Area Impervious (ha)	7.1	8.8	0.1	0.6
Area Pervious (ha)	2.4	4.7	1.4	0.1

Refer to the masterplan document for a more detailed discussion of the catchments.

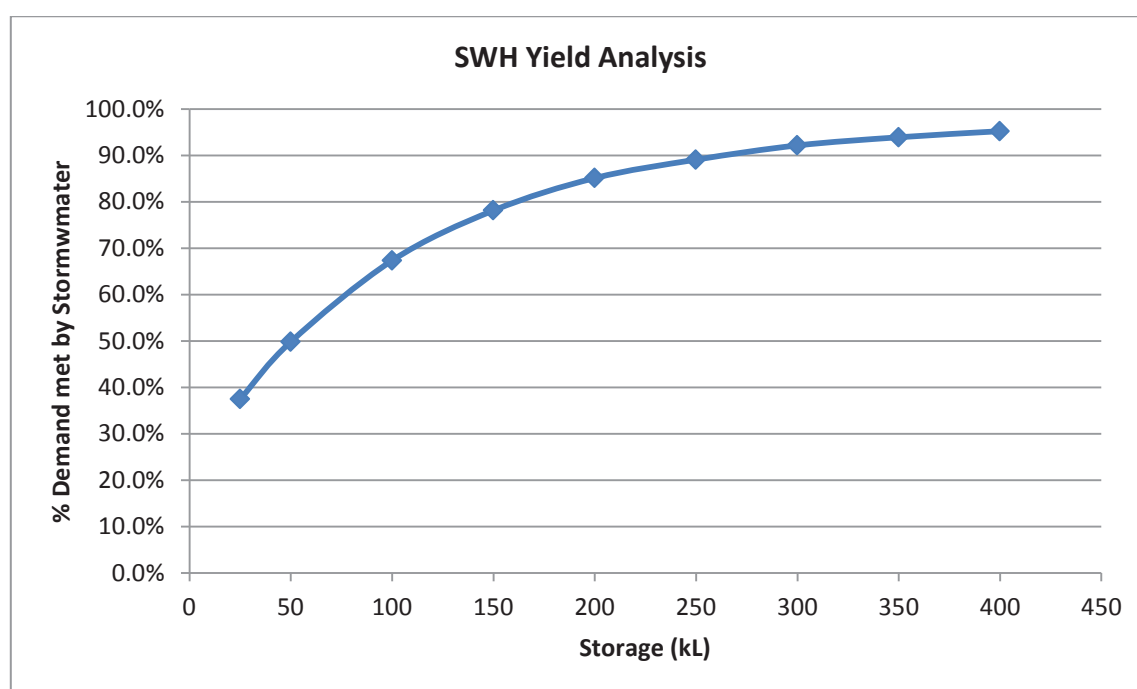
Figure 3: Stormwater Harvesting - Yield Analysis Results

The stormwater tank has been sized using the water balance function in MUSIC. A yield analysis has been undertaken to determine the optimal tank size to supply harvested stormwater for irrigation purposes. The optimal tank size is the point of whereby increasing the tank size will lead to a diminishing return in the % of irrigation demands met by harvested stormwater. This relationship can be seen in Figure 3 below, and the optimal tank size appears to be in the range of 200kL which can provide 85% yield (equivalent to 3.74ML of stormwater per year).

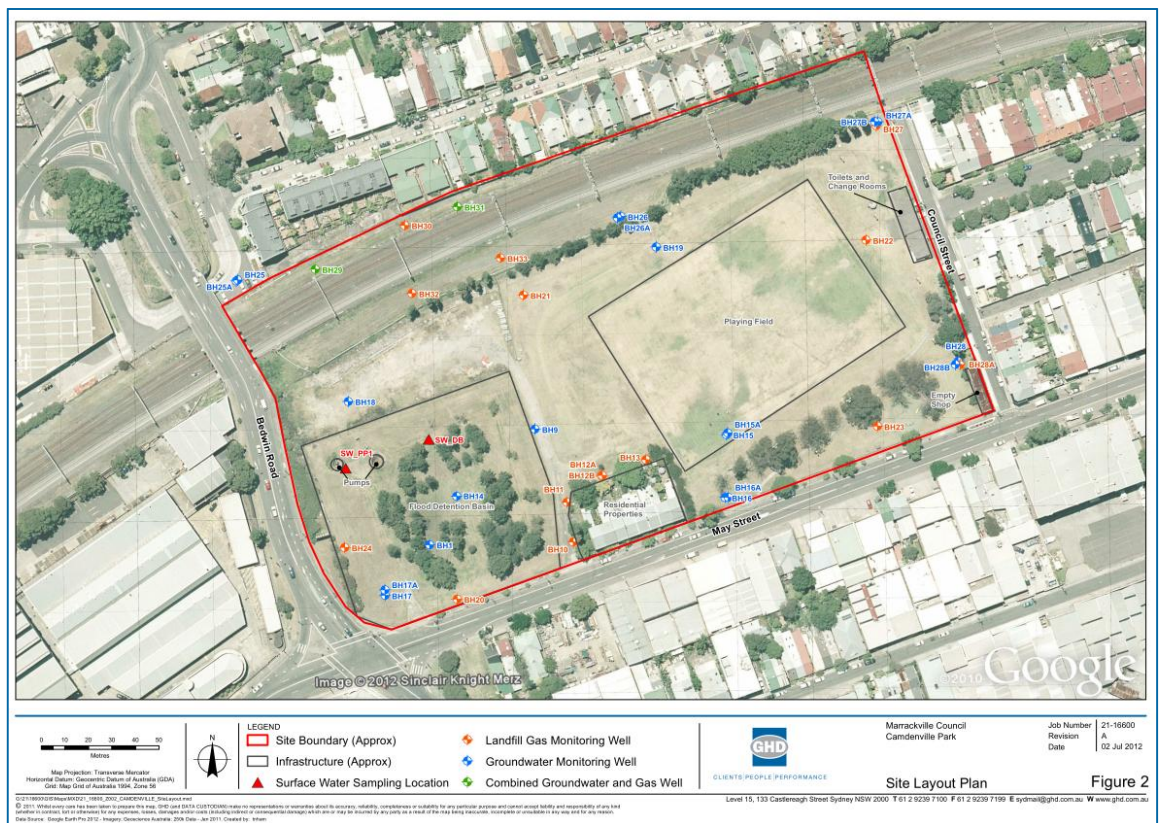
Figure 7 GHD sampling location plan (2012)

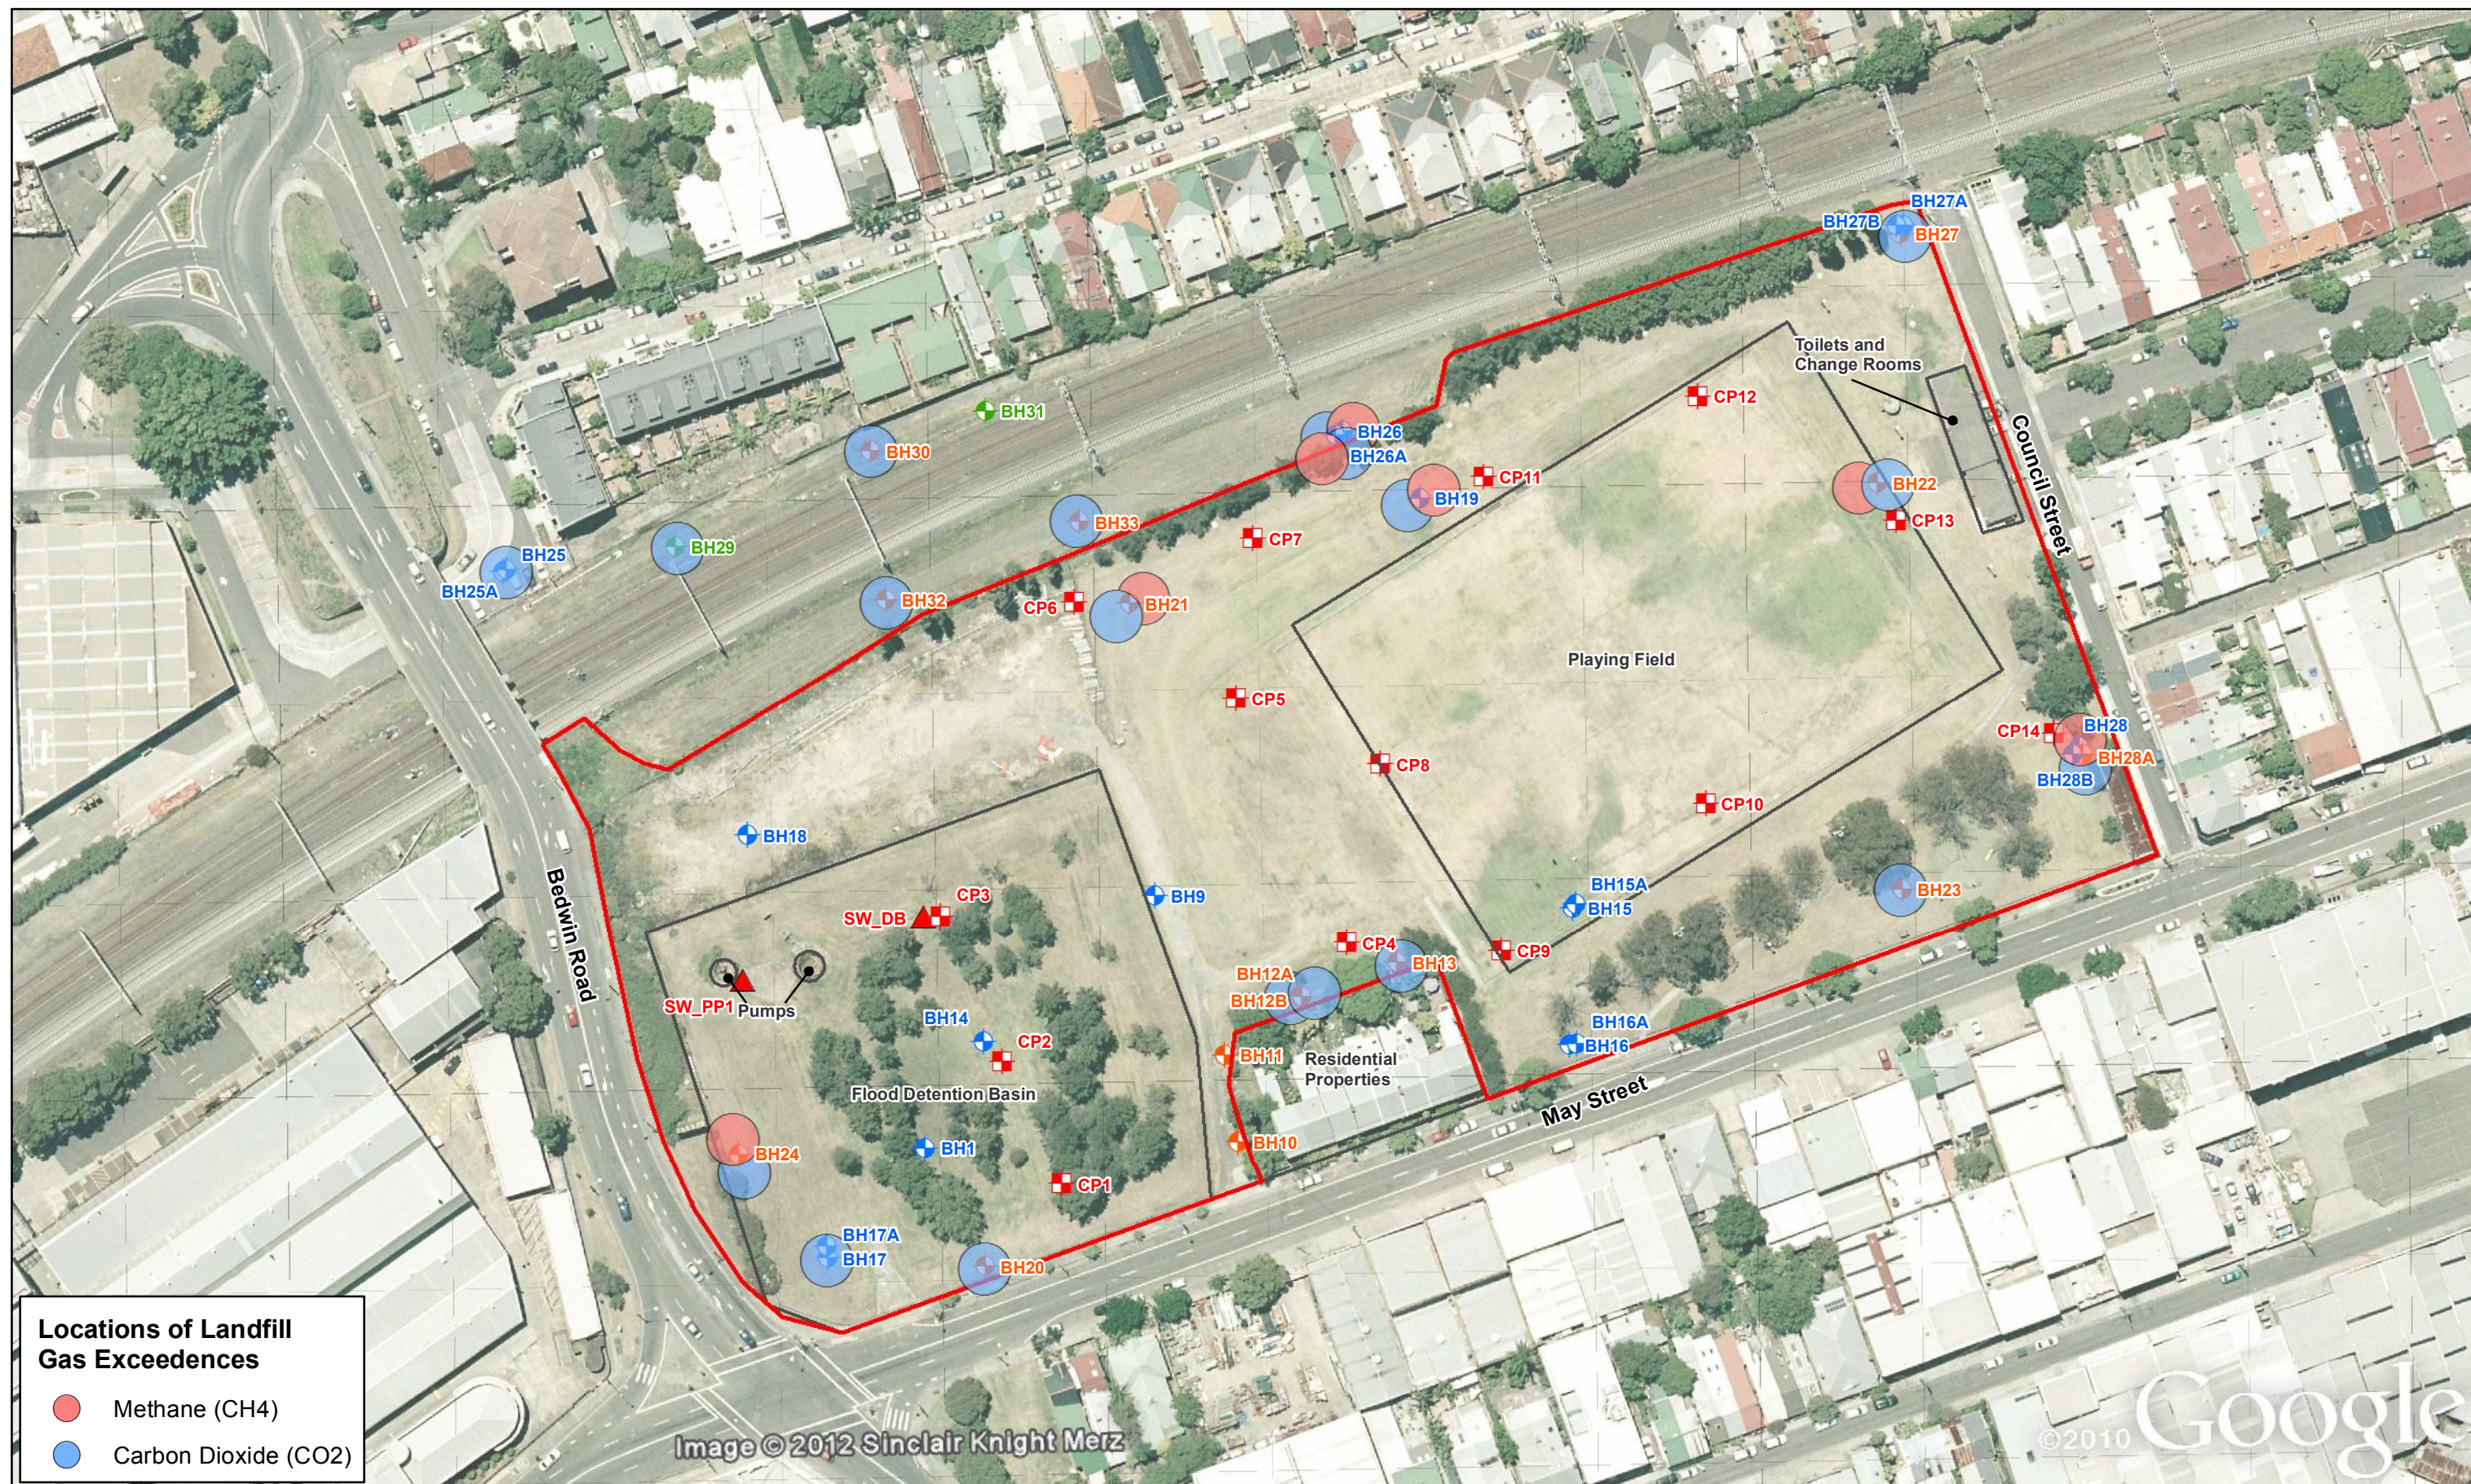
Figure 9 provides an overview of the gas monitoring data.
