Yeo Park Rotunda
Yeo Park, Old Canterbury Road, Ashfield

Conservation Management Plan

Date:
27th June 2023

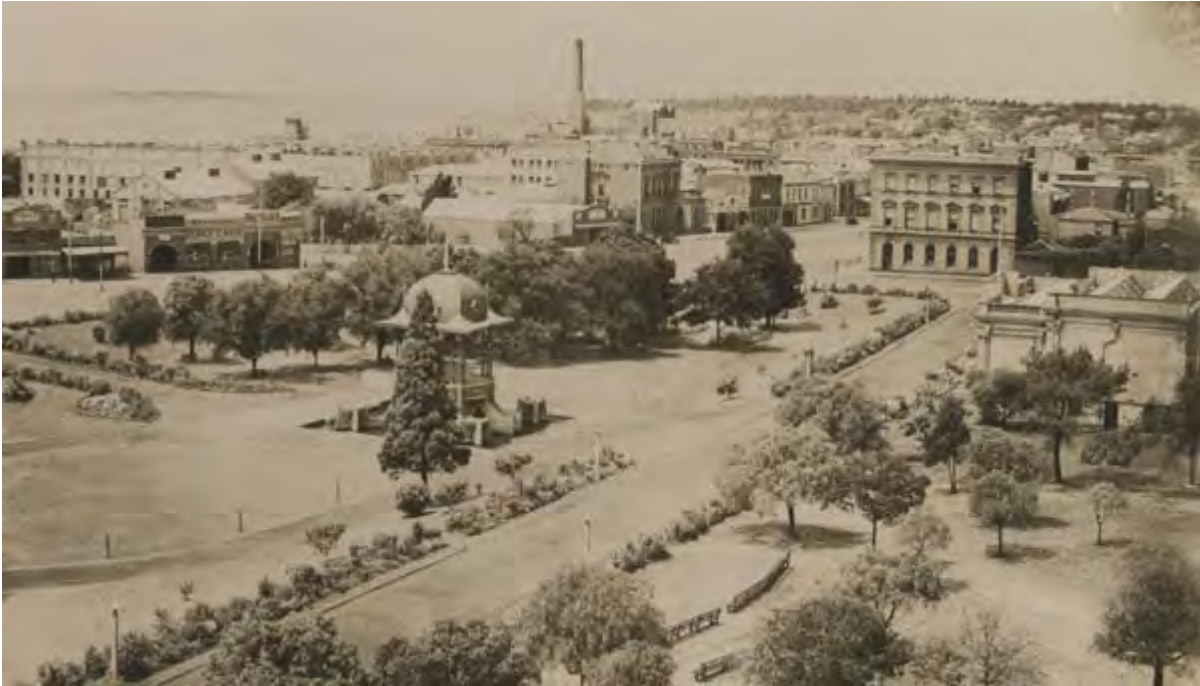
Figure 2.19: 1920s photograph of the band rotunda in Johnstone Park as built. The band rotunda at Yeo Park built in 1929 is a near identical copy. Source: Geelong Heritage Centre Main Photographic Collection, 2009/04722

Walsh's design of the Rotunda closely follows (perhaps copied entirely) the example in Geelong. As at Geelong,⁷³ it comprises:

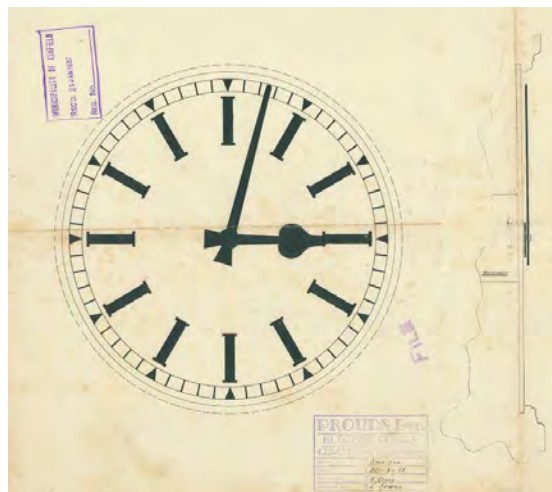
Figure 2.24: A drawing of the original dial and hands of the clock face installed by Prouds Ltd in 1937.
Source: Inner West Council

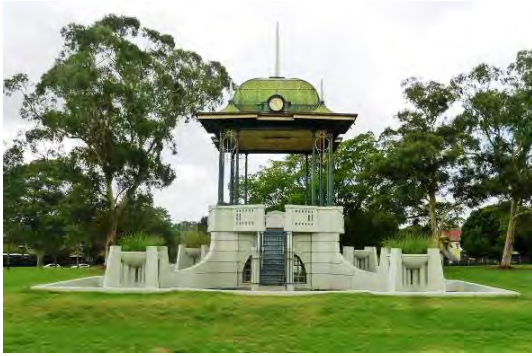
Figure 3.13: Northern elevation of rotunda

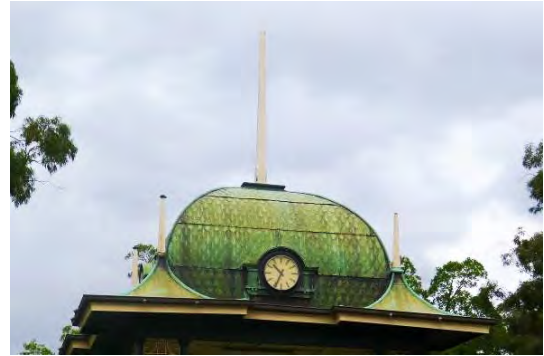
Figure 3.14: Detail of roof – western side.

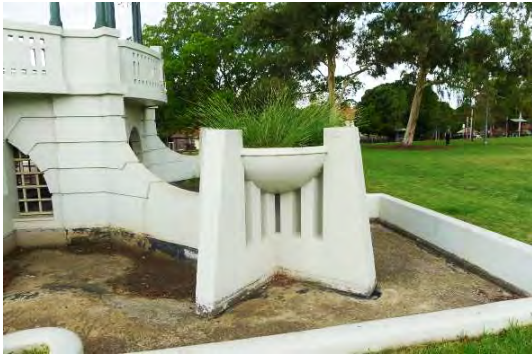
Figure 3.15: Typical detail of rotunda base and fern bowls within basin.

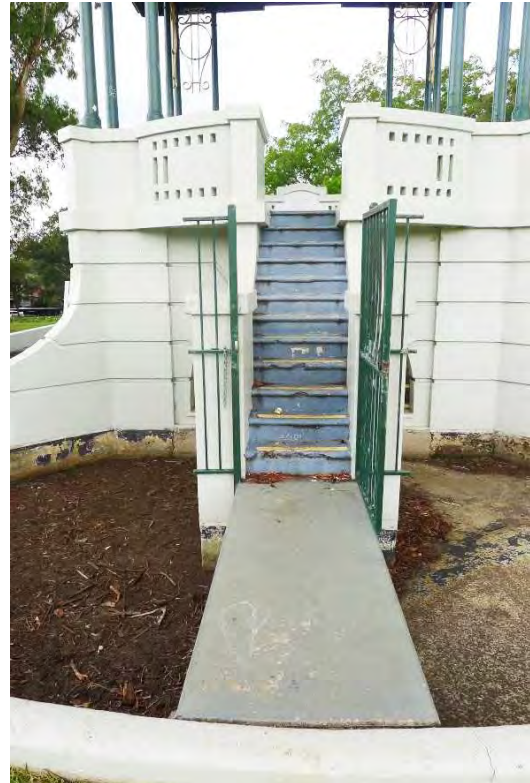
Figure 3.16: Concrete drawbridge and entry stairs into rotunda on northern side.

Drawbridge	<p>New concrete bridge permanently over basin.</p> <p>Rests on concrete ledge. Brick base underneath.</p>	G	L
Perimeter Wall	<p>Reinforced concrete with cement render.</p> <p>Some chips and vertical cracks at regular intervals along the wall.</p>	G	O
Stairs	<p>Steep, narrow concrete stairs with no handrail to either side. The width of the stairs measure 780mm at the narrowest point, and widen to 900mm. Each stair has a riser of 180-190mm and going of 230mm. Including the nosing, the total measured 260mm.</p> <p>The surfaces of the stairs are very smooth and have little traction. The nosings have also been knocked off most treads.</p>	P	O
Security Gate	Metal gate affixed to posts either side of stair entry.	G	MD
Undercroft			
Floor	Reinforced concrete with topping slab. Polished.	G	O
Ceiling	Reinforced concrete underside of floor of rotunda.	G	O
Drawbridge	Boarded drawbridge, wheels, Phillips head screws.	G	LT

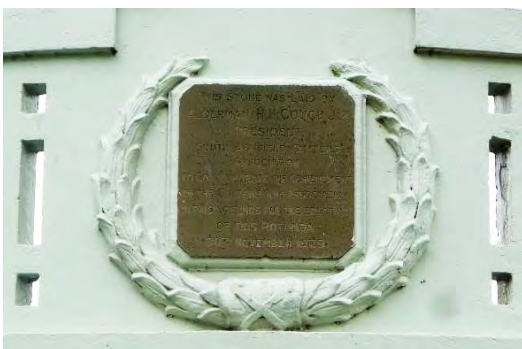
Figure 3.18: Typical trachyte plaque located at the centre of the perforated balustrade on the western side. Similar plaques are located on the eastern and /southern sides.

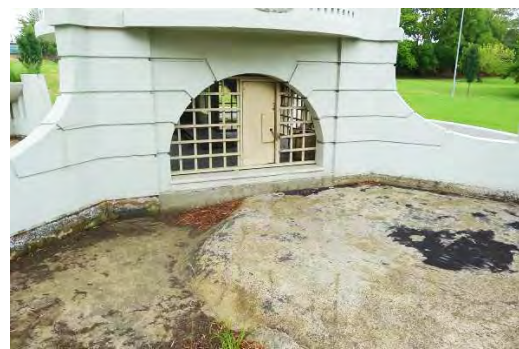
Figure 3.19: Basin and access door to undercroft. Note dark-coloured remnants of possibly original asphalt.

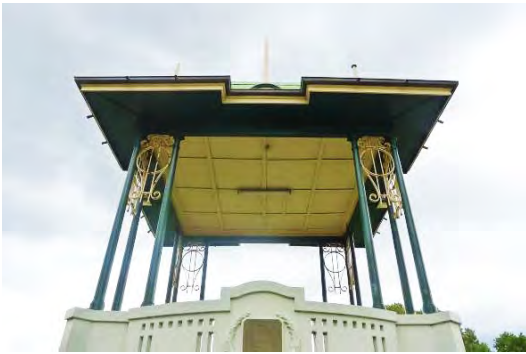
Figure 3.20: Ceiling of Rotunda

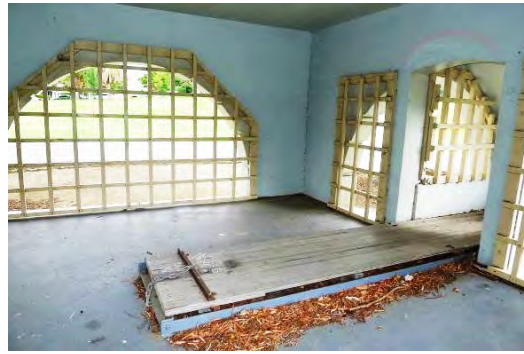
Figure 3.21: Undercroft area, showing boarded drawbridge and tracks.

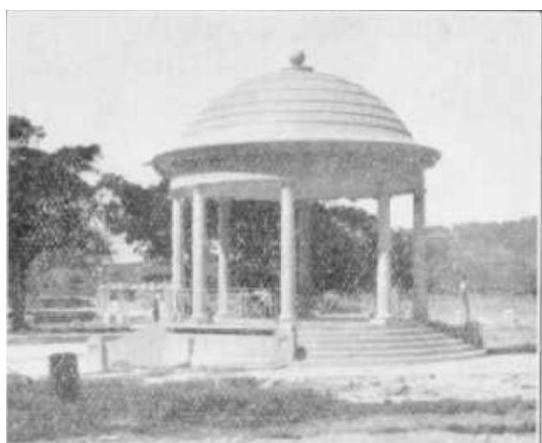
Figure 4. 2: The band rotunda at Balmoral Beach erected in 1930. Designed by the Council's architect, Albert Herbert Hale (1868-1941), and was built by Leslie Donan, who built the bandstand in Yeo Park in 1929. Source: *Building*, October 1930

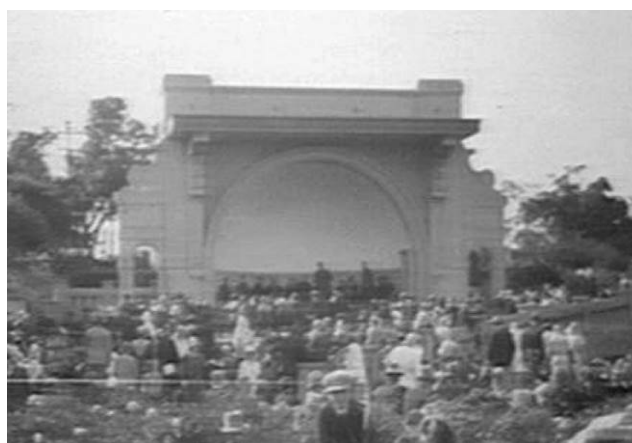
Figure 4. 3: The open-air proscenium type bandstand at Taronga Zoo erected in 1922. It was designed by architect Alfred Spain. Source: State Library of NSW (GPO1-22477)

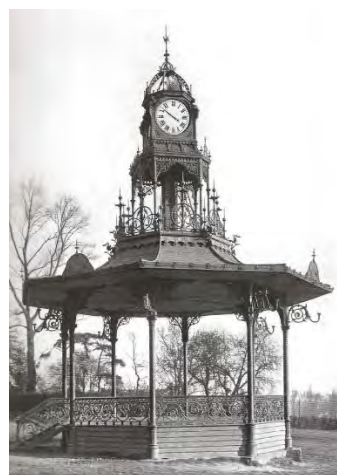
Figure 4. 11: 1896 photograph of a Saracen Foundry bandstand. Source: www.bbc.com

The incorporation of the four clocks in the roof of a bandstand, has precedents in Macfarlane's Saracen Foundry's late nineteenth century designs (see Figure 4.11),¹¹ but were very uncommon and rarely used in England, probably owing to the complexity, expense in initial outlay and recurring maintenance, and there being really no need for them in a public park. There is no other example of a bandstand with clocks in NSW.

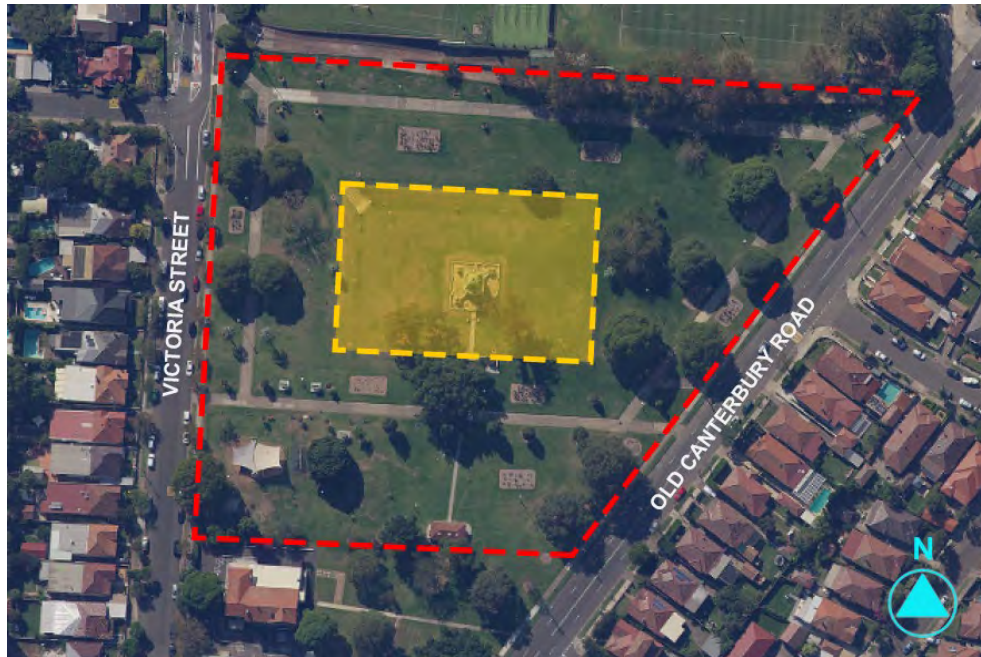
Figure 6. 1:
Definition of the
immediate setting
of the place (in
orange) and the
allotment
boundaries of Yeo
Park (in red).

Policy 2: The conservation policies contained in this report apply to the Rotunda and the immediate setting only as shown in Figure 6.1 including site features and in situ archaeology (both below ground, under buildings and within building cavities) held at the place.

Policy 3: The immediate setting of the place as an open grassed area defined by the sloping banks of the formed amphitheatre as shown in Figure 6.1. and should be retained.

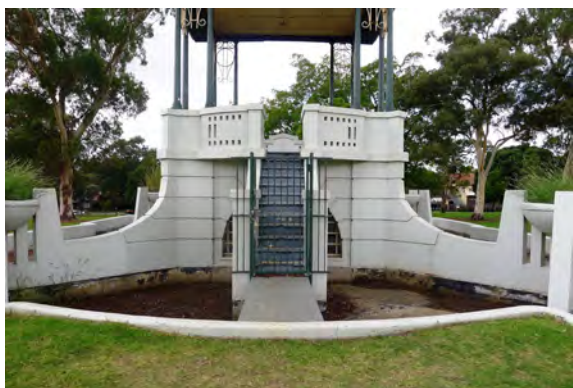
Figure 6.3: The later security gate to the steps

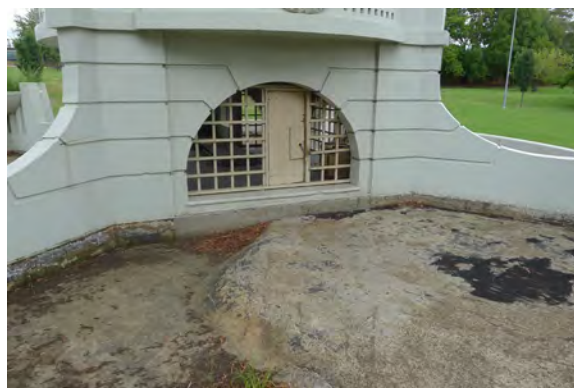
Figure 6.4: Lattice screens and entry door into undercroft.

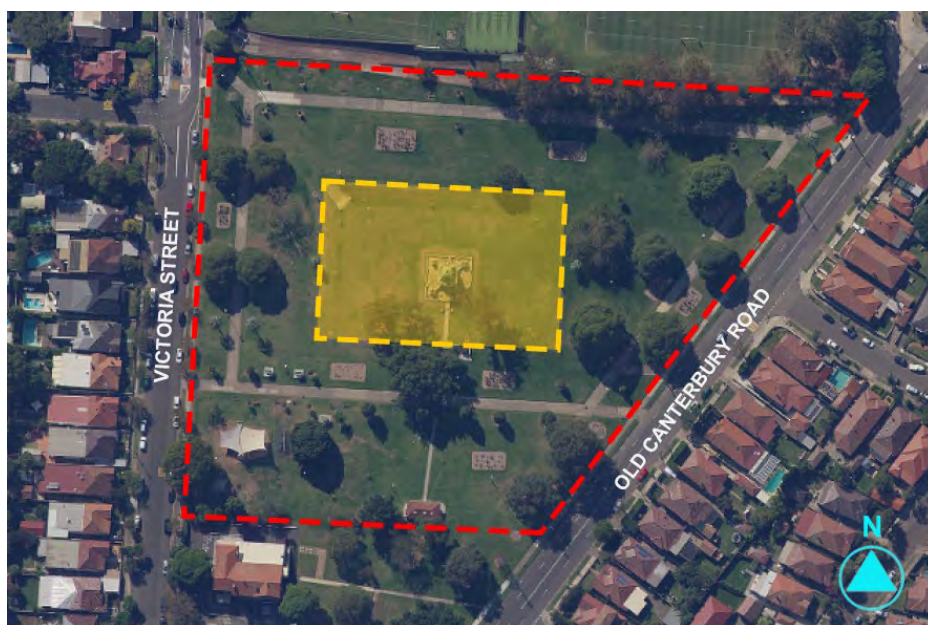
Figure 6. 5: Definition of the immediate setting of the place (in orange), which comprises the formed amphitheatre.

Policy 38: The existing configuration and landform of the immediate setting of the Rotunda (the formed amphitheatre) should be retained and maintained, including the stairs and absence of footpaths. Minor alterations may be appropriate to support the historic use or other compatible use of the place.
