Hazardous Building Materials Assessment

Leichhardt Depot Office

229 Catherine Street
Leichhardt NSW 2040

Inner West Council
March 2018

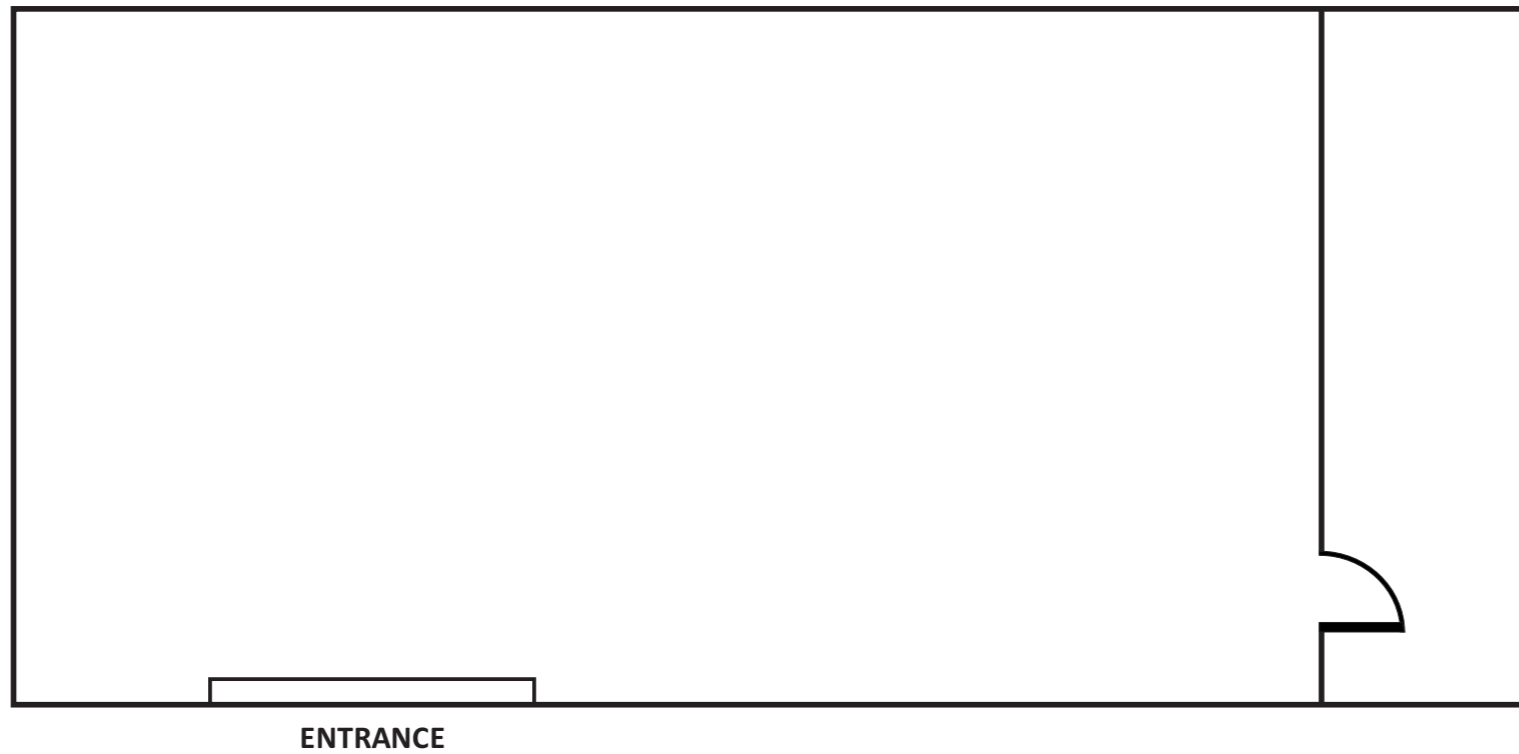
Leichhardt Depot Office Ground Level

*Only asbestos-containing materials (ACM) have been labelled on the attached site plan to prevent confusion and ensure that these materials are given priority for action. Therefore, other hazardous materials may be present within the building and the register attached in **Section 1** should be consulted prior to work commencing.*
