Hazardous Building Materials Assessment Lambert Park – Turnstile Building Marion Street Leichhardt NSW 2040

Inner West Council
April 2018

Job No.: 57722-065

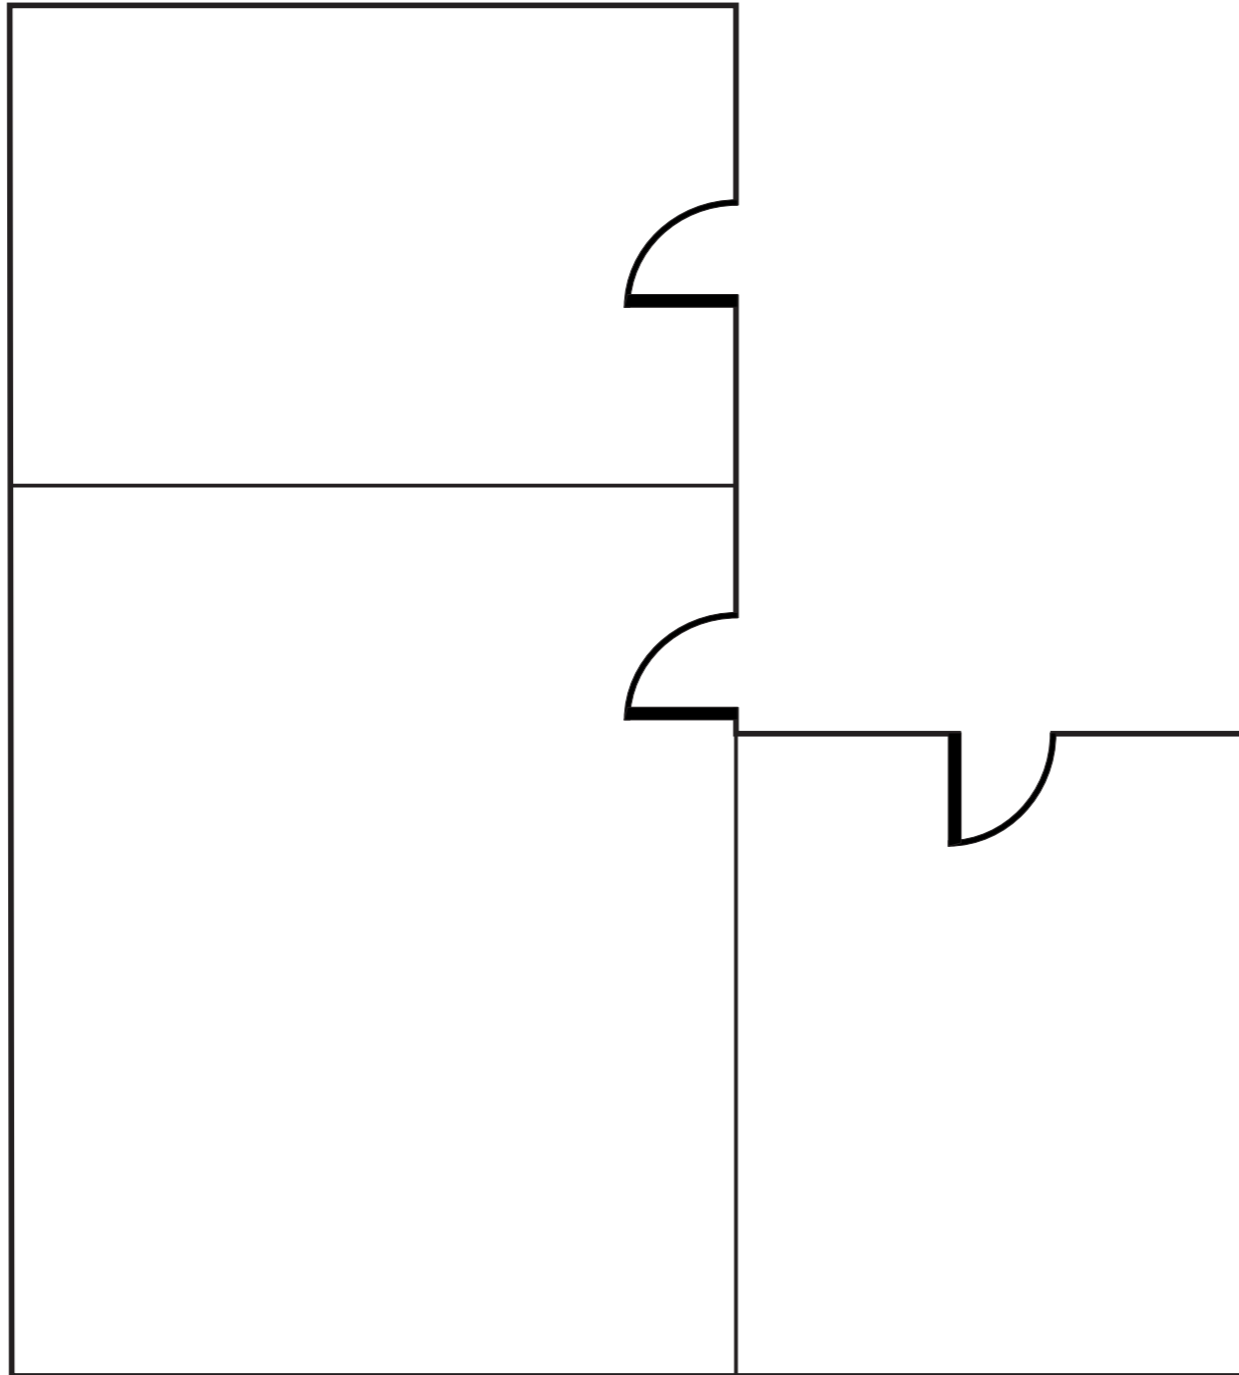
Lambert Park Turnstile Building, Leichhardt Ground Level

*Only asbestos-containing materials (ACM) have been labelled on the attached site plan to prevent confusion and ensure that these materials are given priority for action. Therefore, other hazardous materials may be present within the building and the register attached in **Section 1** should be consulted prior to work commencing.*
