Hazardous Building Materials Assessment Johnson Park Toilets Constitution Road Marrickville NSW 2204

Inner West Council
April 2018

Job No.: 57722-087

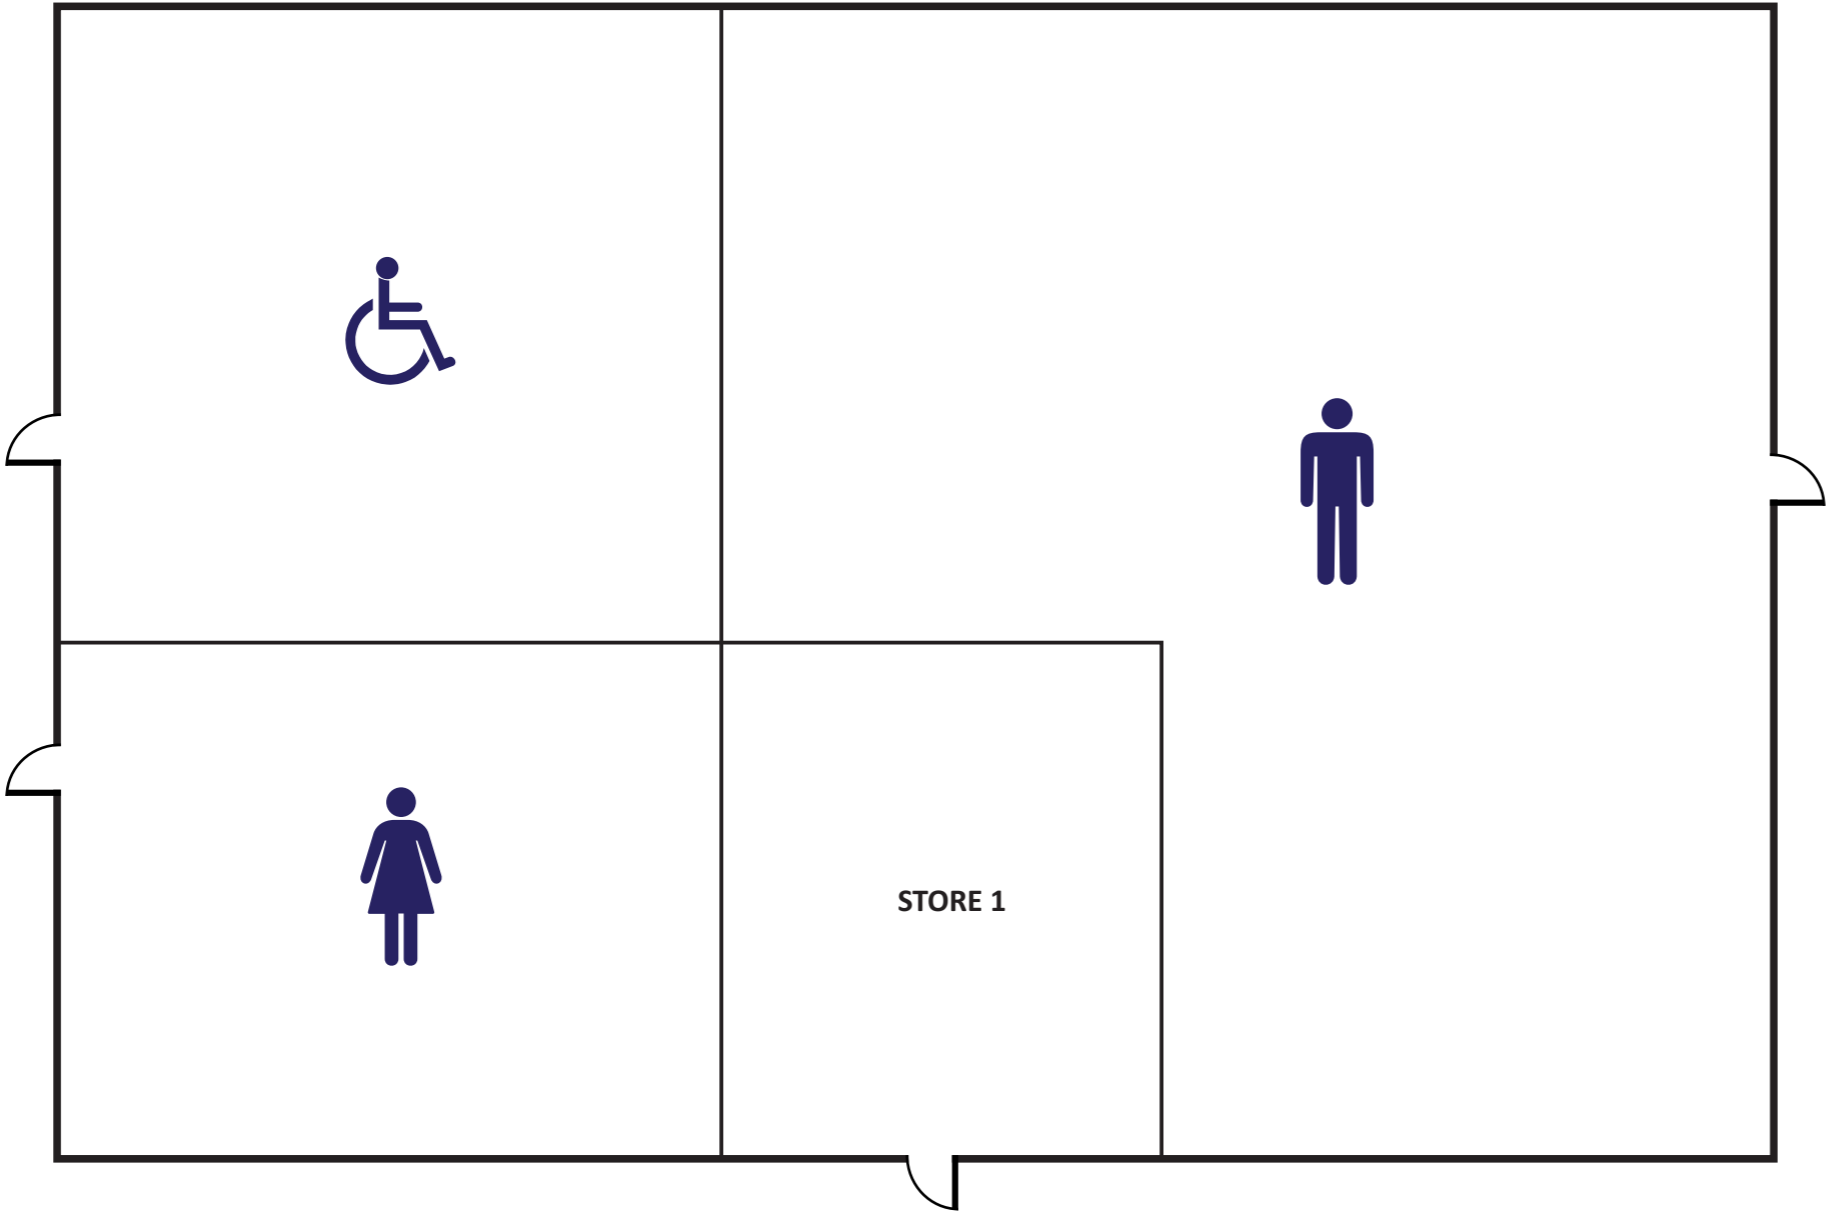
Johnson Park Toilets, Marrickville - Ground Level

*Only asbestos-containing materials (ACM) have been labelled on the attached site plan to prevent confusion and ensure that these materials are given priority for action. Therefore, other hazardous materials may be present within the building and the register attached in **Section 1** should be consulted prior to work commencing.*
