Hazardous Building Materials Assessment

Tillman Park Toilets

Unwins Bridge Road,
Tempe NSW 2044

Inner West Council
April 2018

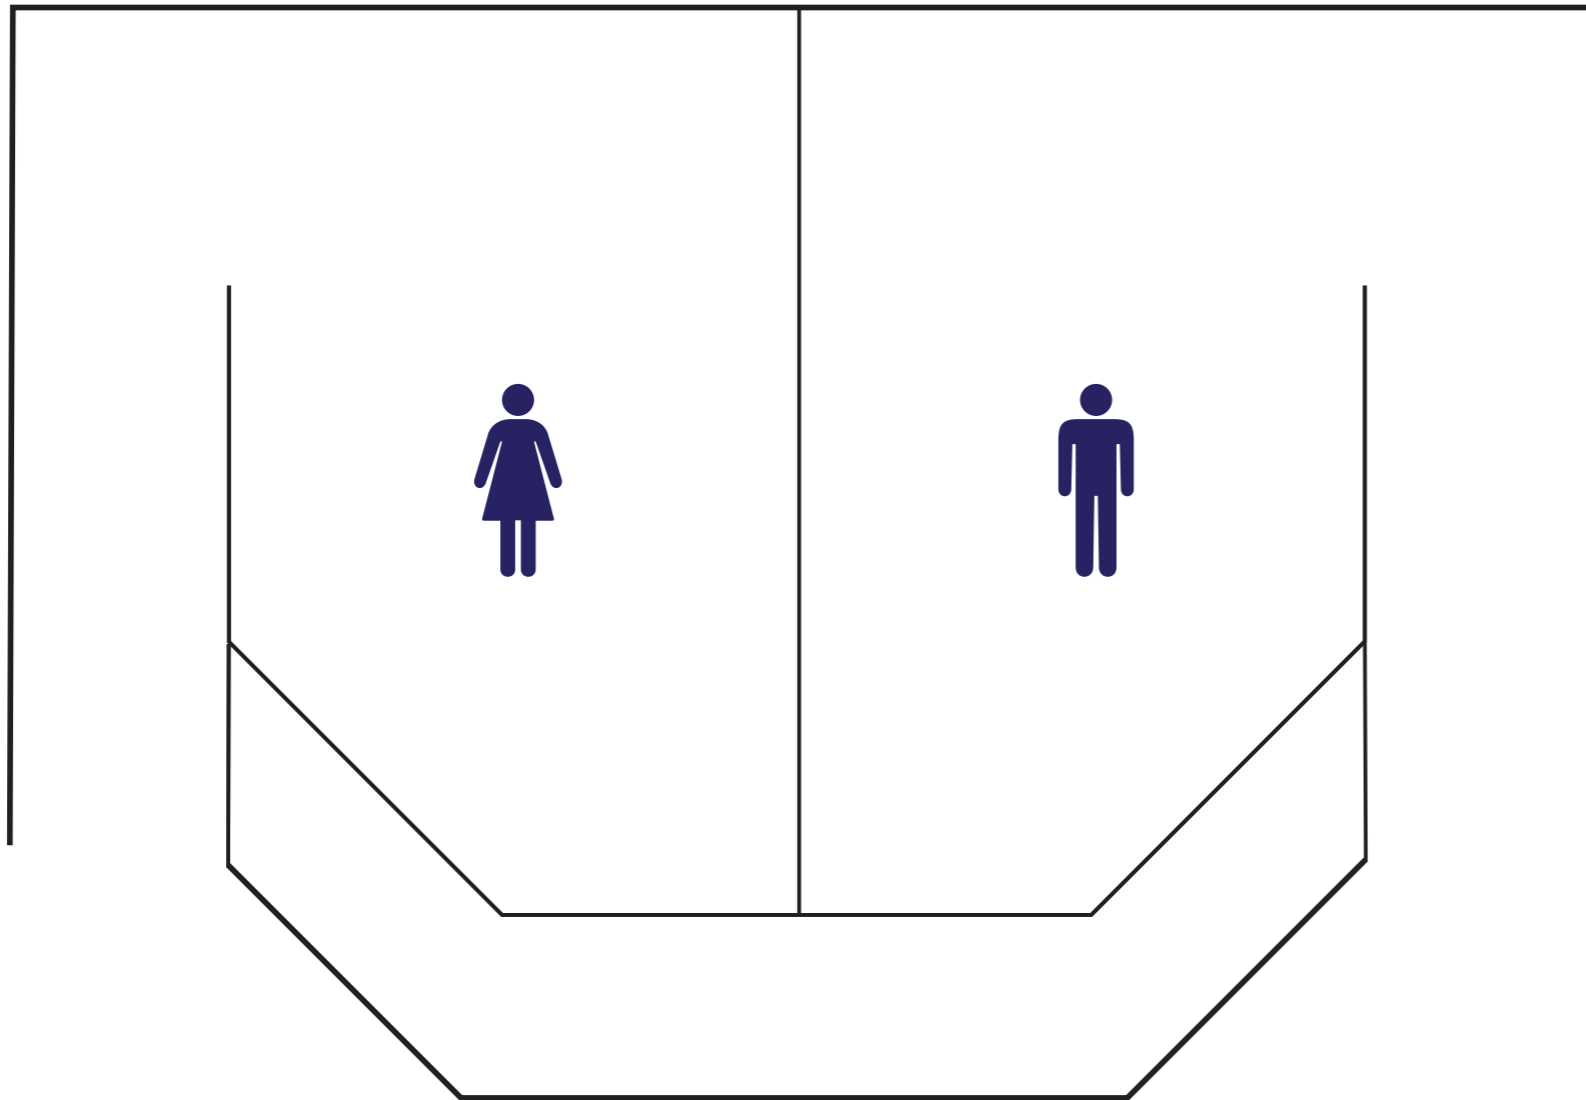
Drawn by: TME	Date: 22/02/2018
Checked by: MM	Date: 22/02/2018
Figure number: 1	Revision: 2
File name: 57722-115 - Rev 2

*Only asbestos-containing materials (ACM) have been labelled on the attached site plan to prevent confusion and ensure that these materials are given priority for action. Therefore, other hazardous materials may be present within the building and the register attached in **Section 1** should be consulted prior to work commencing.*
