DEVELOPMENT ASSESSMENT REPORT

<b>Application No.</b>	REV/2022/0026
<b>Address</b>	5 Farleigh Street ASHFIELD NSW 2131
<b>Proposal</b>	S8.2 Review application of DA/2022/0244 that approved tree pruning. The review seeks tree removal and pruning.
<b>Date of Lodgement</b>	13 September 2022
<b>Applicant</b>	Mrs Joanne M Herron
<b>Owner</b>	Mr Adam J Herron Mrs Joanne M Herron
<b>Number of Submissions</b>	One (1)
<b>Value of works</b>	\$12,000.00
<b>Reason for determination at Planning Panel</b>	Refusal of S8.2 Review
<b>Main Issues</b>	Removal of healthy tree
<b>Recommendation</b>	Refusal
<b>Attachment A</b>	Reasons for refusal
<b>Attachment B</b>	Arborist's report
<b>Attachment C</b>	Conditions of consent (in the event of approval)

<b>ABN</b> <b>97 363 034 490</b>	PRELIMINARY TREE ASSESSMENT FOR A TREE LOCATED IN 5 FARLEIGH STREET, ASHFIELD
Phone 0405 626 970  Email majbruce@hotmail.com

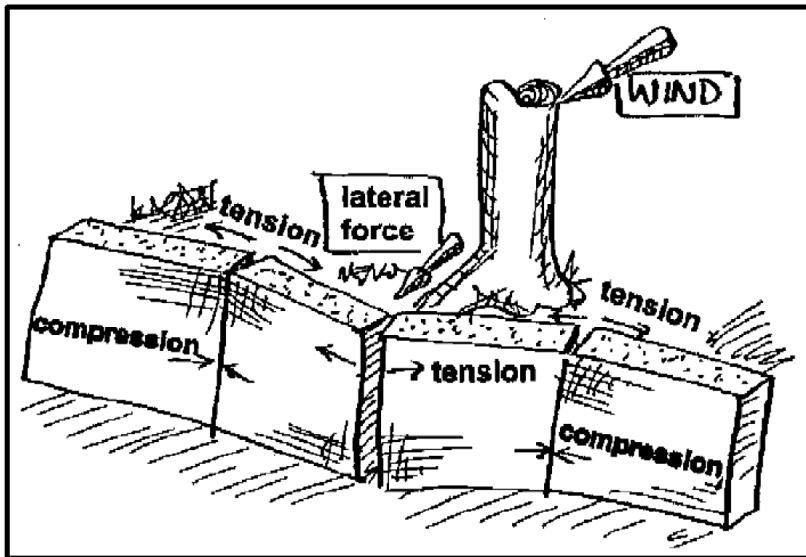
- 5.2 The Spotted Gums structural roots are highly likely to be pressing against the wall of the swimming pool. This pressure will increase as the tree gets bigger. There is the potential that the Spotted Gum will eventually cause the development of vertical cracks in the fabric of the swimming pool wall. Mattheck et al (2003), P.758 states "As far as the interaction with buildings is concerned, the small fatigue strength of the brickwork against the fatigue loads introduced by the root also plays a major role. Even small roots may cause damage to the building by fatigue load." and "Against a wall pressing roots (lateral force) can cause different crack formations" (See Figure 7 and Figure 13) There is the potential for the swimming pool wall to fail from compression forces generated by the Spotted Gum's structural roots and amplified by strong winds. The Spotted Gum has already started to buttress, and the structural root are beginning to disturb the soil surface and artificial turf, as they expand in dimension, and the roots are becoming a trip hazard. (See Figure 9) There are structural roots starting to lift the pool safety fence. (See Figure 10) Further, there is a large crack developing in a nearby retaining wall. (See Figure 11) The cracks pattern is similar to the pattern described by Mattheck et al (2003), P.758, (See Figure 12) with the crack appearing to be larger at the top with the top of the wall curving up at the top of the crack. This Spotted Gum will continue to damage surrounding structures, with the potential to cause damage to the heritage listed dwelling. Unfortunately, the Spotted Gum is too large for the location and should be removed;

Figure 6: Showing the potential mechanism for damage to the swimming pool wall from Figure 10: Vertical crack caused by a root pressing against the wall. Mattheck et al (2003), P.759

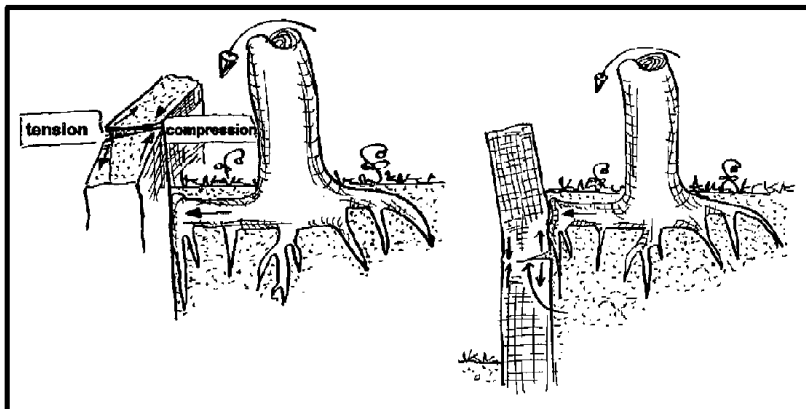
Figure 7: Showing the development of roots compressing against a wall from Figure 11: Easy to detect and hidden cracks caused by roots pressing against walls. Mattheck et al (2003), P.759

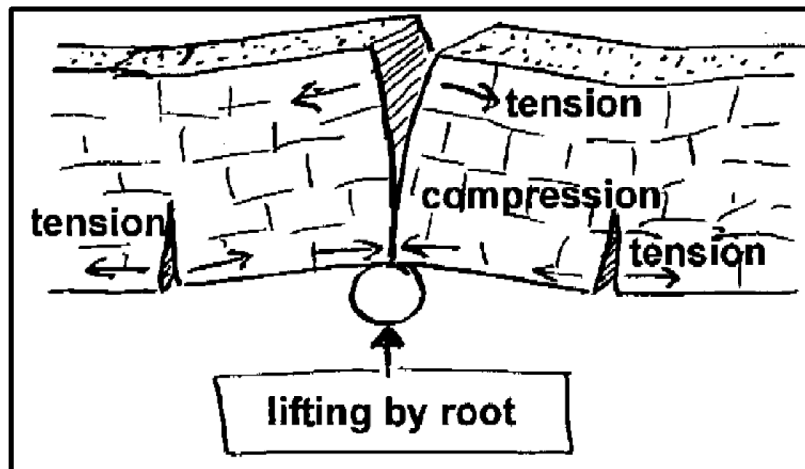
Figure 12: Showing how a root lifts and cracks a wall from Figure 9: Roots can lift heavy loads. The induced bending stresses cause cracks. Mattheck et al (2003), P.758
