FENWICK'S STONE BUILDING
2-8 WESTON STREET
BALMAIN NSW 2041

CONSERVATION MANAGEMENT PLAN

JANUARY 2009

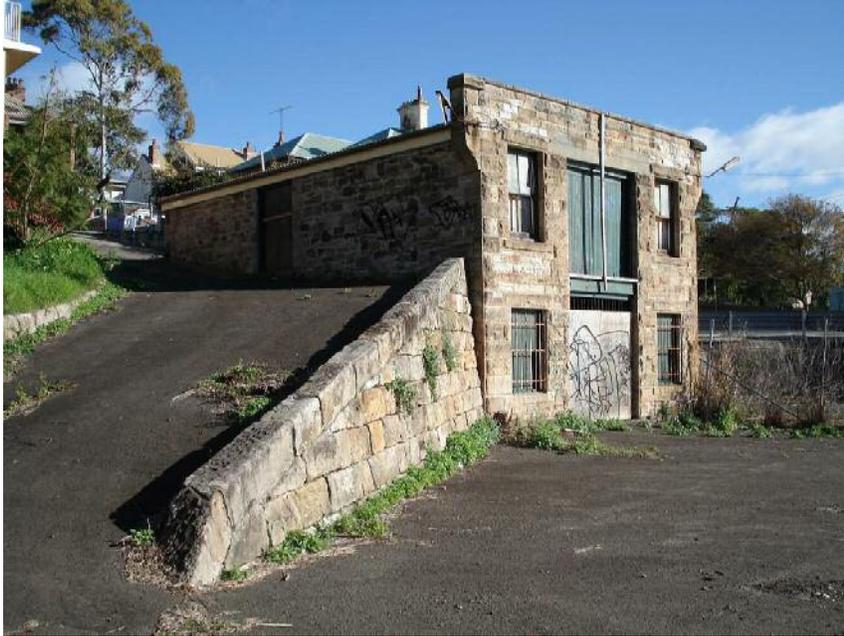
Figure 13 Photograph - view of the building from the south-east. NBRSPartners (WDW), 2007.

The stone retaining wall and ramp of 1963 abuts the north-eastern corner of the building. Intrusive elements include steel grilles on windows and two fluorescent luminaires fixed on steel poles to the parapet. The windows are double hung timber sashes each with two panes divided vertically. They are in poor condition. The doors do not appear to be original and are likely to be replacements of the 1880s originals. A *Ficus* spp. weed is growing at the foot of the wall.

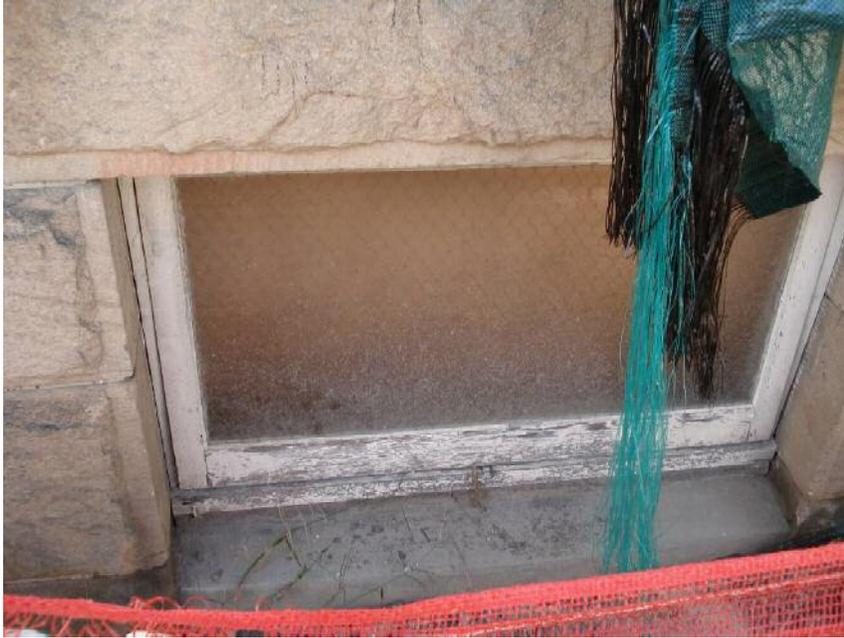
The western façade is not visible from the key views from the south-east through to the north. It was substantially modified in 1963 not only by the removal and replacement of the roof but by increasing the ground level. The rubble wall has two windows. Both have rock-faced stone lintels and appear to be original openings. The window frame and sash of the northern window appear to be original or early - it is a four pane window. A concrete kerb - presumably from 1963 - has been placed in front of this window making a pit for water in addition to the hydrostatic pressure and water ingress from the earth. The southern window frame, sash and concrete sill appear to date from 1963. The window comprises a single pane of wired glass in a timber frame. Clearly the ground level was raised somewhat in 1963 but the height of the early window whose sill is higher than that on the northern wall indicates that the first constructed ground level may have been quite high up the building in this location in any case. There is a deep crack through the stonework near the south-western corner of the wall.

Figure 21 *Photograph - the southern window of the western elevation.
NBRSPartners (WDW), 2008.*

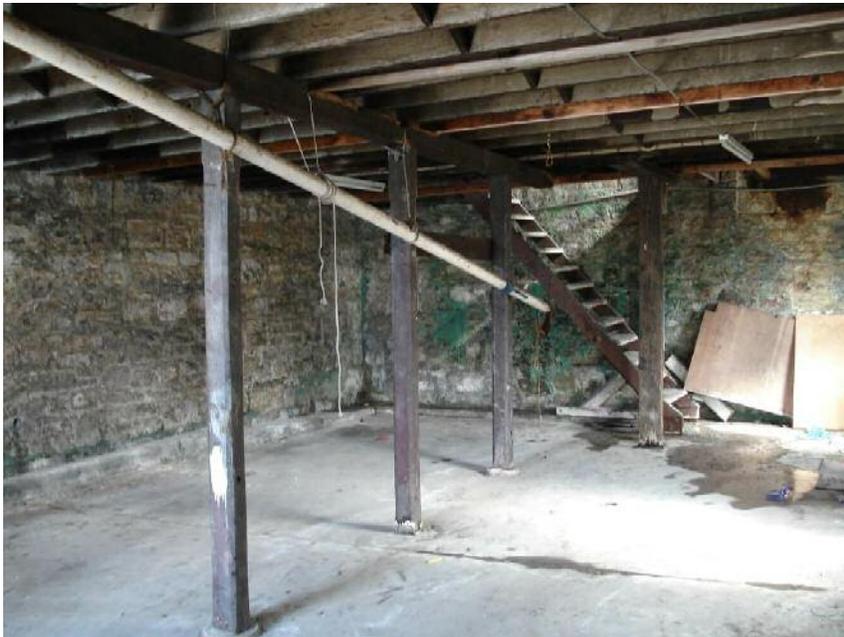
The walls are un-rendered sandstone rubble walls. There are serious damp issues particularly in the western and southern walls which retain the ground on the other side of the wall at least to the height of the first floor. Geotechnical investigations indicate that near the southern wall, rock can be found at 1.4 metres above ground floor level. The nature and condition of the outer side of the walls and their interface with the natural foundations has not been investigated and is unknown.

Figure 27 Photograph - The ground floor interior looking to the south-west. NBRSPartners (WDW), 2008.
