# **VINNER WEST COUNCIL**

DEVELOPMENT ASSESSMENT REPORT		
Application No.	D/2018/213	
Address	Department of Housing Lease, 18A Adolphus Street, BALMAIN NSW 2041	
Proposal	Demolition of existing retaining walls and boundary fences and construction of new retaining walls and front boundary walls to the Adolphus and Wallace Street frontages.	
Date of Lodgement	27 April 2018	
Applicant	Land and Housing Corporation	
Owner	Leichhardt Municipal Council and New South Wales Land and Housing Corporation [allows panel members to identify Council applications &/or conflicts]	
Number of Submissions	1 objection	
Value of works	\$150,000	
Reason for determination at Planning Panel	Conflict of Interest – Council owned land	
Main Issues	Tree removal; Loss of landscape amenity	
Recommendation	Approval	
5 1 7 7 7 7 7 7 7 7 7 7 7 7 7	8 10 12 14 16 18 10 12 14 16 18 10 12 14 16 18 10 12 14 16 18 14 16 18 10 12 14 16 18 10 10 10 10 10 10 10 10 10 10

# 1. Executive Summary

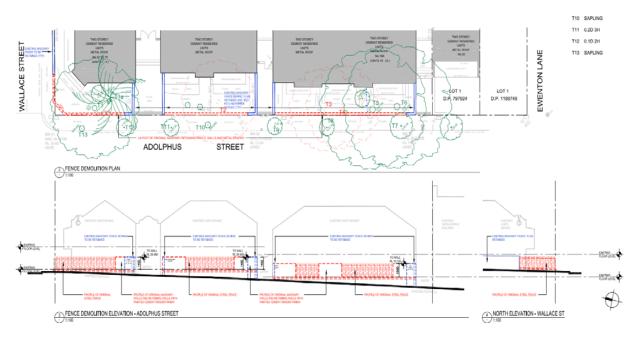
Figure 1: Proposed tree removal and demolition of retaining wall/ front fence at 18A Adolphus Street, Balmain

Extracts of the proposed plans are shown in the figures below.

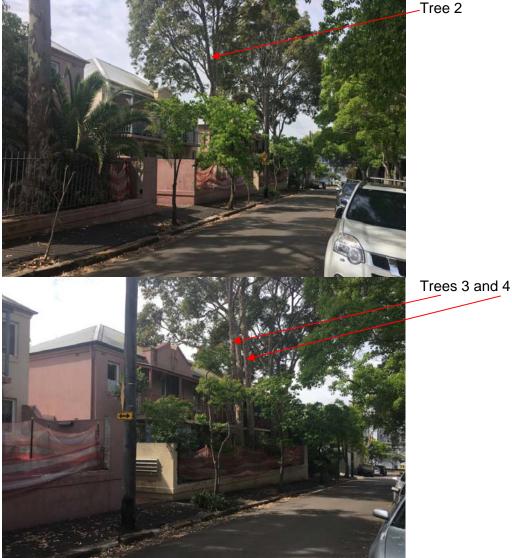
Figure 3: Photo of existing trees to be removed at 18A Adolphus Street, Balmain

In particular, there are concerns of foreseeable physical damage of the three subject trees during demolition due to the close proximity to the existing retaining wall to the trunk flare and suspected structural roots from the above trees.

Photo of the trees proposed to be removed is shown below.

Further concerns are raised in relation to the possibility of the trees becoming destabilised in their current locations during the demolition of the retaining wall due to fill being identified to be comprising of large sandstone pieces, bricks, gravel and concrete amongst silt and other rubble. These soils are considered low sheer soils "*which have limited ability to hold large trees under heavy loads. These trees would be prone to lodging*".

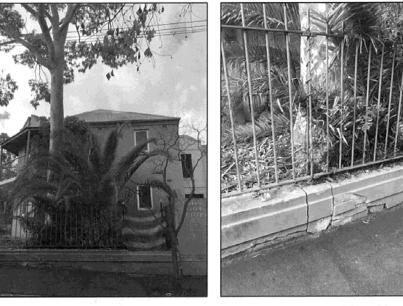
Figure 1: Tree 1 & 1a.

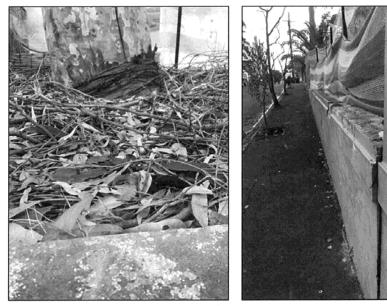
Figure 5: Tree 2.

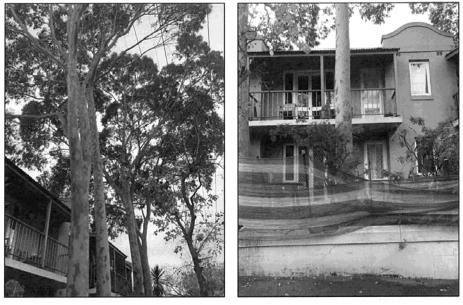
Figure 9: Showing the crowns of Tree 3, 4, 5, 6 & 7.

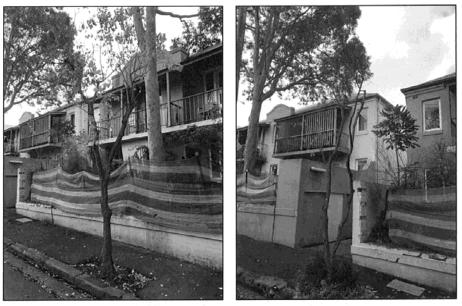
Figure 15: Tree 8.

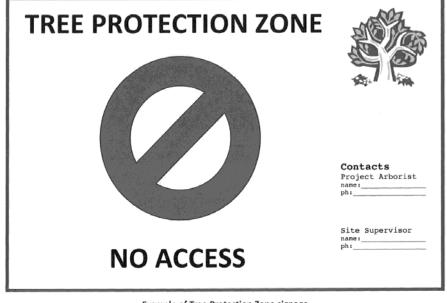
Example of Tree Protection Zone signage

1.3 Tree Protection signage is to be attached to each *Tree Protection Zone* and displayed from within the development site in accordance with AS 4970-2009 Protection of Trees on Development Sites (Australian Standard<sup>®</sup>, 2009), Section 4.4 – see example below.

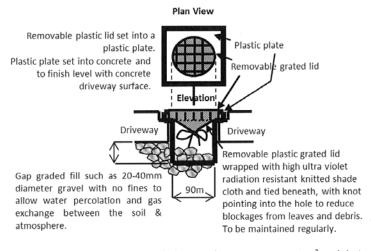
## Irrigation / Gaseous Exchange Vent

NOTE: Such vents can be installed in a grid pattern at 1 per 1  $m^2$  and their planning and construction utilised in consultation with an appropriate structural or civil engineer.

- 1.4.1.4 Watering / Gaseous exchange vents are to be installed in the area of the driveway that passes within the dripline of the tree or the prescribed *Tree Protection Zone* area and the number and location are to be determined by a Consultant Arboriculturist and the driveway design approved by a Certified Engineer. Exposed edges of the path are to be concealed with the finished level beside the path equivalent to the top of the path by minimal filling with a sandy soil and turf, or mulch, or a garden bed with minimal cultivation, or other landscape treatments as appropriate. (see image below)

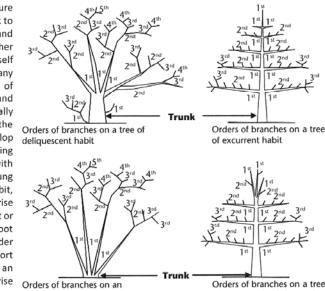
Figure 21 Orders of branches.

Orders of branches on an acaulescent tree of deliquescent habit Orders of branches on a tree of excurrent habit becoming deliquescent in the upper

**Orders of Branches** The marked divisions between successively smaller branches (James, 2003)p. 168, commencing at the initial division where the trunk terminates on a deliquescent tree or from lateral branches on an excurrent tree. Successive branching is generally characterised by a gradual reduction in branch diameters at each division, and each gradation from the trunk can be categorised numerically, e.g. first order, second order, third order etc. (See Figure 21.)
