Hazardous Building Materials Register and Asbestos Management Plan

Ashfield Council

**Ashfield Early Learning Centre
10 Norton Street
ASHFIELD NSW 2131**

Report Number: 9206.12.HMSR

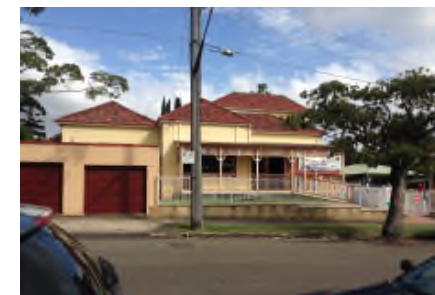
Asset Photo

ID	Location	Material Type	Sample No.	Analysis Result	Extent	Condition	Friability	Disturbance Potential	Risk Status	Re-inspect Date	Control Priority	Control Recommendation	Removed	Photos
Exterior														
1	Eastern porch Northern and southern ends - Upper panels (inaccessible)	Asbestos Cement Sheeting	-	Assumed Positive <i>Assumed to Contain Asbestos (Visually Assessed)</i>	~4m ²	Good	Non-Friable	Low	Low	Sep 2018
