Hazardous Building Materials Register and Asbestos Management Plan

Ashfield Council

**Brown Street Car Park
Brown Street
ASHFIELD NSW 2131**

Report Number: 9206.11.HMSR

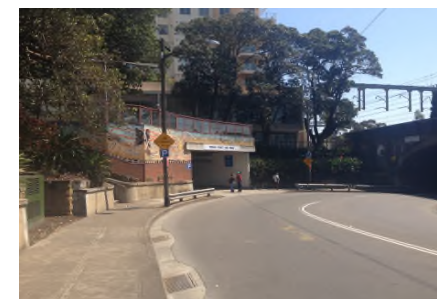
Asset Photo

ID	Location	Material Type	Sample No.	Analysis Result	Extent	Condition	Friability	Disturbance Potential	Risk Status	Re-inspect Date	Control Priority	Control Recommendation	Removed	Photos
Exterior														
1	Throughout	Various	-	Negative No Hazardous Materials Detected (Visually Assessed)	-	-	-	-	-	-	-	-	-	Photo 1
