Enmore Park

plan of management + masterplan

ENMORE PARK PLAN OF MANAGEMENT

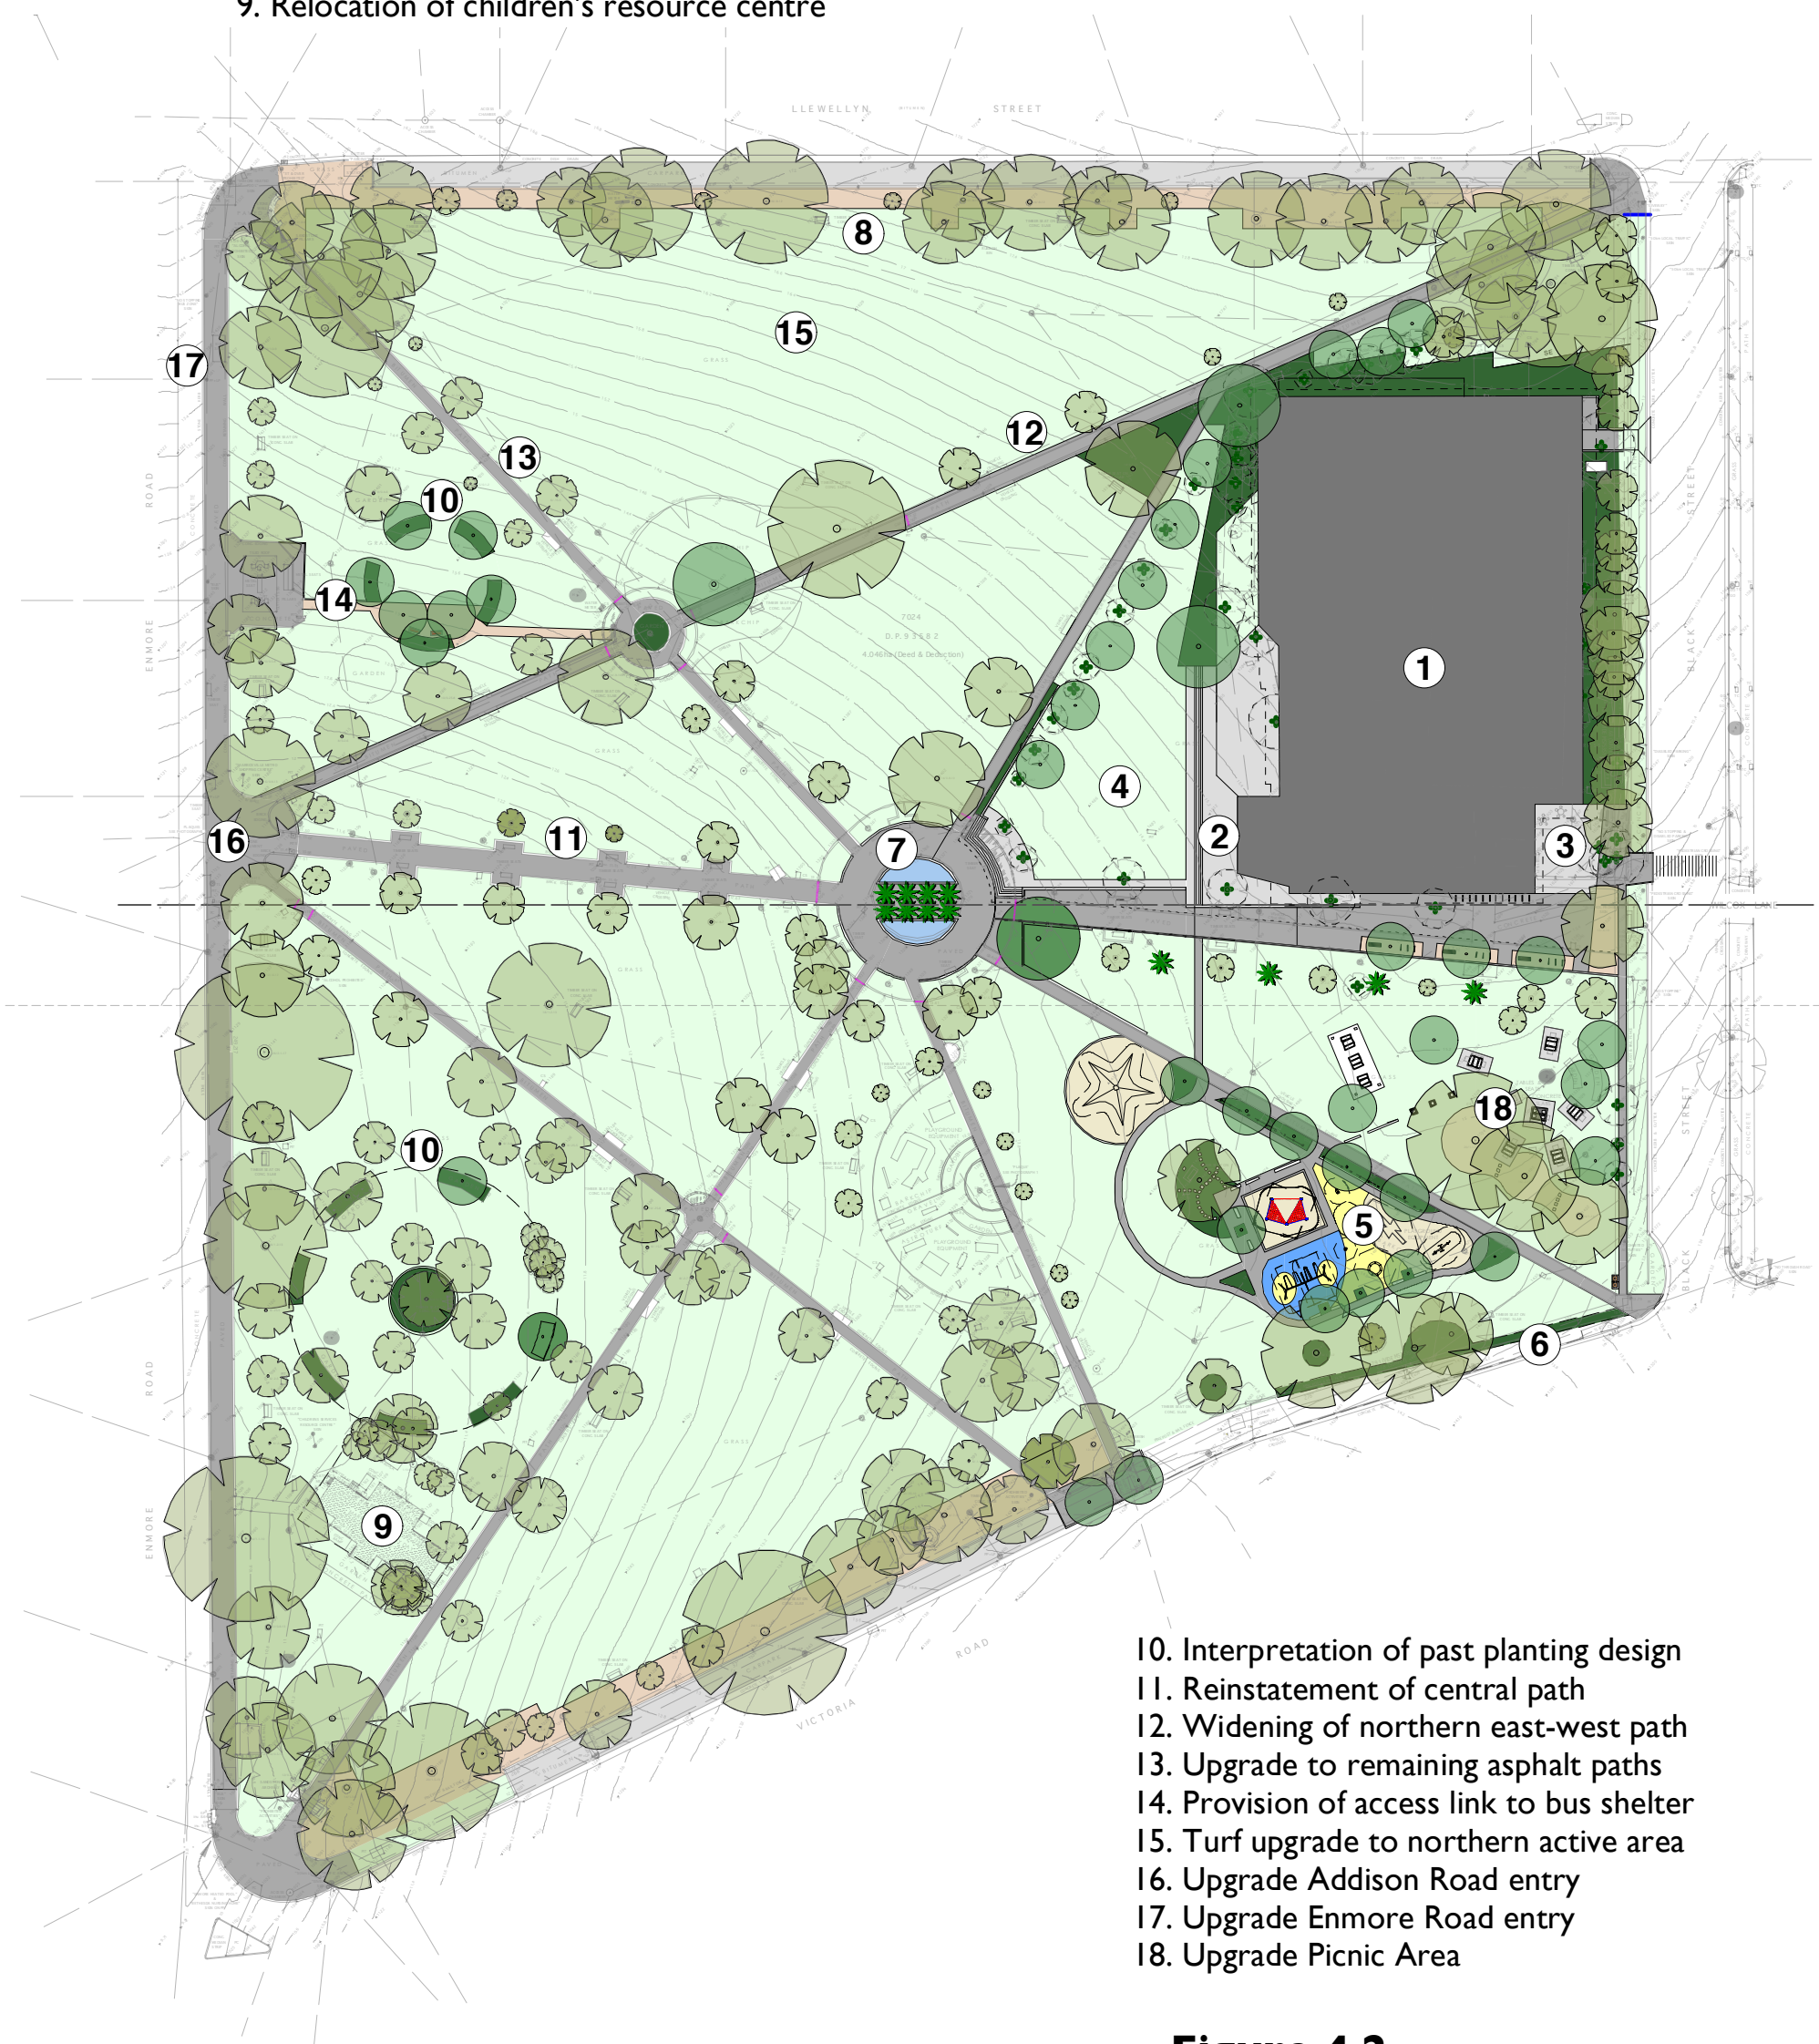
Figure 4.2
Masterplan

1. Pool complex redevelopment
2. Terrace
3. Landscaped pool entry forecourt
4. Grassed Terrace
5. Upgrade to rocket playspace
6. Improvements to Victoria Rd. frontage
7. Upgrade to central rondel
8. Llewellyn St. upgrade
9. Relocation of children's resource centre

The Concept Masterplan is the culmination of potentially three phases of park upgrading, itself representing Phase Three – Long Term (refer Figure 4.2).

Figure 4.2 on the following page describes the preferred masterplan strategies identified in implementation of the detailed planning policies.

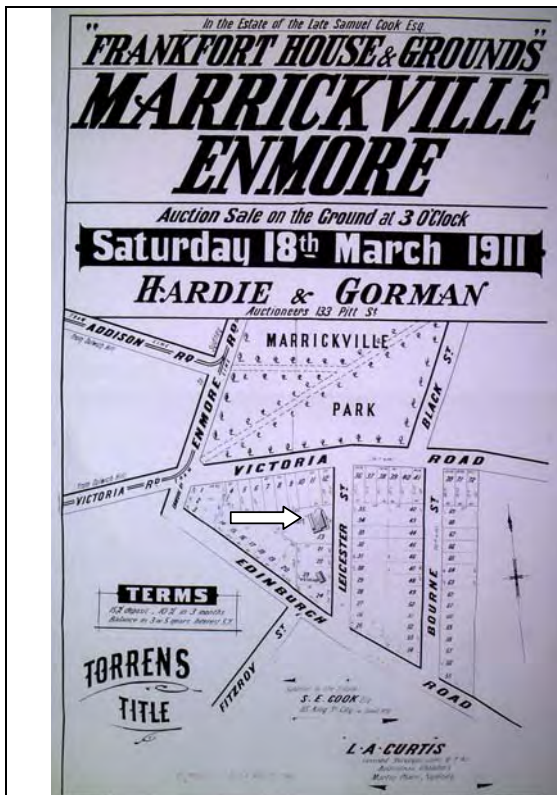
Figure H3 – 1911 subdivision plan for the *Frankfort Estate*, showing Enmore Park (then Marrickville Park) with two paths, one from the Addison Rd entry and one extending NE/SW across the park. This representation of paths may have been indicative only. Source: Marrickville local history centre (aperture card).

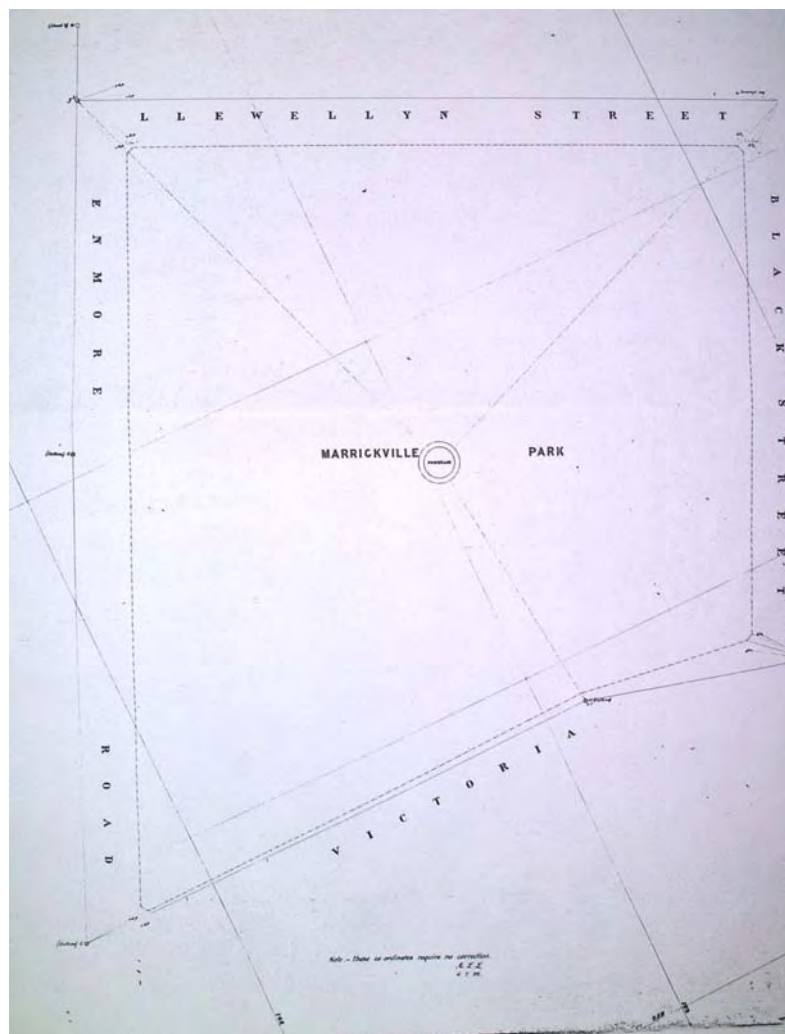
Figure H5 – Sydney Water plan from 1892 shows the boundaries of the park and a fountain which formerly stood at its centre. Source: Marrickville local history centre (aperture card).

A Sydney Water plan of the park from 1892 shows a broad fountain at the centre of Enmore Park, then referred to as Marrickville Park. This fountain reputedly contained ferns within it, according to a letter from a local resident contained in Council correspondence files from 1926-29 (File No. 54 Council Archives).

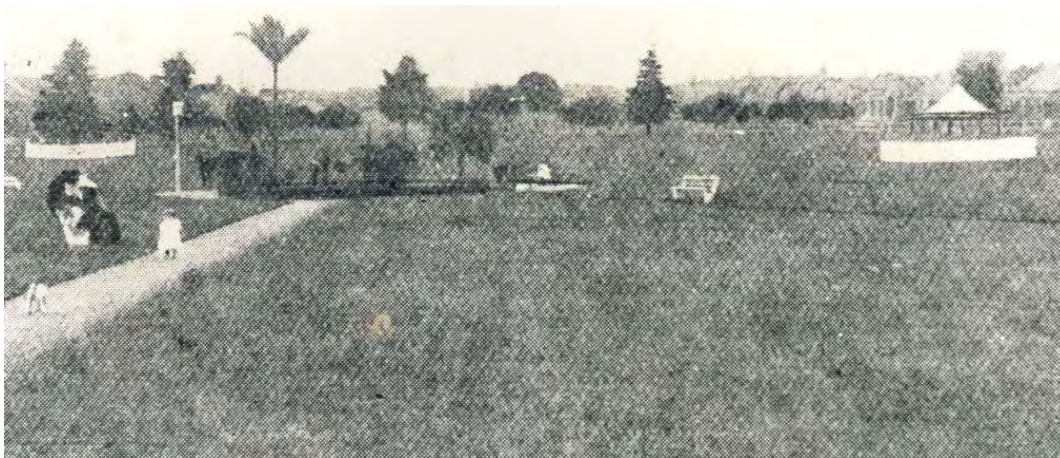
Figure H6 Photo c.1912, reproduced in the 1922 Jubilee volume, showing what is likely to have been the original rotunda in the park (at right) just to the north-east of the park's central circle (marked by the palm tree). This rotunda was probably removed when the above mentioned concrete bandstand was built over the location of the former fountain. No photographs of the fountain nor rotunda, however, have yet been obtained. Source: Marrickville local history centre.

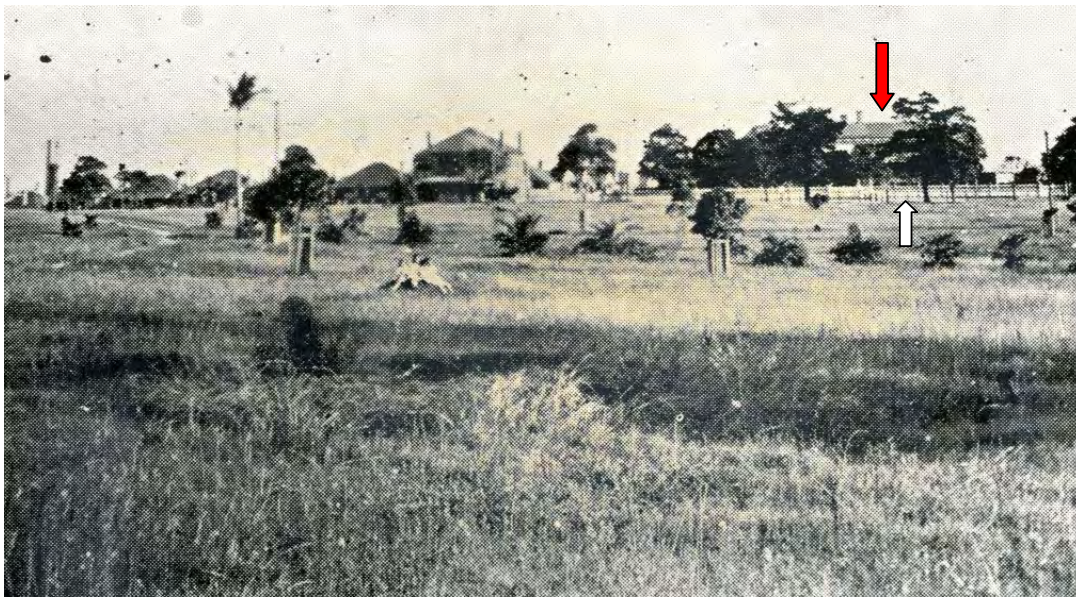
Figure H7 Photo from c.1922 looking south-east through the park, showing the park's central feature marked by the tall palm and the young Phoenix palms (extending across the photo at centre) planted along the path from Enmore Road. It would seem that the large bandstand was not built by the time this photograph was taken. The arrow shows the perimeter fence around the park.

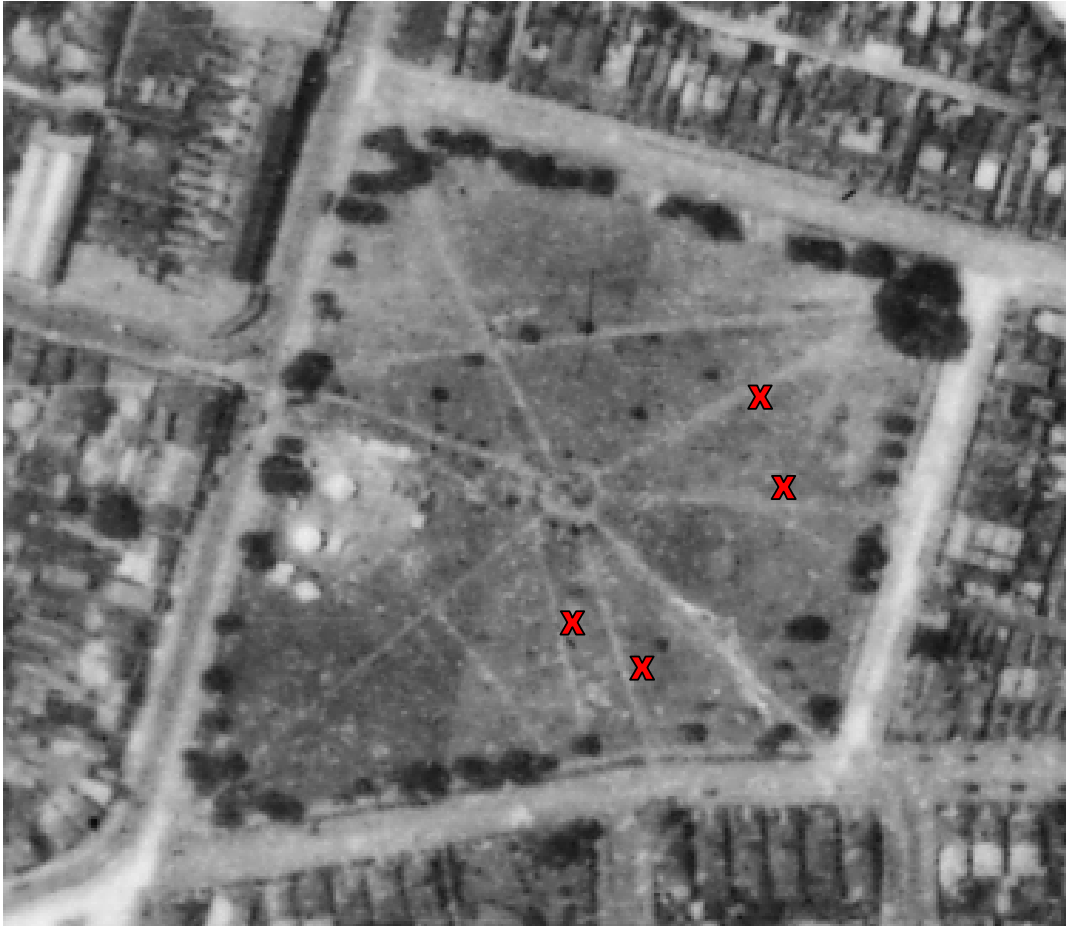
Figure H8 – Aerial photograph from 1930, showing marked with red crosses those pathways or desire lines through the park which no longer remain. However, the access provided by these removed tracks was retained by new paths laid out in similar locations in subsequent decades. There appears to be no bandstand at the centre of the park at this time. Source: Marrickville Council.

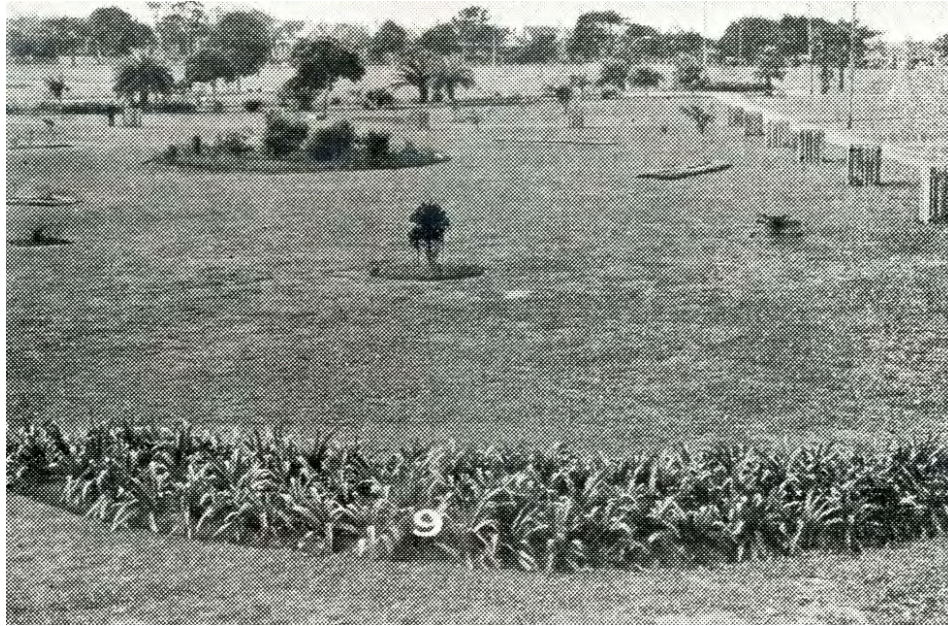
Figure H9 – Photo from c. early 1940s looking toward the park's central circle from the south-west corner of the park near the children's care facility. The circular configuration of island garden beds in the foreground and plantings along the path at right were made as part of the beautification works in the mid 1930s. Some of these garden beds have been retained. Source: Marrickville local history centre.

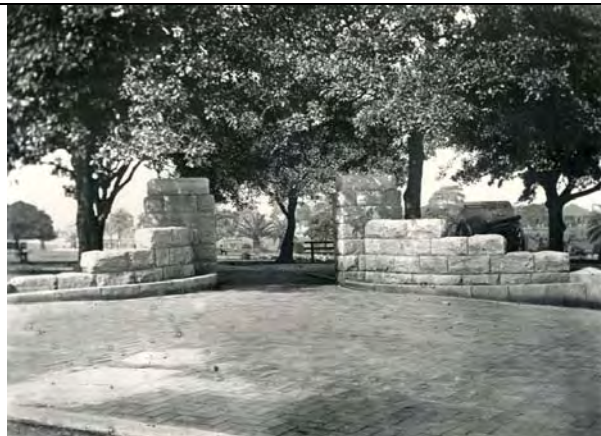
Figure H10 – c. late 1930s or early 1940s, showing the recently built sandstone entry gateway on the corner of Llewellyn Street and Enmore Road. The similar gateway and archway on the corner of Victoria Street and Enmore Road was constructed at the same time. Source: Marrickville local history centre.

In 1937, a sum of £500 was allocated towards the construction of two stone entrances to the park and stonework for a tram shelter. These were constructed, partly using relief labour, between 1937 and 1938, the gateways still remaining in their original configuration⁶.

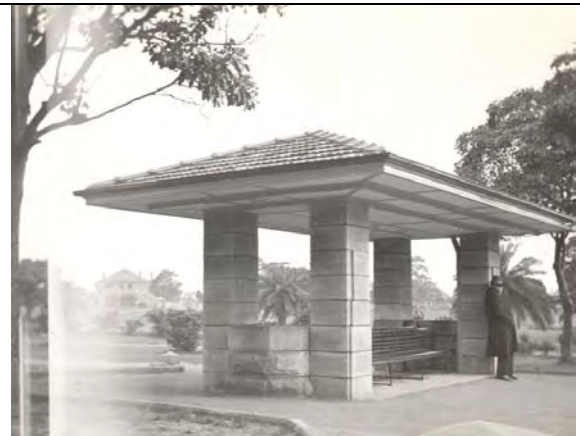
Figure H11 – Photo from c. late 1930s of the bus shelter on Enmore Road. The structure appears to have been little changed since that time. However, a path that led to the eastern side of the shelter from within the park, which existed since at least 1942, was removed after 1970. Low sandstone markers remain which identify where that pathway met the paved surrounds of the shelter. Source: Marrickville local history centre.

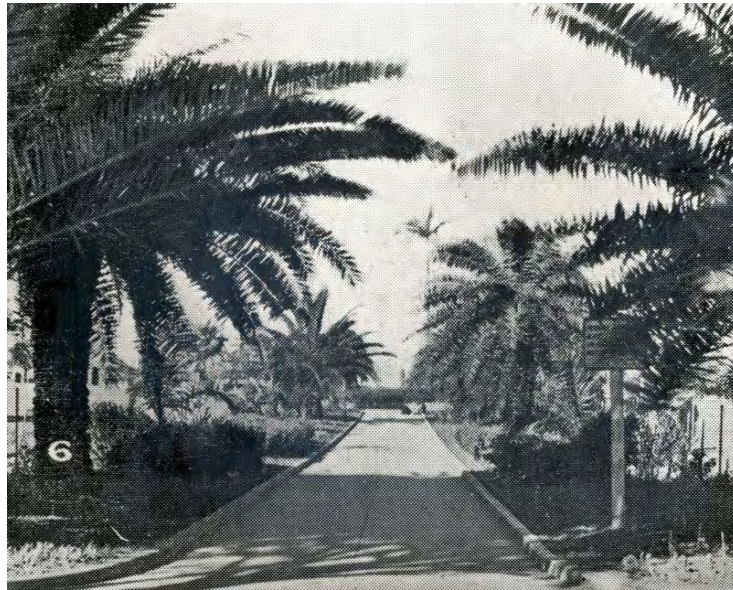
Figure H12 – Photo from c. late 1930s looking east up the main entry pathway from Enmore Road, with the Phoenix palms lining the path. These palms were removed c. early 1950s. No bandstand is apparent at the end of this pathway. Source: Marrickville local history centre.

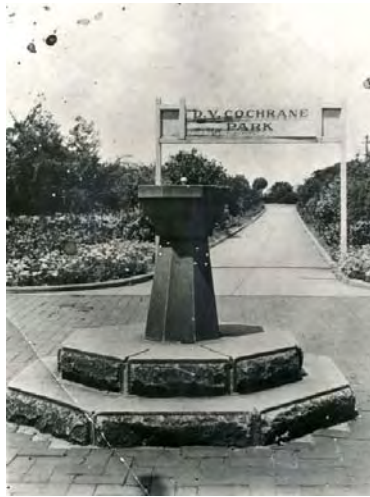
Figure H14 – c. late 1940s or early 1950s, showing the Enmore Road entry to the park. Note that the rows of Phoenix palms which led up to the park's central circle from the late 1910s had been removed and replaced by mixed shrub borders. Source: Marrickville local history centre.

By the early 1950s, the Phoenix palms along the central Enmore Road entry to the park had been removed and replaced by mixed shrubberies, in line with the fashion for mixed shrub borders seen commonly in Sydney park and institutional gardening at that time. Planter bed features and pathway plantings made between the late 1930s and the early 1950s can be seen clearly on the below 1951 aerial photograph, most of these works being carried out near the Enmore Road frontage of the park.

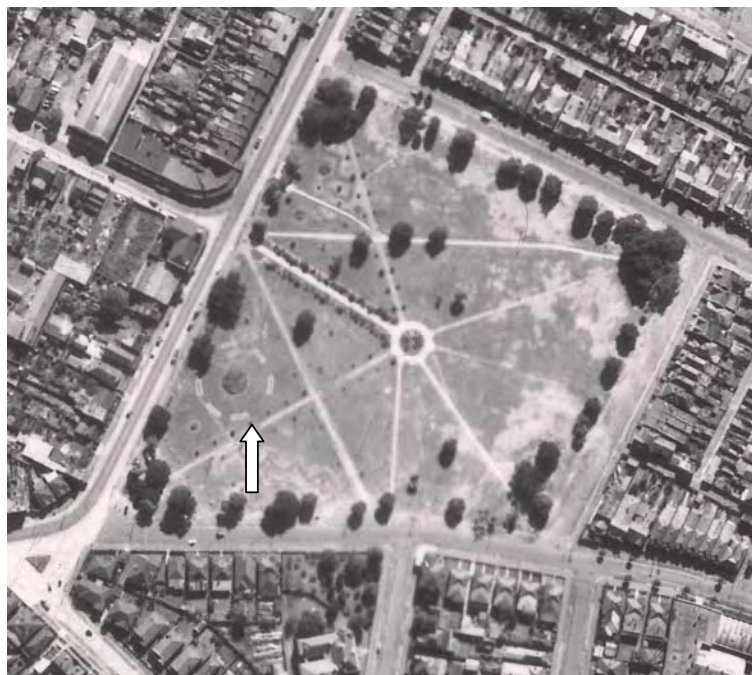
Figure H15 – Aerial photograph from 1951, showing the maturing plantings within the body of the site and the various planter bed zones adjoining Enmore Road. Note especially the circular planter sector (arrowed) near the south-west corner of the park. Source: Marrickville Council.

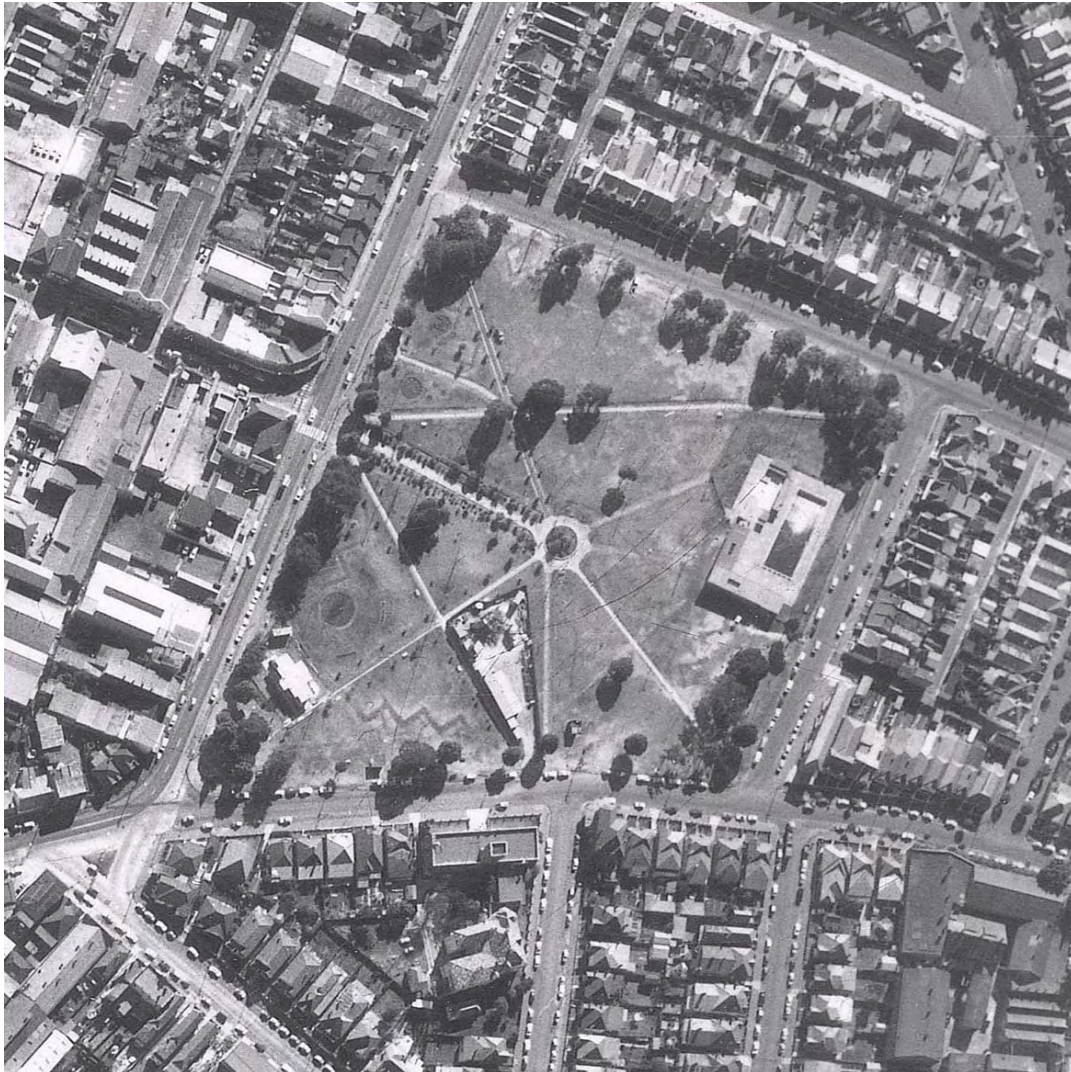
Figure H16 – Aerial photograph from 1970. Note that the footprint of the zig-zaging elements seen on the 1942 aerial can still be seen in the south-western corner of the park at this date. (Some portion of them remain identifiable even on current aerals). Note also that much of the circular arrangement of planter beds near the childcare facility seems to have been downgraded, although the outline of the curved beds is just visible.

Several major works occurred in Enmore Park between 1951 and 1970, with the construction of the swimming complex, the use of a large triangular southern quadrant of the park for an as yet unknown facility [oral history should be able to ascertain this] and the construction of the child care building in the park's south-west corner. The path network by this date remained much the same as that which existed prior to 1930; however, the path extending to the park's centre along the southern side of the pool complex was not built by 1970.

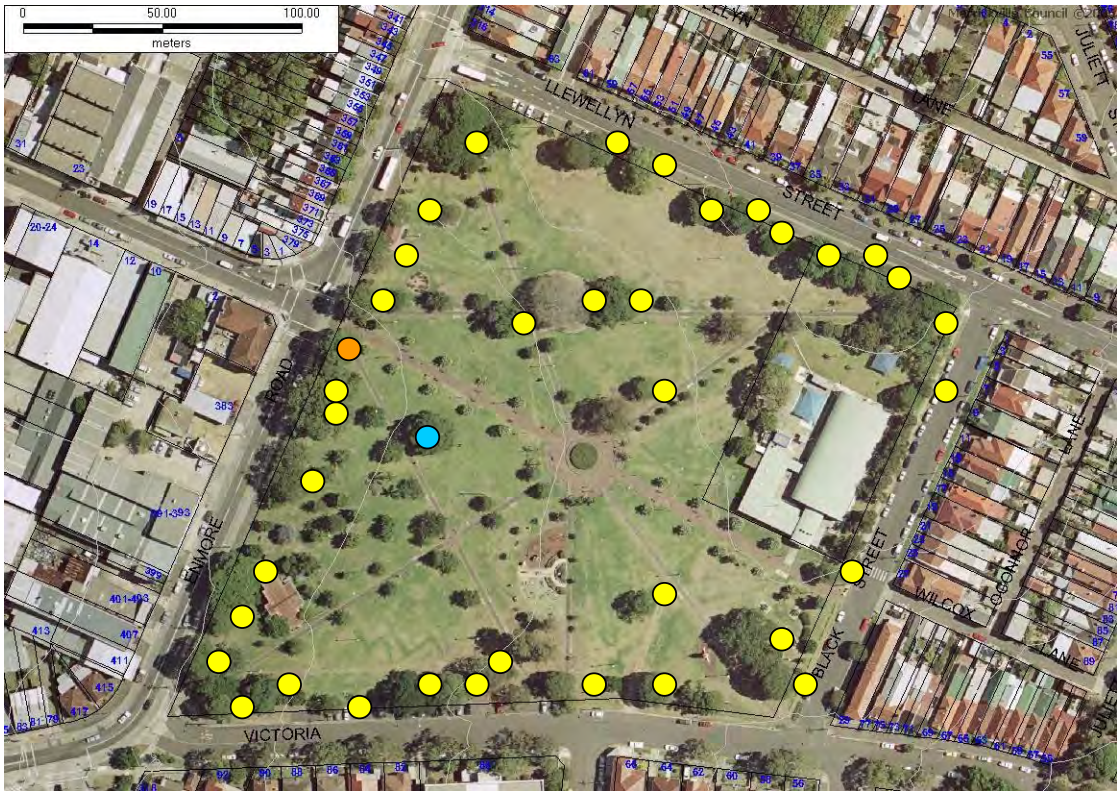
Map showing key park plantings. All plantings not identified were made after 1970. (From aerial photo analysis only)

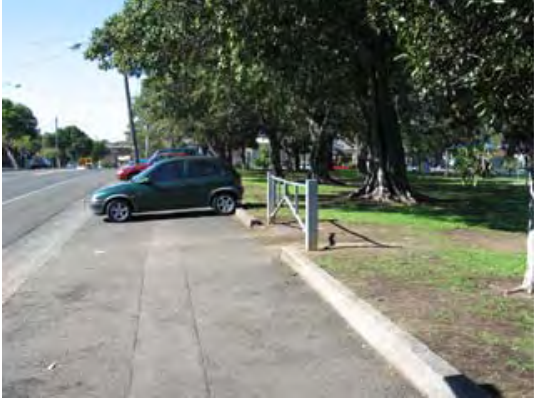
11a.	<p>Trees along Llewellyn Street</p> <p>A staggered line of mostly Fig trees along the northern boundary of the park which appear semi-mature on the 1930 site aerial photo.</p>

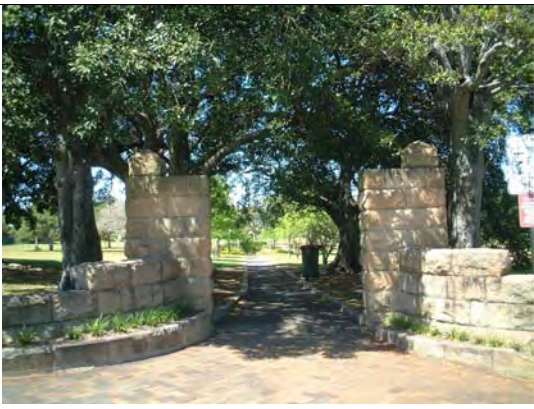
<p>Rating: Moderate – High</p> <p>Should be conserved and maintained by a skilled arborist.</p>
12	<p>Fig trees on the corner of Llewellyn Street and Enmore Road</p> <p>This grove of Fig trees appears semi-mature on the 1930 site aerial photo. As this was always a key entry to the park, these plantings would have been installed early in the park's history to define the access point.</p>

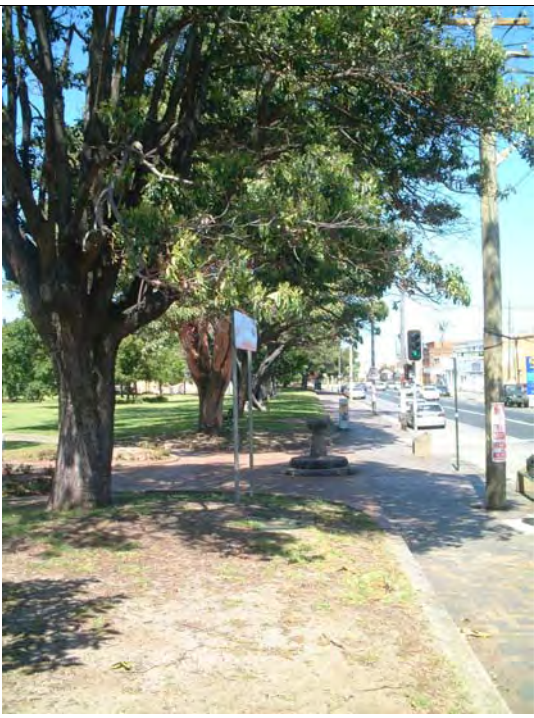
13.	<p>Fig trees and Brush Box along the park's Enmore Road frontage</p> <p>Some of the Brush Box and Fig plantings along Enmore Road appear as mature trees in photos of this side of the park from the late 1930s.</p> <p>Whilst the plantings form a relatively consistent line along the Enmore Road frontage, it is clear that they were not planted in a formal, consistently spaced alignment.</p>

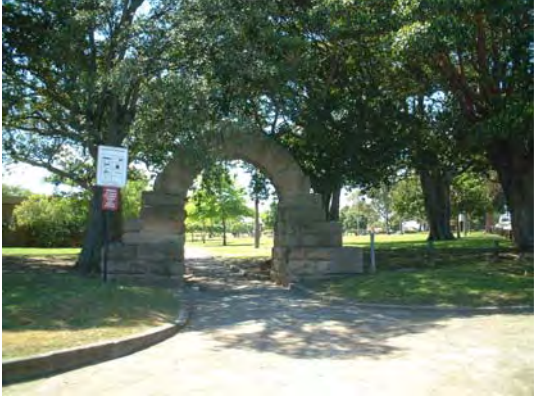
14.	<p>Fig trees and Brush Box around the park's south-western corner</p> <p>This grove of trees appears semi-mature on the 1930 site aerial photo. As this was always a key entry and view into the park for people approaching Enmore from the south, these plantings would have been installed early in the park's history to define the access point.</p>

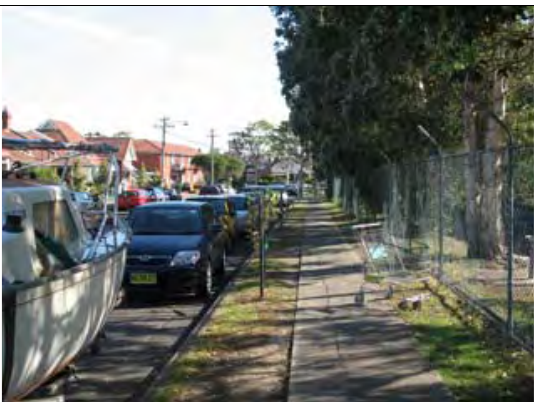
16.	<p>Paperbarks along the Black Street boundary</p> <p>The existing row of <i>Melaleucas</i> along the eastern façade of the pool complex were planted after 1970 and have no heritage value.</p>

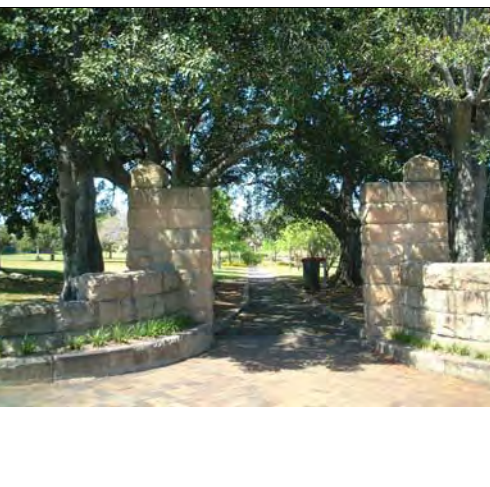
21.	<p>North-western entry gateway</p> <p>This sandstone gateway from the corner of Llewellyn St and Enmore Rd was built in the late 1930s as part of a substantial upgrading of the park.</p> <p>It appears to have been retained in its original form, although the two blocks at the top of each 'pillar' were not present in the photo of the item taken after its completion.</p> <p>The brick paving in front of the element may date back to its construction, when brick edging was seen around this street corner.</p>

<p>Rating: High</p> <p>Retain as existing. Confirm original location of two blocks on the top of the gateway.</p> <p>Repair damaged sections as required and as advised by a conservation architect.</p>

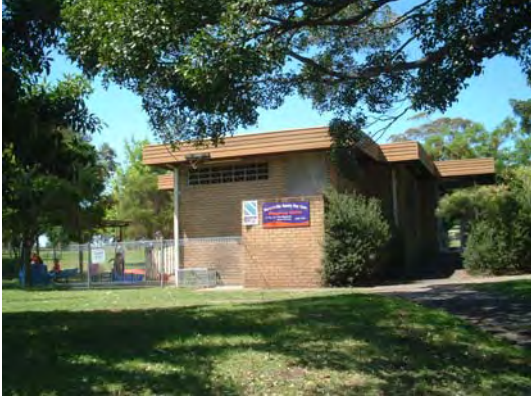
26.	<p>Children's care facility</p> <p>Built between 1951 and 1970, first as a library then as a Childrens Resource Centre, and now known as a child minding centre.</p>

<p>Rating: None</p> <p>A functional building whose design was influenced by the prevailing Sydney School of architecture of the 1960s.</p> <p>It is for Council to decide, after community consultation, on whether it is appropriate to continue to have this facility located within the Park.</p>

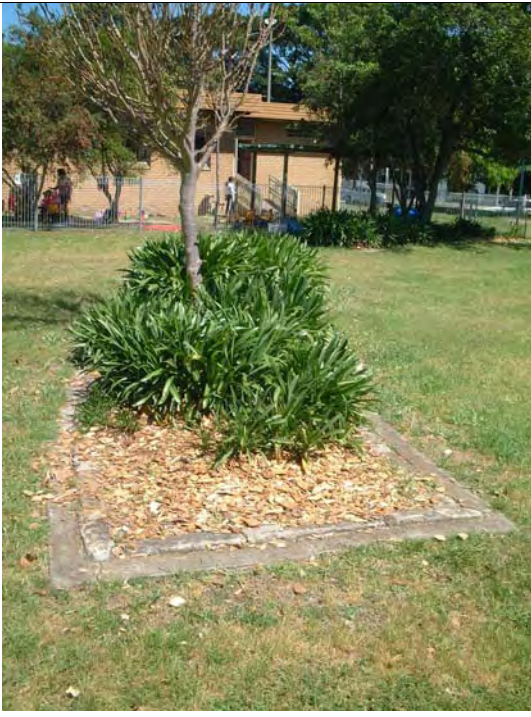
27.	<p>Sandstone-edged planter beds</p> <p>A circular formation of arc-shaped planter beds first seen in a photo of the park taken following the upgrading works of the late 1930s.</p> <p>The formation, with a circular bed set in its centre is first clearly seen on the 1951 aerial photo below</p>

<p>The original sandstone edges have been supplemented by concrete mowing strips which tend to diminish an appreciation of the original fabric.</p>

<p>Rating: Moderate</p> <p>Retain planter beds and replant with species used commonly during the 1930s and 1940s.</p> <p>Remove those shrub and tree plantings which restrict an appreciation of the overall configuration of the formation.</p> <p>Consider a series of evenly spaced seats within or around the zone to reinforce the original design intention and a greater appreciation of it.</p>

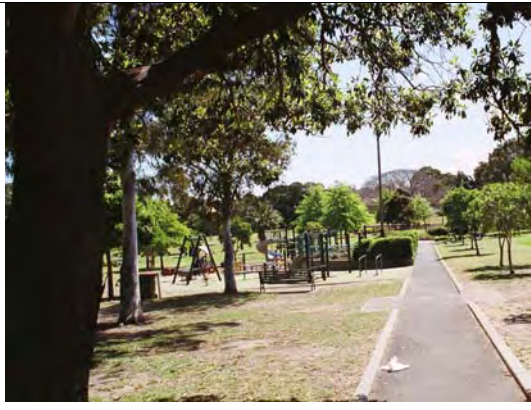
28.	<p>Sensory garden and playground</p> <p>The children's playground (at left) is bounded on its northern side by a sensory garden, which abuts the pathway leading to the central rondel from Victoria Road.</p> <p>The sensory garden has only a few hardy remnants of its original plantings and has probably suffered from children's play.</p> <p>Neither it nor the playground have historical value</p>

<p>Rating: None</p> <p>These elements are relatively recent (post 1990) and are somewhat transient.</p> <p>They could be instated elsewhere in the Park, in an upgraded form, if desired.</p>

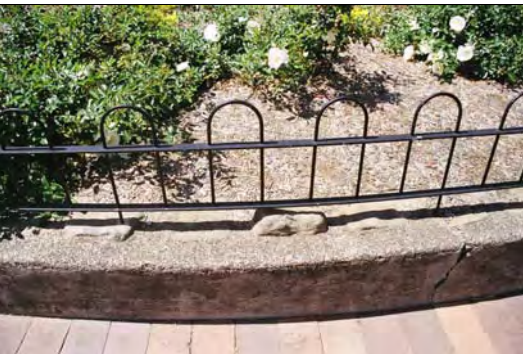
33.	<p>Central rondel – edging</p> <p>The original stone edging around the central rondel is just visible behind the later concrete 'kerbing'.</p>

<p>Rating: Low</p> <p>Not particularly significant in itself but for marking the original edge of the rondel throughout perhaps nearly a century.</p> <p>While not an ideal solution aesthetically, this edging ought to be retained for historical interpretation purposes.</p>

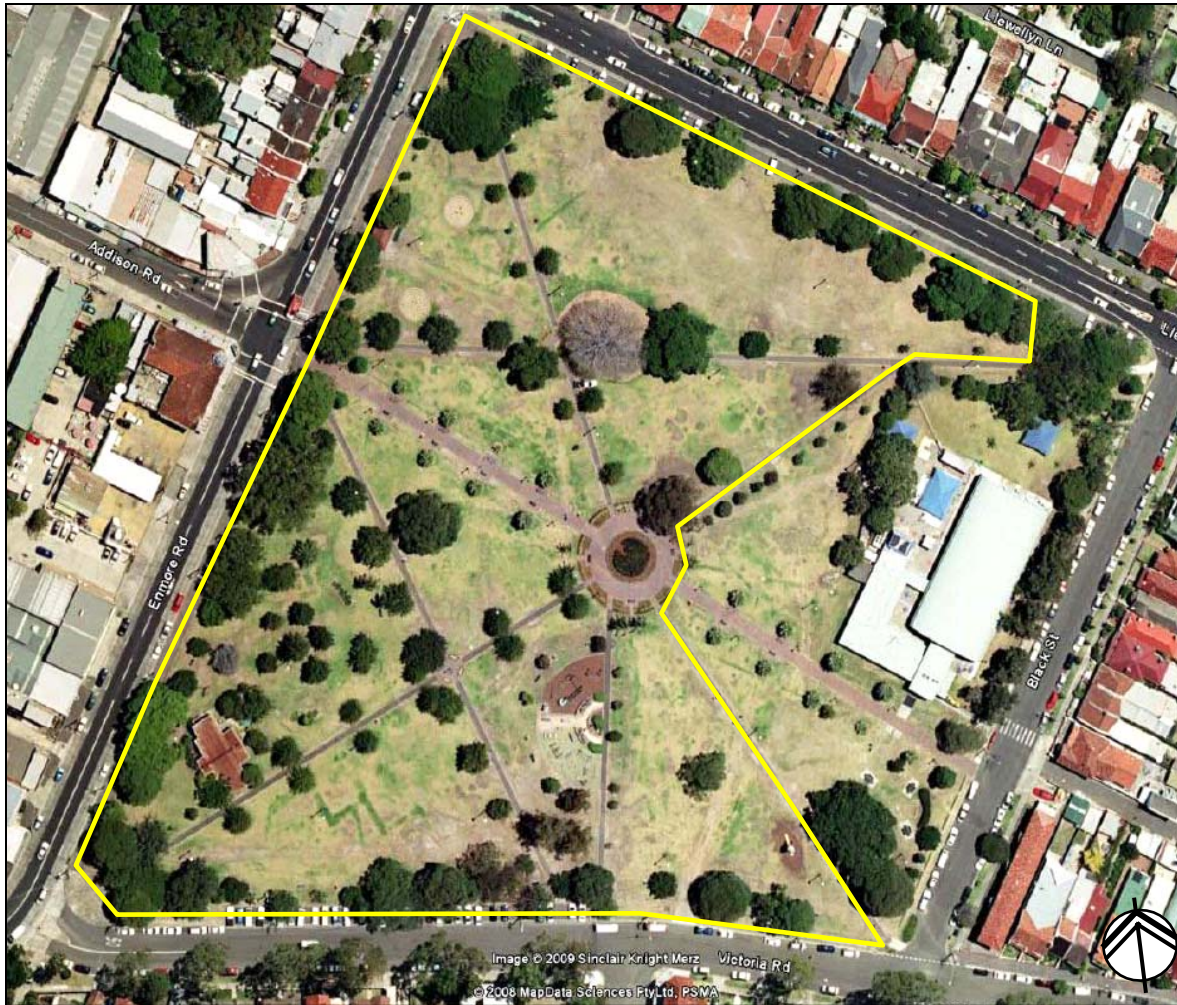
Figure 2
ENMORE PARK – AERIAL VIEW OF SUBJECT AREA

The trees inside the area bounded by the yellow, unbroken line are the subject of this report.

- 2.3** The trees assessed for this report are numbered from 92 to 250. The remaining ninety-one (91) trees were subject to a separate audit and development impact assessment and report prepared for the proposed re-development of the Annette Kellerman Aquatic centre. An aerial view of the site (Figure2) is on the following page.

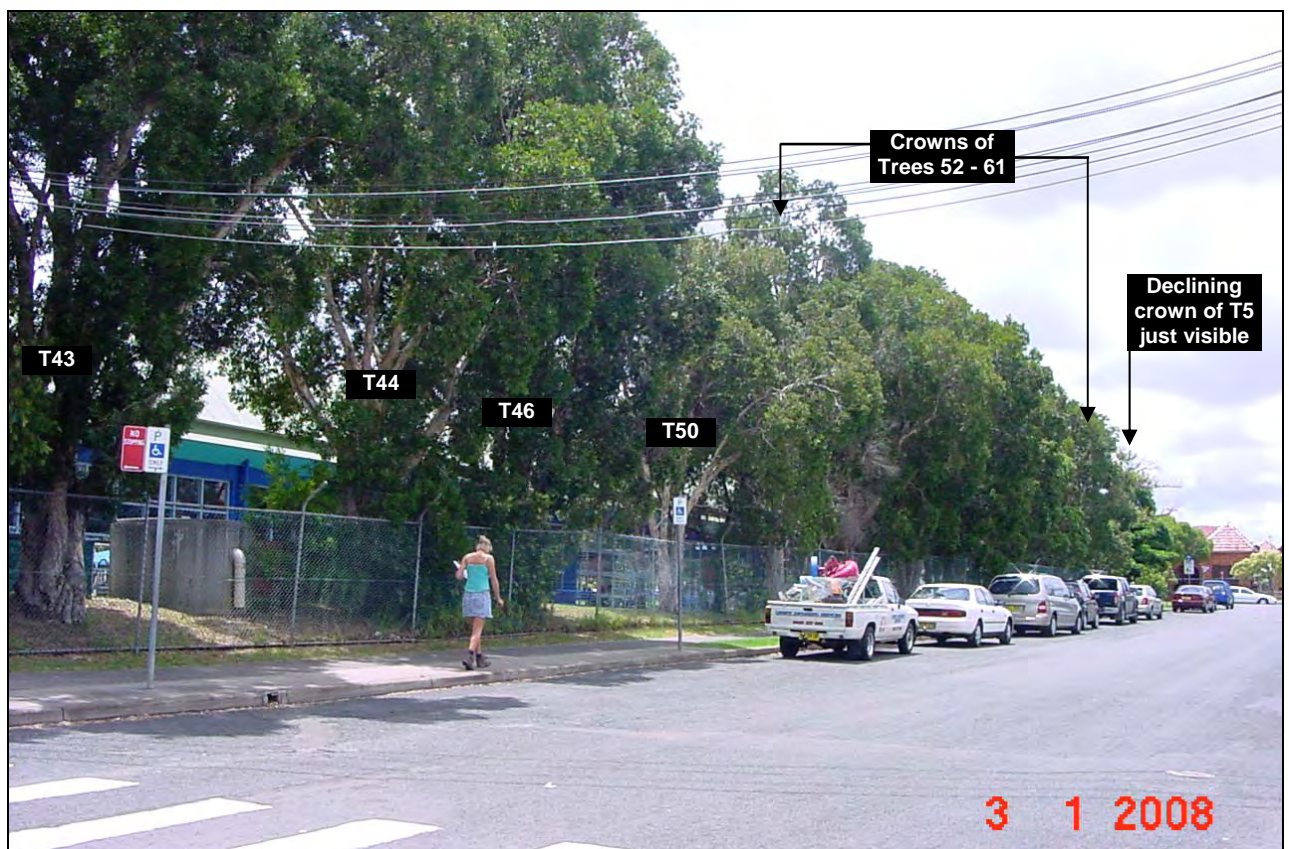
Plate 1

Although most of these trees are not individually significant, as a row of trees they contribute substantially to the landscape character of the street.

3.1.2 The plantings along the east boundary, facing Black Street, consist mainly of large, mature *Melaleuca quinquenervia* (Broad-leaved Paperbark), and a few mature Brush Boxes. Although these trees are not individually significant, or part of the original park planting, as a row of trees they provide substantial landscape screening and visual reduction of the current building and pool facilities, between the park and the street.

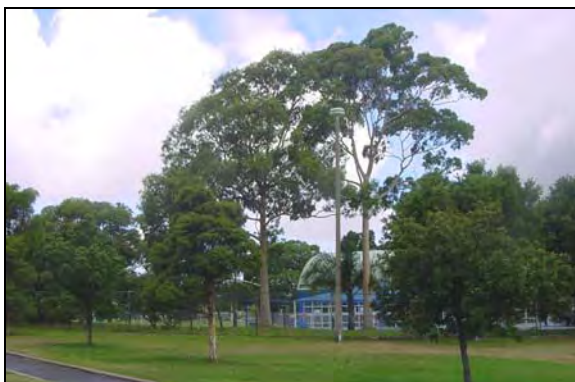
Plates 2 and 3

The tree height and crown spread of these two Lemon –scented Gums identifies these as significant park trees.

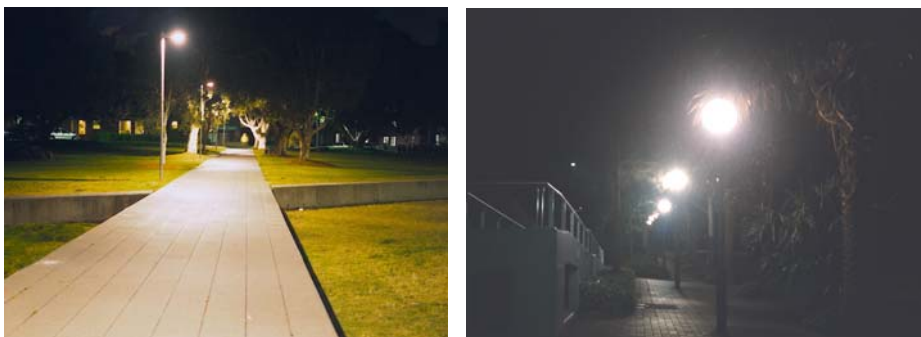
The photo on the left shows a path with high colour rendering lamps with good glare control while the installation on the right uses poor colour rendering lamps with louvers to provide some glare control. Note that you can see the person at the end of the path on the left. The left installation also uses less than half the energy of the installation on the right.

A glaring light source prevents people from seeing past the fitting so that their field of view is limited to the area within the lights. The effect is claustrophobic and reduces the feeling of safety for the person as they cannot tell if there is someone just beyond the lights.

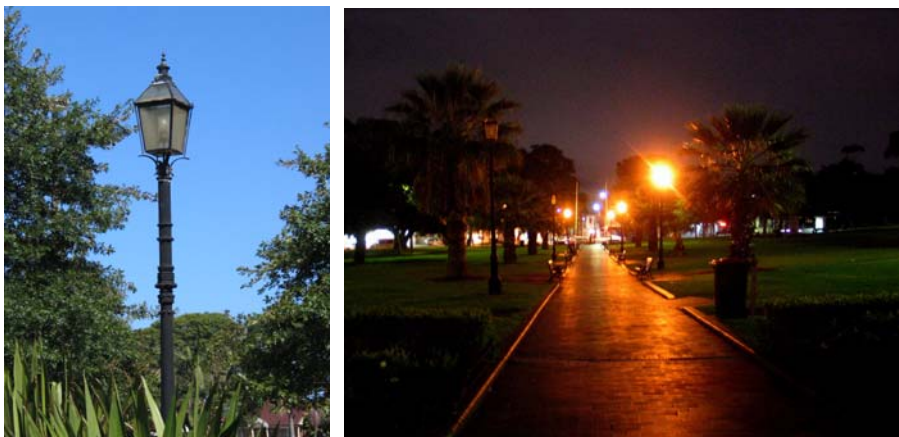
The central circle in the park and the main use pseudo historic lanterns. These were made by Edwards Lighting Engineers, a foundry in Ballart and would probably date from the 1970s. The fittings have obscure glass and low colour rendering, high pressure sodium lamps. The fittings are glaring and inefficient because the majority of the light goes into the sky. These fittings would not meet the upward light limitations of AS/NZS1158.

Note the glare and the poor visibility surrounding the path. These fittings do not have EnergyAustralia numbers and therefore are probably privately owned by the council.

This path appeared to be the principal route through the path at night, linking the houses on the eastern side of the park with the bus stop.

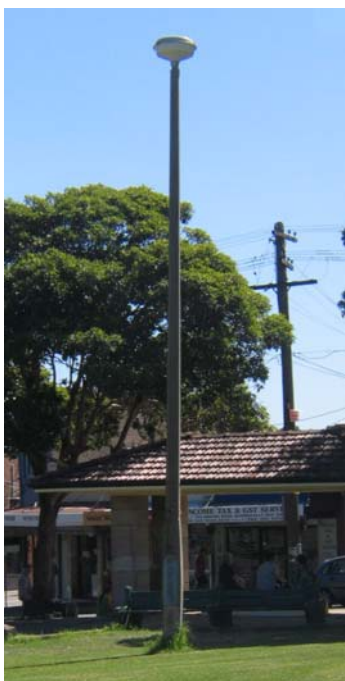
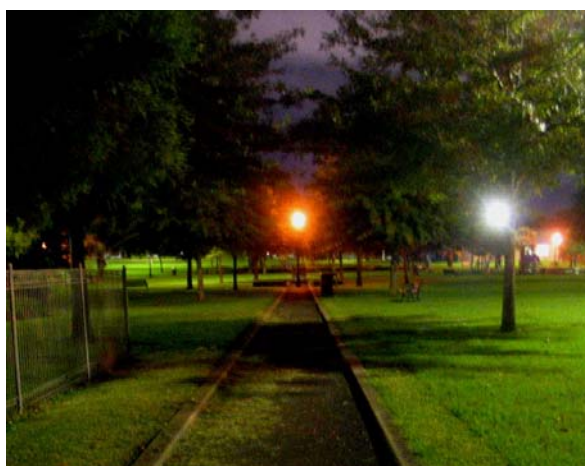
There are a number of high mast fittings throughout the park. These are GEC 'Parkway' fittings and have been a relatively standard fitting used by EnergyAustralia to light parks.

The fittings are generally scattered through the open grass and do not follow the paths. The fittings are typically around 8 metres high and use mercury vapour lamps. Although they have a solid top to limit the spill light into the sky they have very little optical control. As a result only around 20% of the light reaches the ground. In addition the mercury vapour lamps are poor colour rendering and are one of the least efficient lamps on the market today. They have effectively been banned by the Building Code of Australia for the external lighting of buildings.

Because the lights are away from the paths and relatively high they actually cast shadows on the paths so that some of the sections of path were the darkest part of the park. The lighting increases the intensity of the shadows in the paths.
