HCA 5 Parramatta Road Commercial Precinct Heritage Conservation Area

5.1 LOCATION

5.2 DESCRIPTION

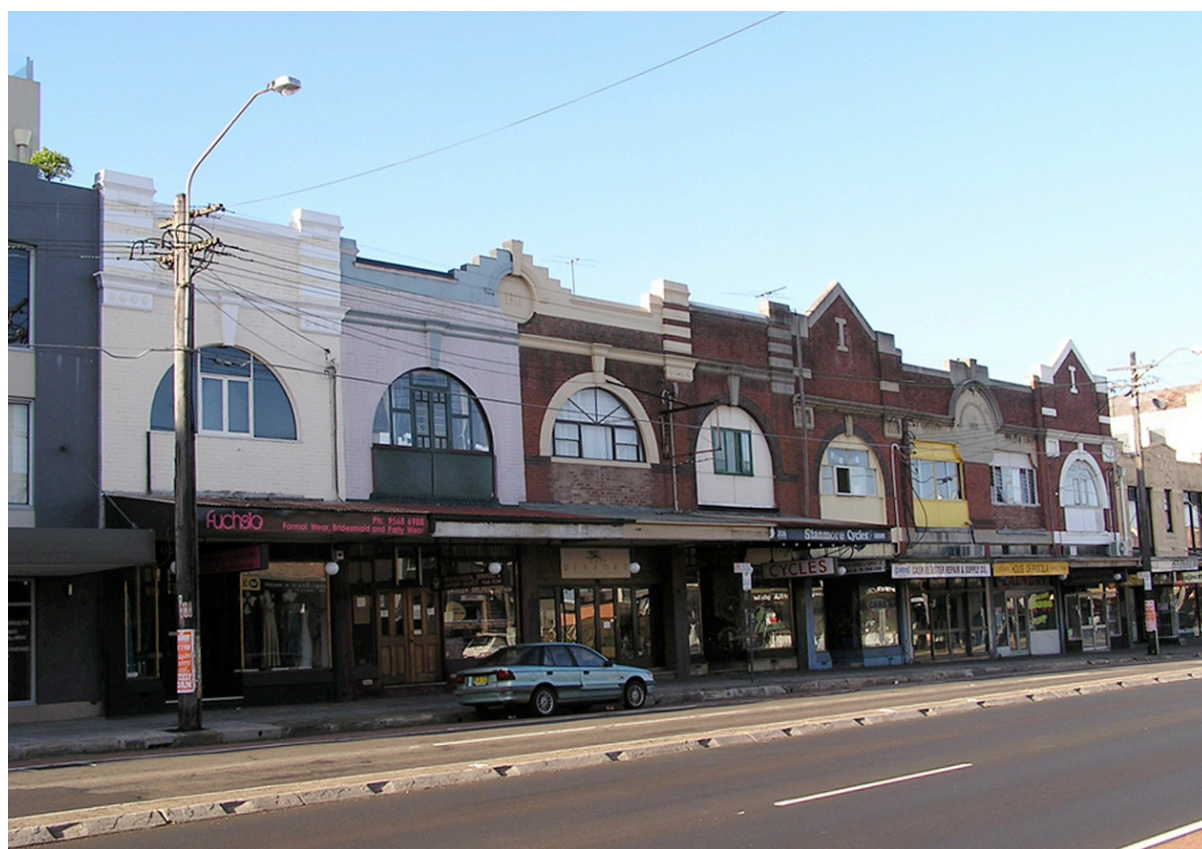
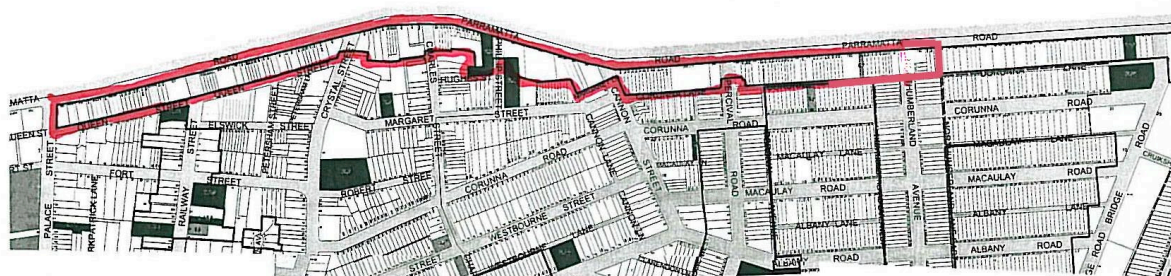
Figure 5.1 HCA 5 Parramatta Road Commercial Precinct Heritage Conservation Area

The Parramatta Road Commercial Precinct Heritage Conservation Area is located in north Petersham and extends along the southern side of Parramatta Road from Palace Street to just east of Northumberland Avenue.

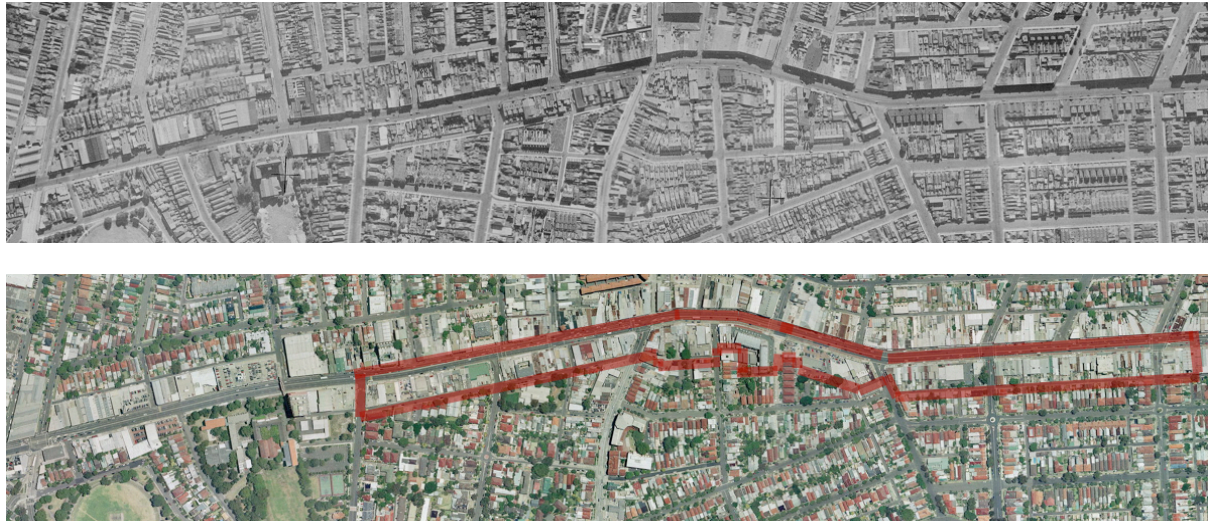
Figure 5.2 The Area in 1943 and 2009 (source: NSW Lands Department SIX Viewer)

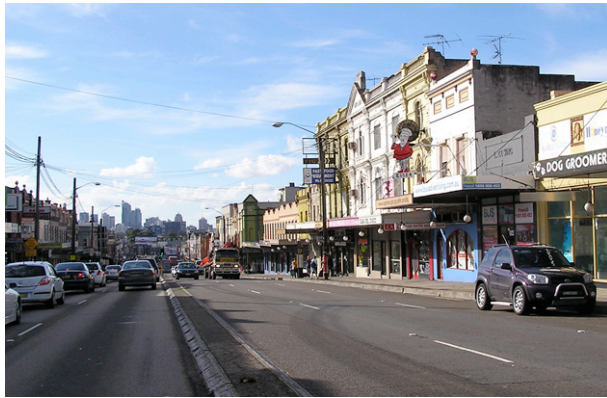
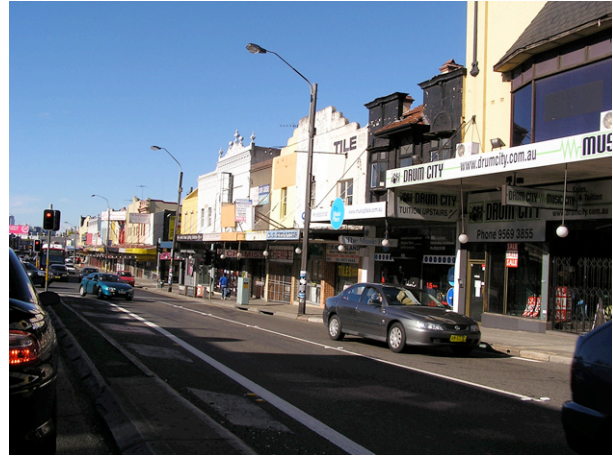
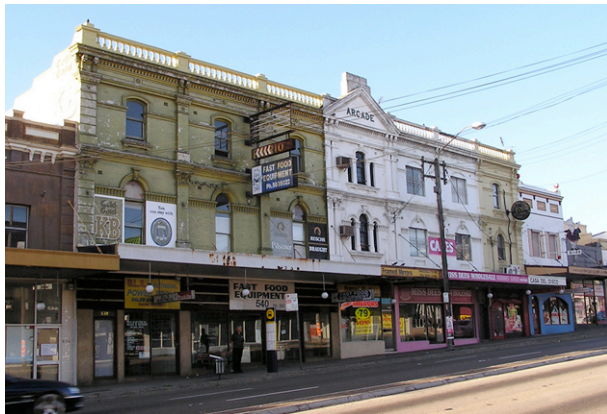
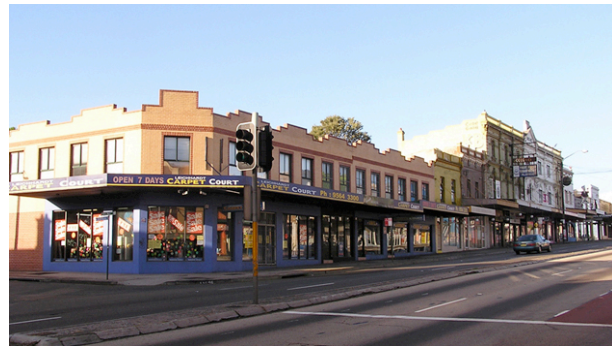
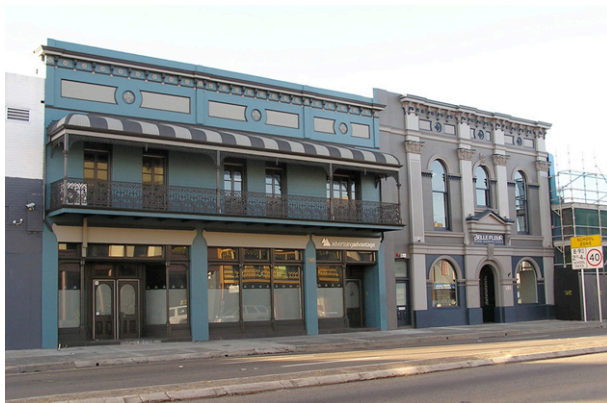
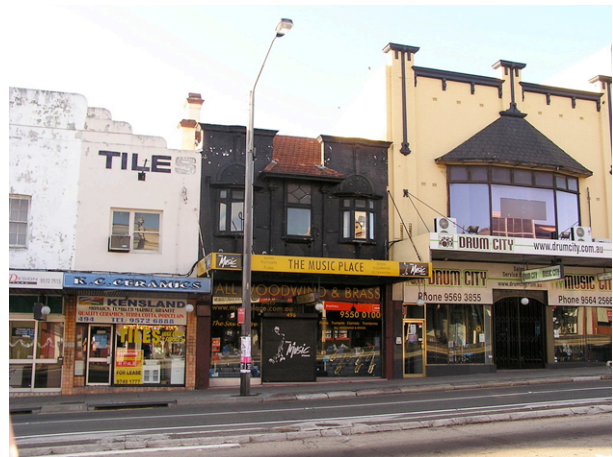
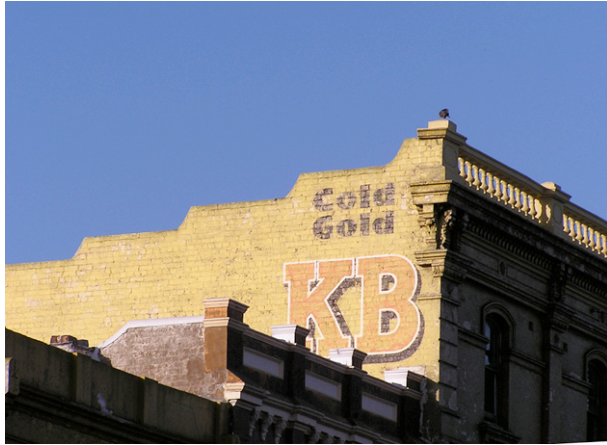
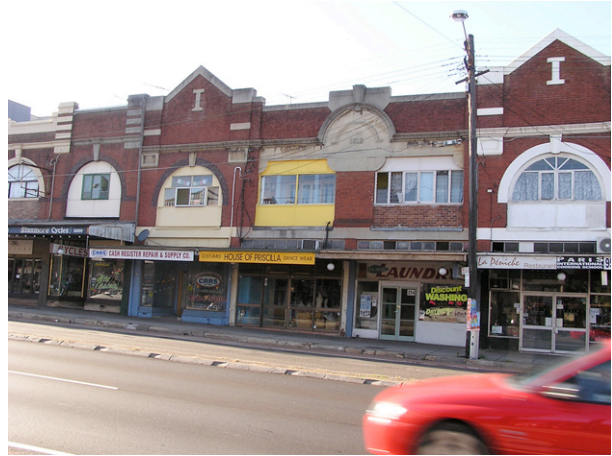
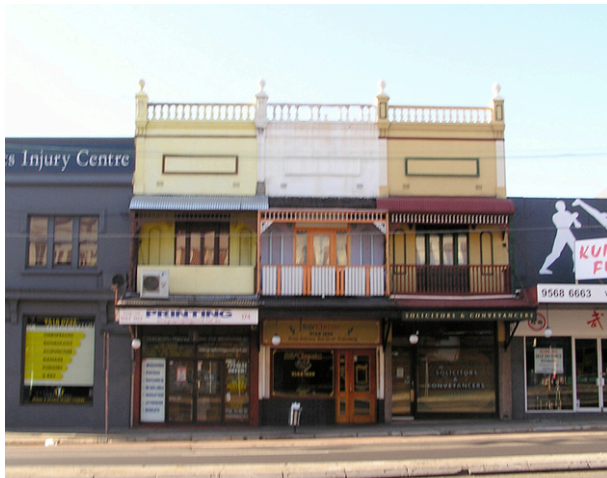
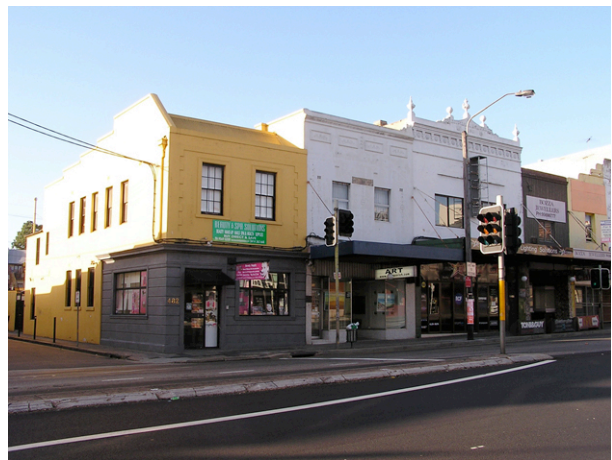
Figures 5.3 – 5.12 demonstrate the variety of built forms found along Parramatta Road. The prevailing parapet height is consistent at between two and three stories. Most of shopfronts have been replaced over the years. The 1920's period hanging ball lights are a feature of all major shopping precincts within the Marrickville local government area.

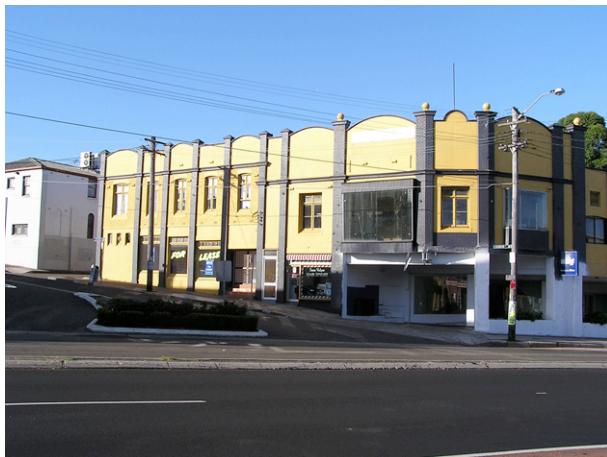
Figure 5.13 Early petrol stations and motor workshops were of a drive-through and are increasingly rare elements in the streetscape.

The character and quality of the existing buildings along the commercial strip vary considerably from the high-quality and intricately detailed to mediocre. Few original shopfronts have survived. An early drive-through service station has also survived under an otherwise ordinary commercial building but is showing signs of significant deterioration.

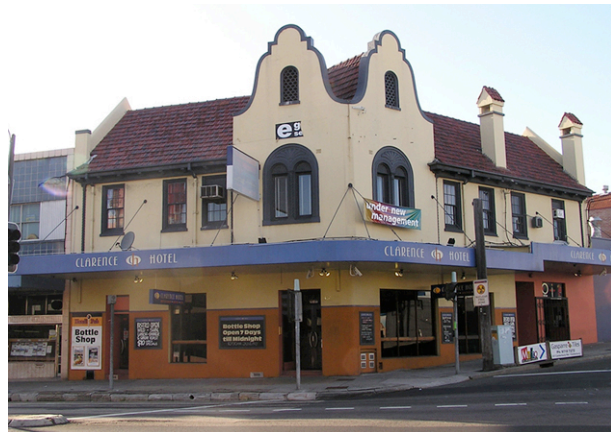
Figure 5.14 Traditional main road uses such as this hotel can still be found along Parramatta Road.

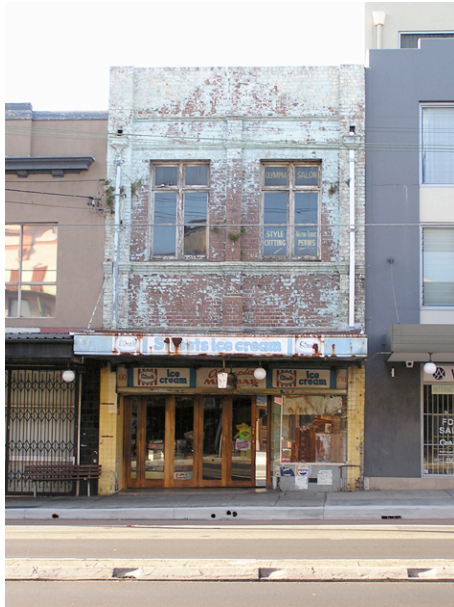
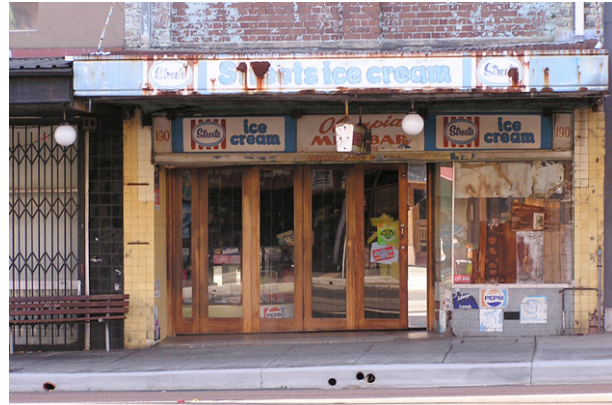
Figure 5.15 and 5.16. The Olympia milk bar was built in conjunction with the Stanmore Cinema to its west and is a Sydney landmark for its substantially intact interior and exterior. The original gates to Annandale Farm were located immediately to the west of the former cinema (recently redeveloped).

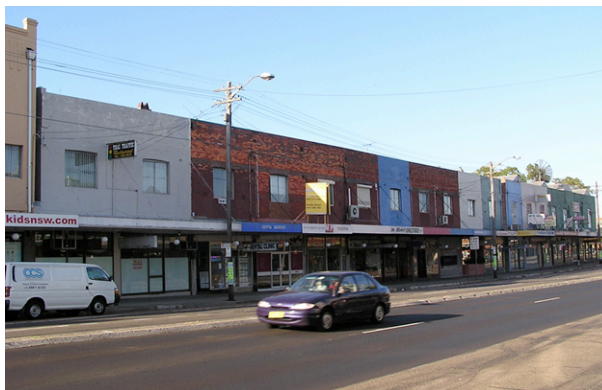
Figure 5.17 this group of shops demonstrates a strong parapet line free of any attempt at adornment or visual interest. It is representative of the late, austerity period of retail development along Parramatta Road.

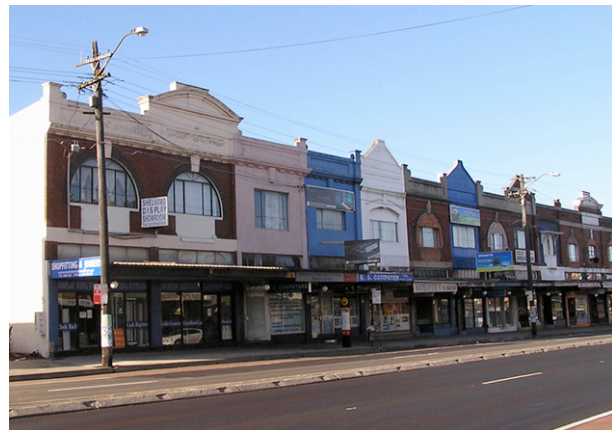
Figure 5.18. This group also demonstrates a strong parapet line with the modulation of the different bays creating a visually interesting skyline. Remnants of the original arched veranda openings to the upstairs residence can still be seen although all have been infilled over the years.

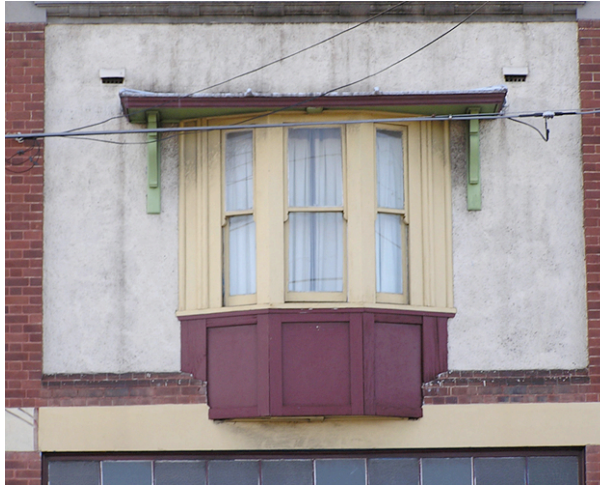
Figure 5.19 an original boxed bay window

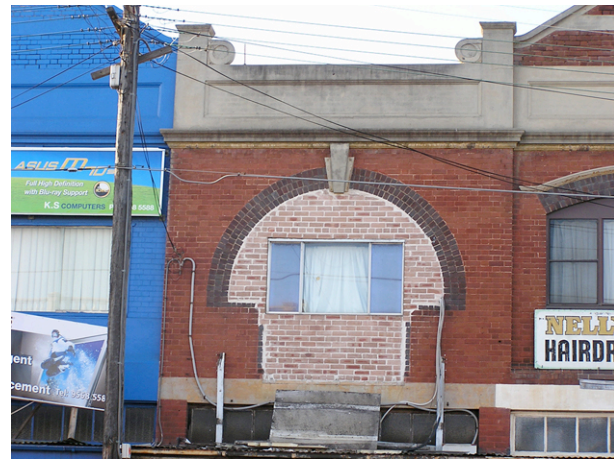
Figure 5.20. This arched veranda opening has been infilled crudely but the original brickwork is intact and has not been rendered or painted, making the layer readily reversible.

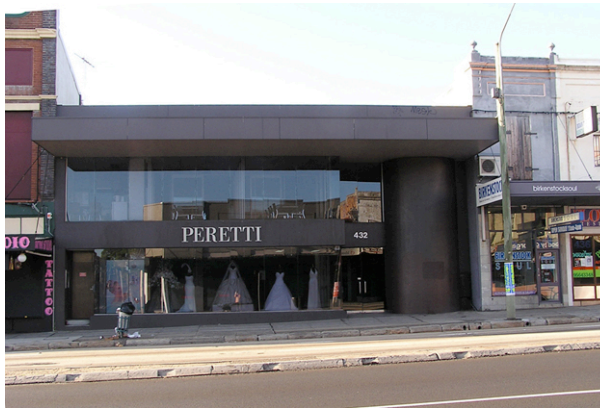
Figure 5.21. The contemporary commercial building is an intrusive visual element in the Parramatta Road streetscape due to its horizontal proportions and lack of respect for the established parapet line. Its current use as a bridal dress shop demonstrates however the current function of Parramatta Road as a comparative shopping destination for specialist retail sales such as bridal wear and musical instruments.

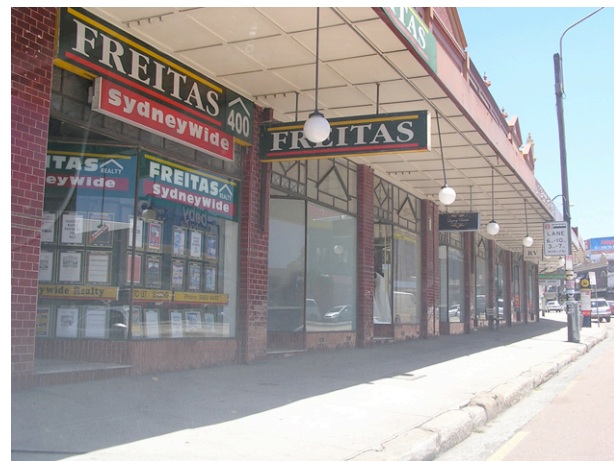
Figure 5.22. This group of shopfronts has been repaired and reinstated as part of a redevelopment of the remainder of the site. The glazed ceramic tiles are typical of the late Federation – Inter-War shopfront.

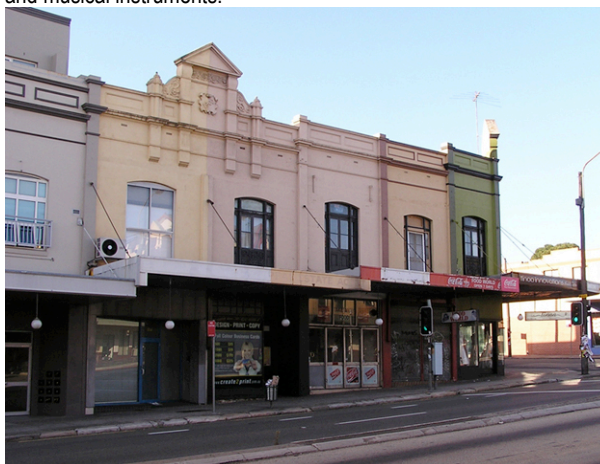
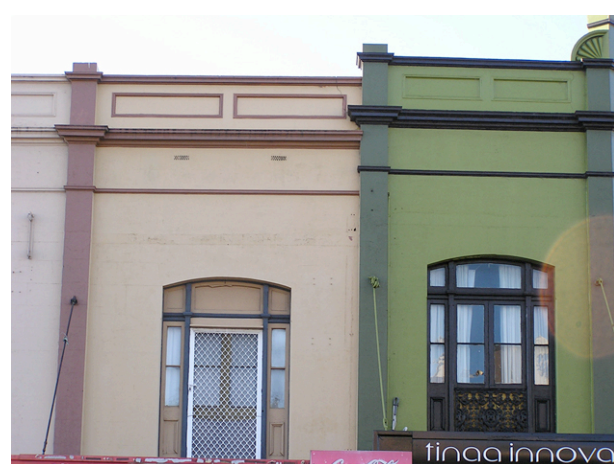
Figure 5.23 and 5.24. The original balcony to the upper level of this group has been removed although evidence can still be seen through the original door openings and in the shadow lines in the rendered facade

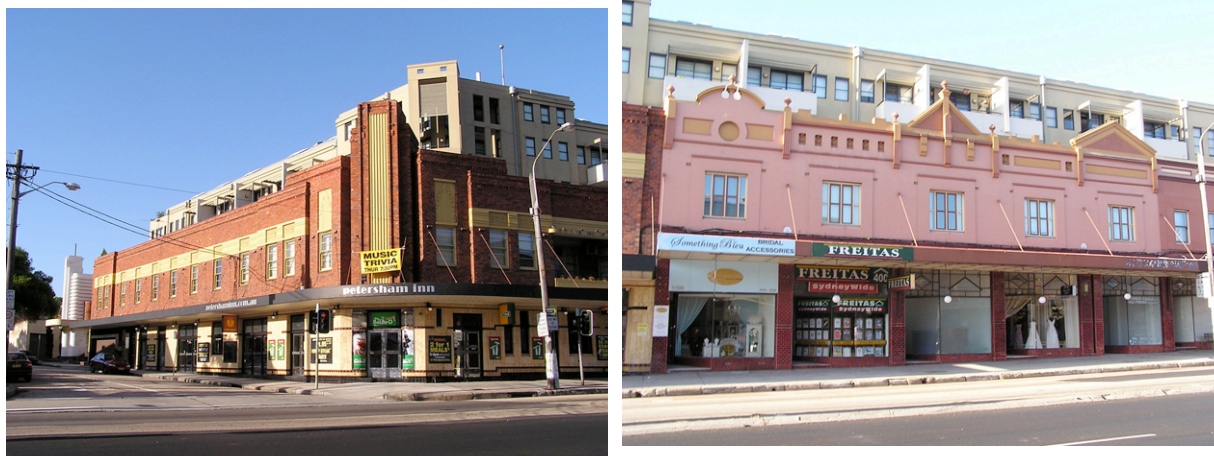
Figure 5.25 and 5.26. Parramatta Road continues to be an important transport corridor and is undergoing increasing pressure for more intensive development. Recent redevelopment proposals have achieved this by building additional levels set back behind the main parapet line with varying degrees of success. The loss of the ability to see the line of the parapet against the sky has an adverse impact on the aesthetic and historic values of the area. Care also needs to be taken to not simply locate all the new development away from the road, since most of the area adjoining the Parramatta Road Commercial Precinct is also heritage conservation area. A very sensitive approach to the design, siting, detailing and materials is essential if increased densities are desired along this busy corridor. .
