HCA 20 Audley Street South (Bayswater Estate), Petersham Heritage Conservation Area

20.1 LOCATION

20.2 DESCRIPTION

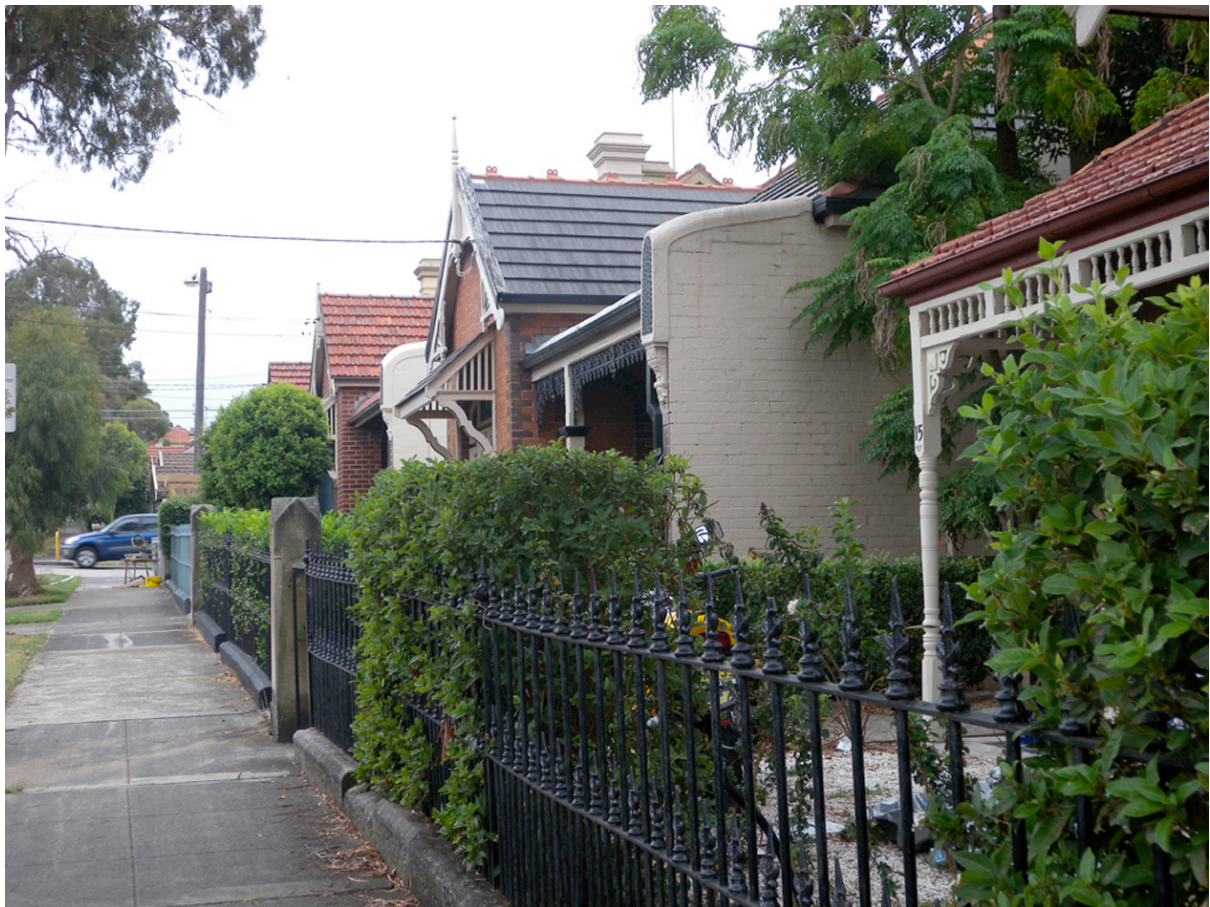
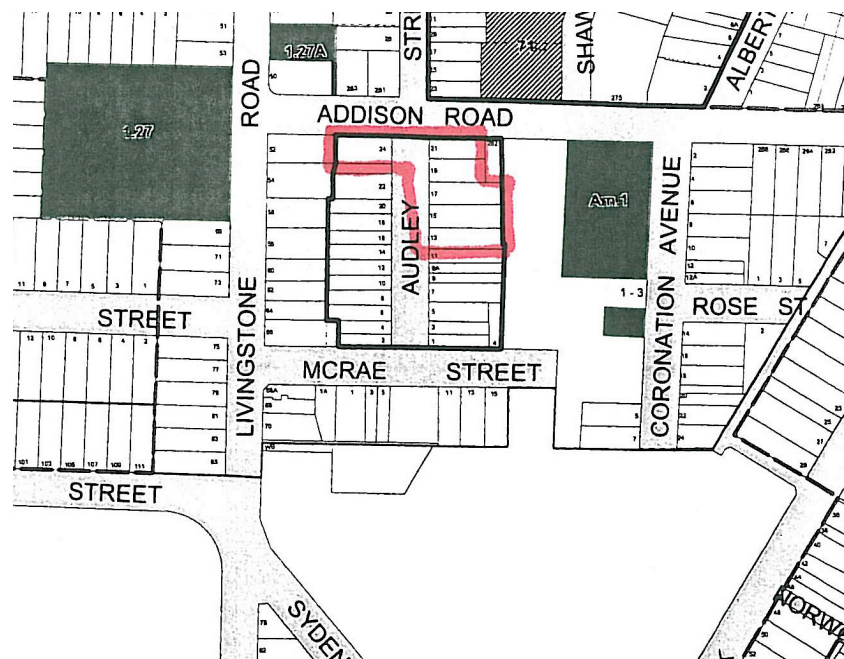
Figure 20.1 HCA 20 – Audley Street South (Bayswater Estate) Heritage Conservation Area

The boundary of the heritage conservation area is defined by the ability of properties to demonstrate the identified heritage values. The northern boundary is formed by Addison Road and the eastern by the rear boundaries of the Federation properties fronting Audley Street. The scale and form of the residential flat development further to the east is not consistent with the values of the heritage conservation area.

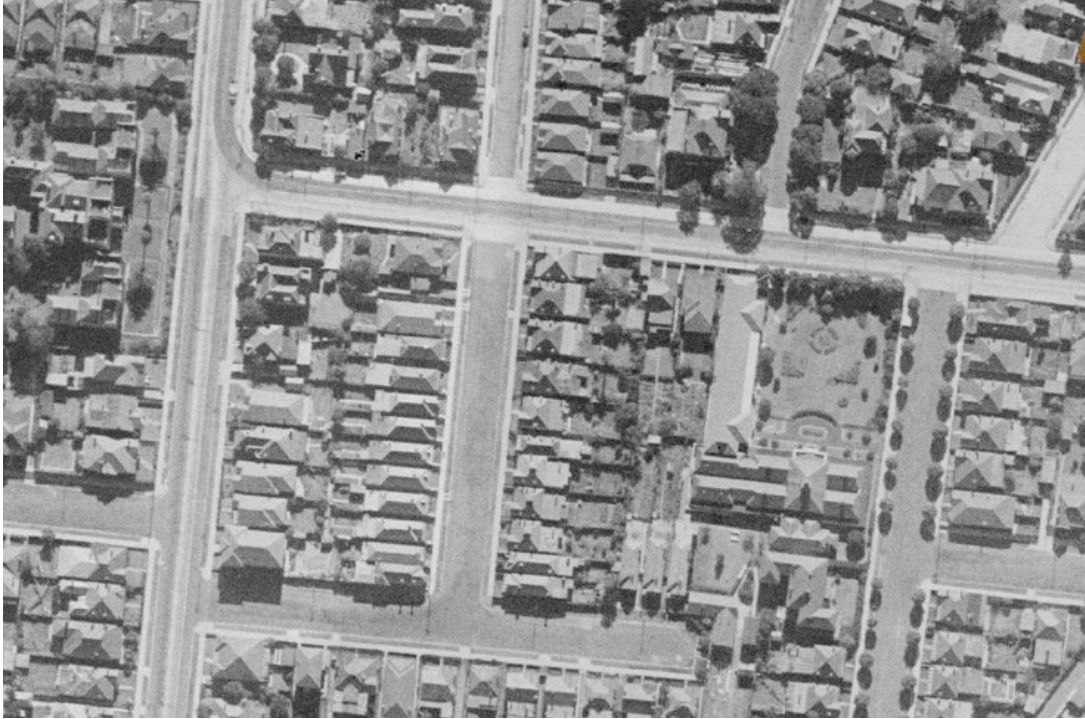
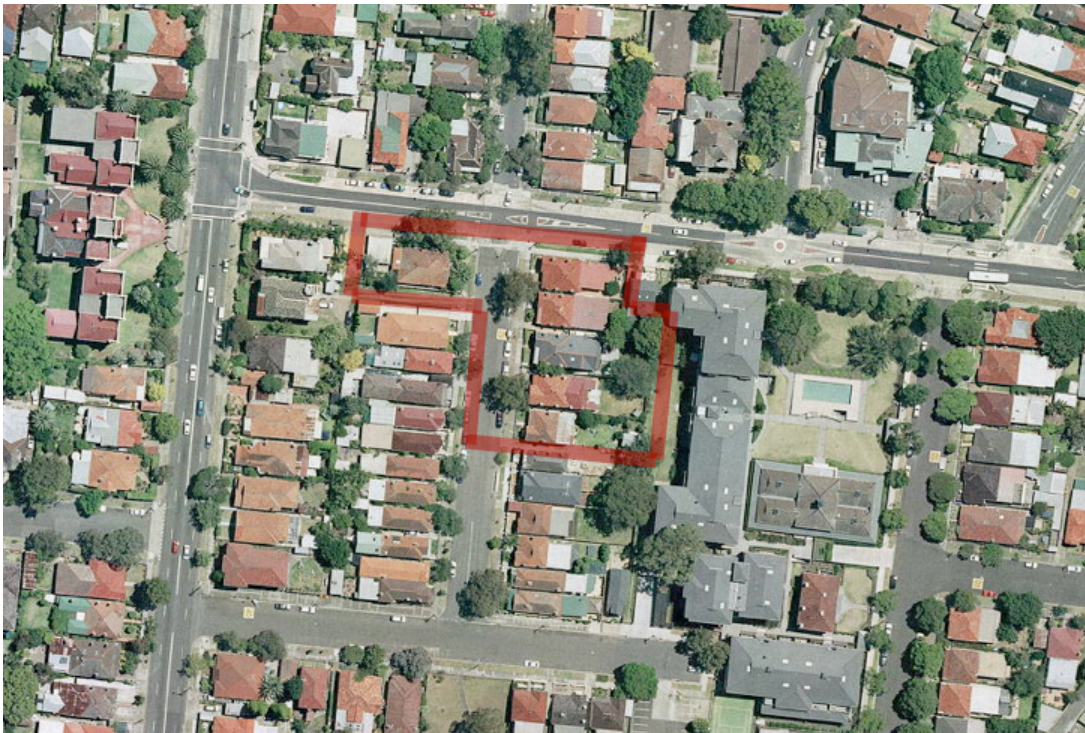
Figure 20.2 The Area in 1943 and 2009 (source: NSW Lands Department SIX Viewer)

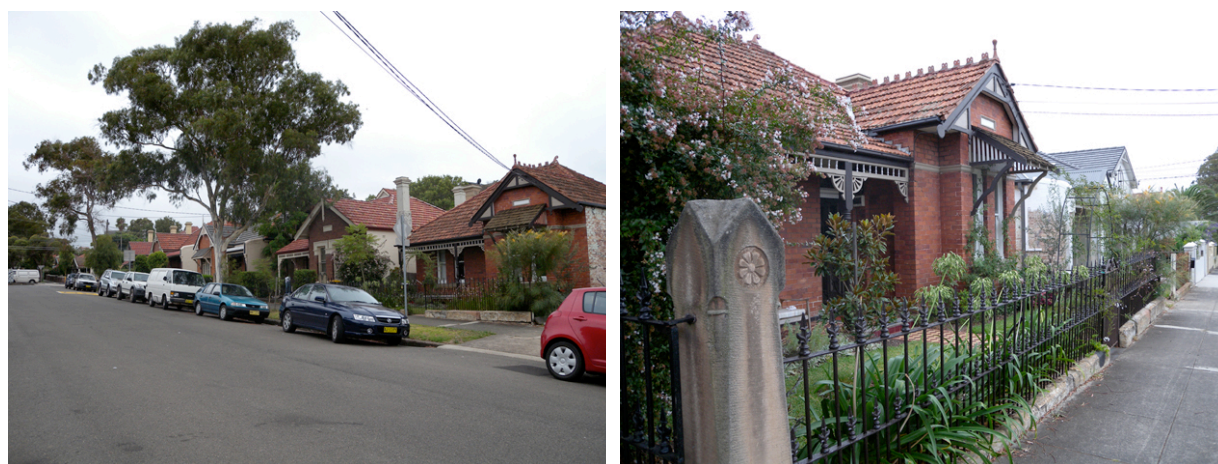
Figure 20.3 and 20.4. The Audley Street South Area demonstrates a highly cohesive streetscape of fine Federation cottages which demonstrates the transition between the high density terraced areas of Marrickville and the growing desire of the middle-class for a detached, suburban lifestyle.

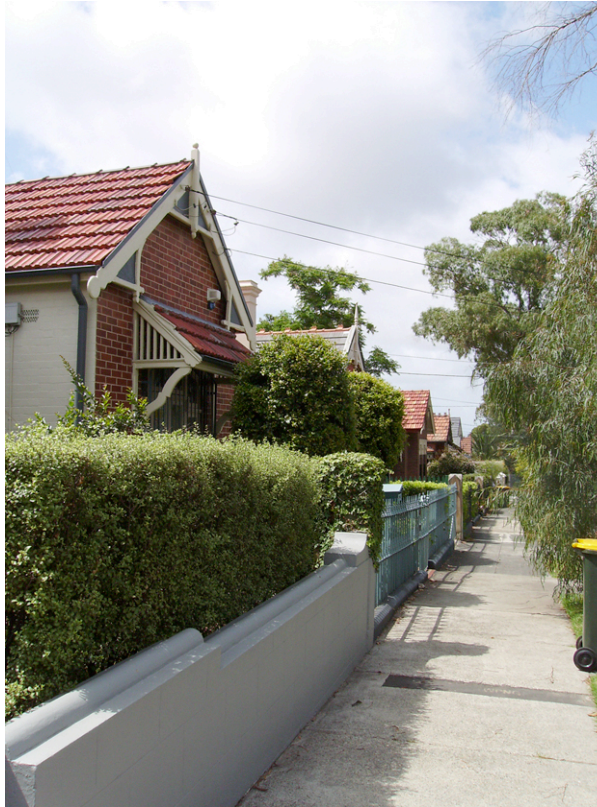
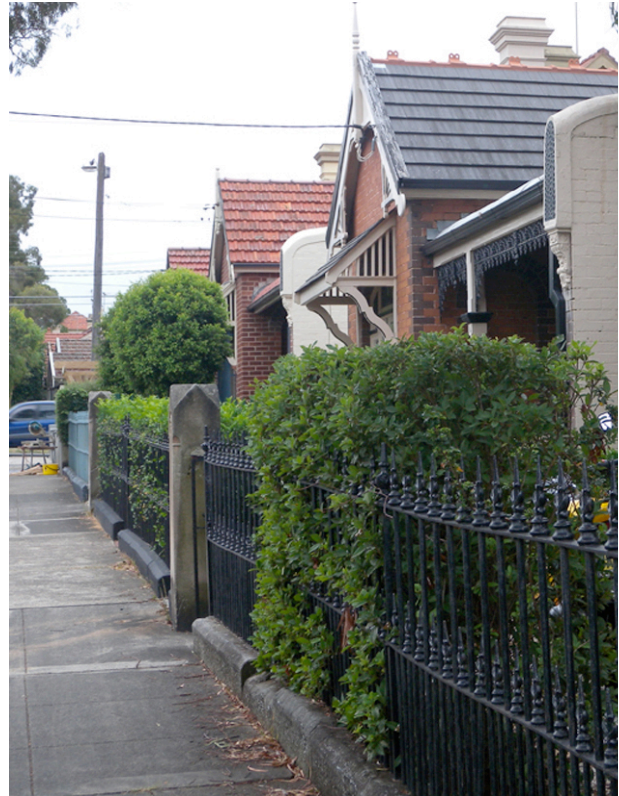
Figure 20.5 and 20.6. The streetscape of Audley Street south is a highly cohesive one. Most houses have retained their original iron palisade fence with sandstone pillars, which together with the regular rhythm of the roofscape created by the gables and chimneys and intact roof volumes enhances the streetscape's strong aesthetic values.

Their garden settings are managed consistently and emphasise the aesthetic qualities and cohesiveness of the streetscape. All except two properties have retained their original iron palisade fences which are set into a chamfered, not roll-topped base.

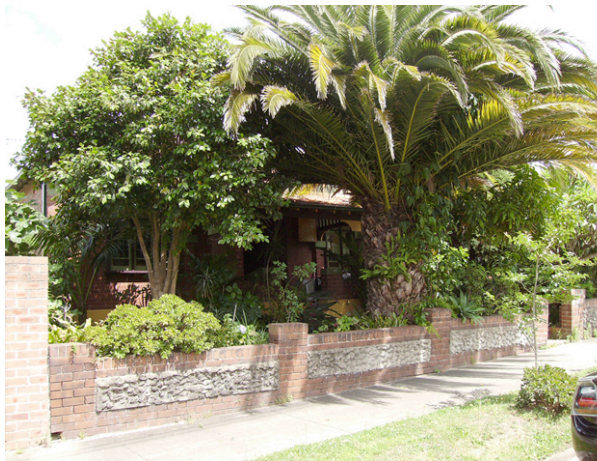
Figure 20.7. The area includes the house on the southwestern corner of Audley Street and Addison Road with its densely planted and mature garden.

The western boundary also excludes the non-contributory elements in the local streetscape and includes the house and garden on the north-western corner of Audley and Addison Roads.

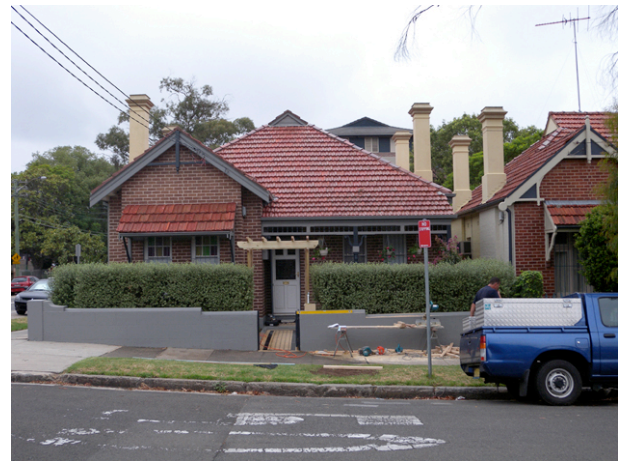
Figure 20.8. Although this house has recently undergone gentrification its roof form and chimneys continue to play an important role in establishing the Area's streetscape value at the entrance from Addison Road.

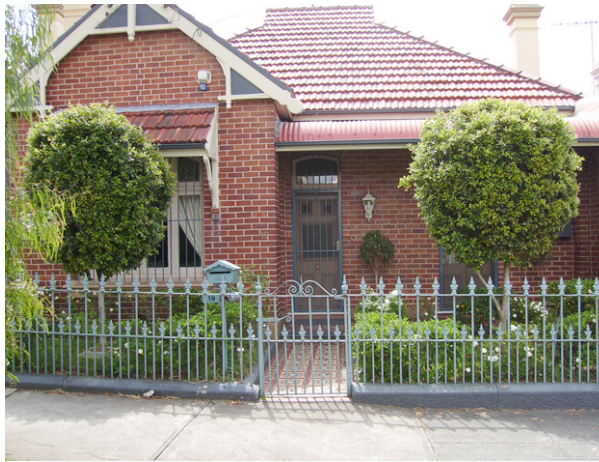
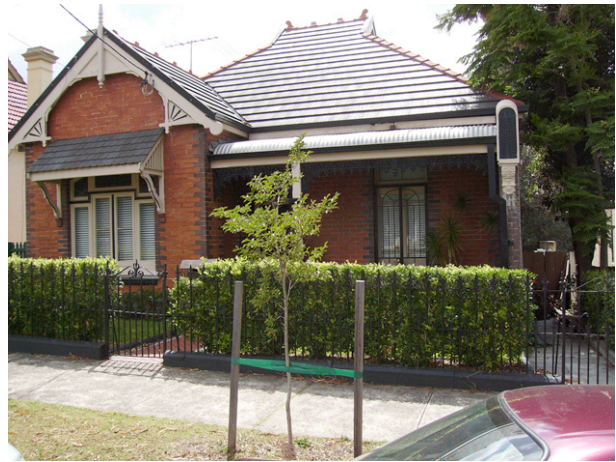
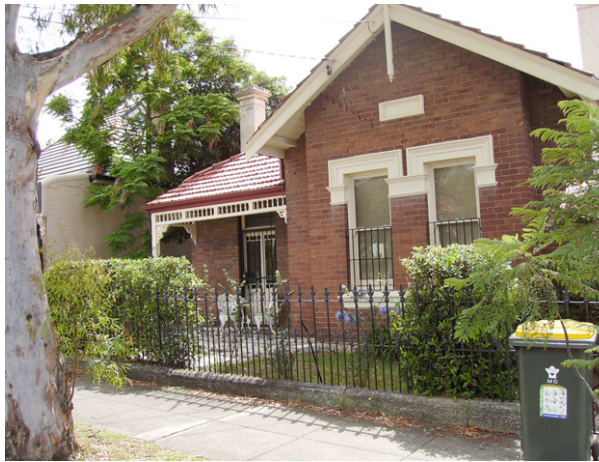
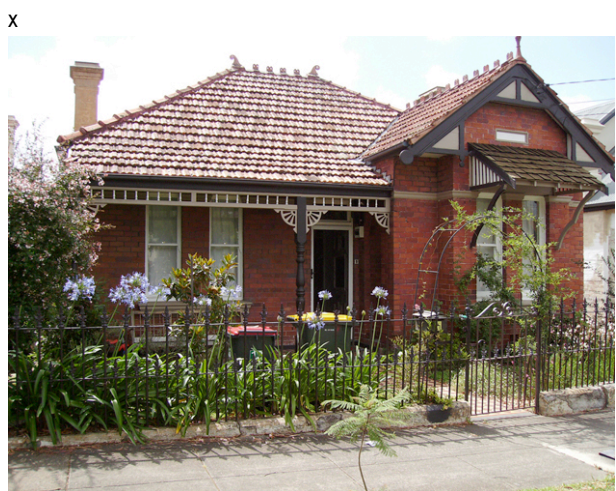
Figures 20.9 to 20.12 illustrate the houses within the area.

It contains good individual examples of Federation bungalows that form a distinctive and cohesive streetscape group. Although some properties have undergone extensive alteration and addition this work has generally been carried out to the rear of the property; or has been limited to visually neutral cosmetic alterations; and has not altered the form of individual dwellings or their ability to contribute to the integrity and heritage significance of the area as a substantially intact Federation streetscape. The property at 24 Audley Street has a mature garden that includes a notable Palm and Frangipani, both of which are characteristic of gardens from the early 20th Century and contribute to the distinctive character of the Area.

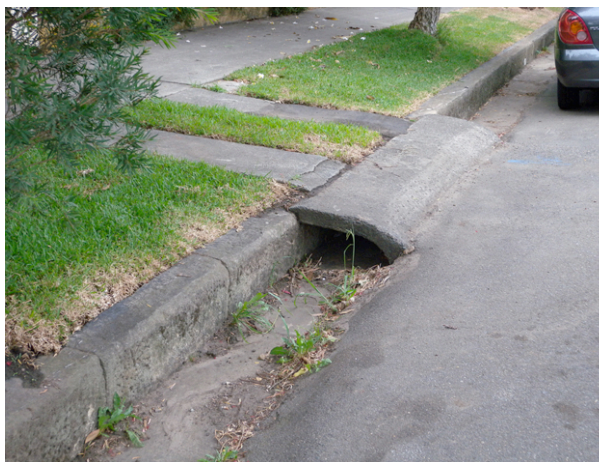
Figure 20.13. The kerbs and gutters are consistent with those throughout the 19th and early 20th Century areas of Marrickville, being formed of sandstone block. The solution shown here is a simple one which allows the underlying sandstone to remain undisturbed whilst allowing car access.
