SUMMER HILL MAIN STREET STUDY 1993

INVENTORY

Address: 30-32 Lackey Street		Item No. 36	Page No. 1/6
Name of Building:			
Former Name:			
Owner:			
Lessee/s:		Current Use/s:	
Date of Construction:	Architect:	Builder:	
<p>History: The 1890 Water Board survey plan shows that a three-bayed building then occupied part of this site. It appears that one of the bays is now incorporated within the adjacent Commonwealth Bank building, the other two being today's Nos. 30 and 32. Because of changes in numbering it is difficult to be sure of the earlier occupiers of these shops. <i>Sands Directory</i> in 1917, however, gives the occupants as: No. 30 John Crawford, bootmaker No. 32 Charles Hallett, jeweller.</p>			
<p>References: Water Board Plans <i>Sands Directories.</i></p>			
<p>Description: These two units, part of a three-bay building, form a two-storey group of shops with dwellings above. The evidence suggests that there was originally a posted single-storey footpath awning; the awning is now a suspended metal structure. Below that, the shopfronts have been extensively and quite disparately remodelled and there is now no evidence of what they might have been. Above the awning the stucco

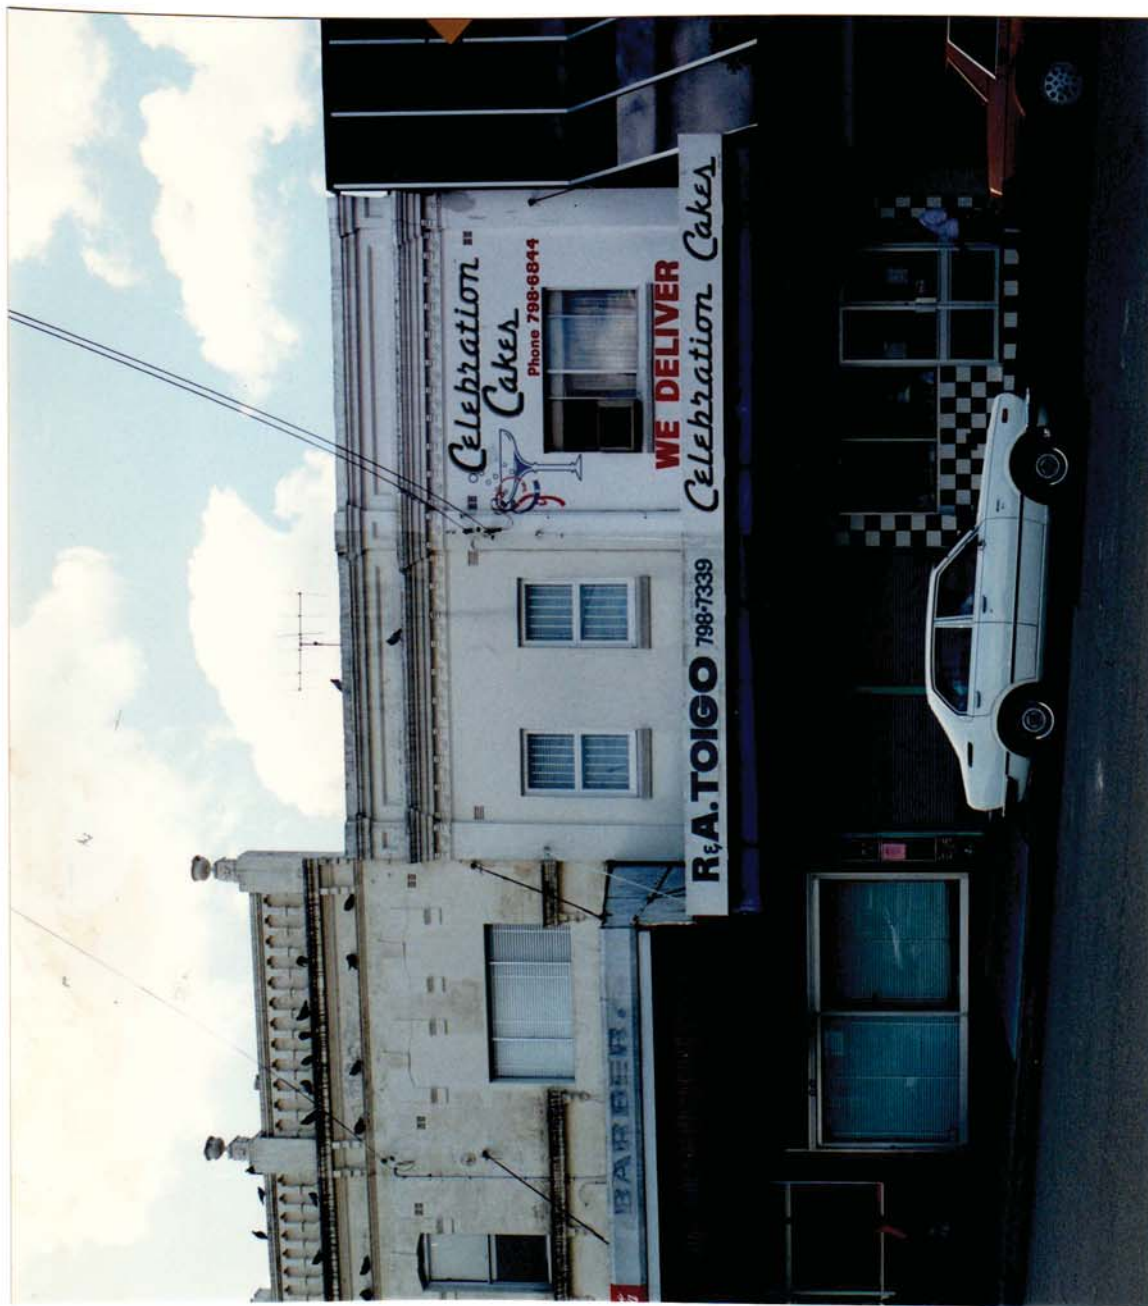
1993 PHOTOGRAPH

<p>Modifications: The original windows of No. 30 have been replaced by a horizontal opening with a metal frame and sashes. The original shopfront of No. 28 has been replaced by roller shuttered openings, while that of No. 30 has been replaced by a gaudy tile-and-metal composition.</p>

Item No. 36	Page No. 2/6	Address: 30-32 Lackey Street				
Name of Building:						
Contribution To Streetscape:	<i>Appropriate Scale/mass</i>	<i>Compatible Form/shape</i>	<i>Harmonious Style</i>	<i>Compatible Materials</i>	<i>Existing Colour Scheme</i>	<i>Existing Shop Fronts</i>
	1	1	1	1	4	4
1 = Excellent 2 = Good 3 = Fair 4 = Poor 5 = Disruptive						
Heritage Listings	LEP	NT	AHC	Heritage Study	Other	
Statement of Significance: <p>A modest facade which despite being somewhat truncated holds its own in the Lackey Street streetscape and contributes positively to it.</p>						
Recommendations For Conservation Action: <p>(a) <i>Immediate:</i> Adopt appropriate paint colour and signage schemes.</p> <p>(b) <i>Medium Term:</i> Reinstate the traditional upper window forms of No. 32.</p> <p>(c) <i>Long Term:</i> Consider rebuilding the shopfronts to recreate an appropriate period character.</p>						
Desirable Planning Objectives:

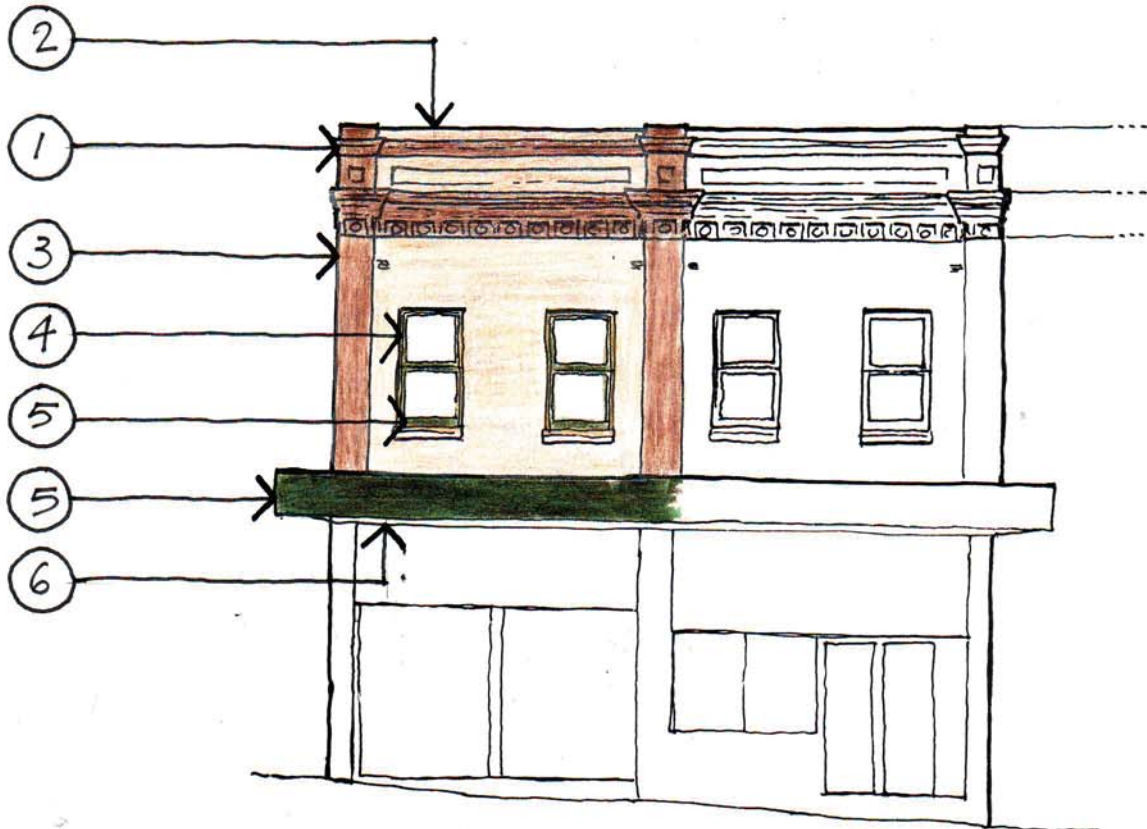
Item No. 36	Page No. 6/6	Address: 30-32 Lackey Street
Name of Building:

1. TANBARK top moldings of cornices
- 2 PALE STONE facade, cornice panels.
- 3 SPARROW. pilasters, cornices
4. LIGHT BEIGE window frames.
- 5 DEEP BRUNSWICK GREEN. window sashes
awning front.
- 6 VELLUM. awning soffit.
