HABERFIELD MAIN STREET STUDY 1993
INVENTORY

Address: 60 Dalhousie Street		Item No. 39	Page No. 1/6
Name of Building: Ella Community Centre			
Former Name: Haberfield Methodist Church			
Owner:			
Lessee/s:		Current Use/s: Community Centre	
Date of Construction: 1908	Architect: A. M. Allan Summer Hill	Builder: A. M. Allan	
<p>History: The foundation stone for a new Methodist Church at Haberfield was laid on 15 February 1908. The new church was part of the Summer Hill-Lewisham Circuit, then in the charge of the Rev. J. G. Middleton. The church was formally opened on 6 May 1908, and a contemporary report said it was erected "after the modified Gothic style of architecture". The building cost £750 and the architect, Mr. A. M. Allan, gave his services "gratuitously". He also sold the church the land on which it was erected, but in this case the cost was £300. The choir at the opening service was conducted by F. O. Hedger, later a Mayor of Ashfield, whose memory is perpetuated by one of the stained glass windows in the building.</p> <p>The Ella Community Centre was established in the former church building in 1974.</p>

HABERFIELD MAIN STREET STUDY 1993**1993 PHOTOGRAPH****Address:** 60

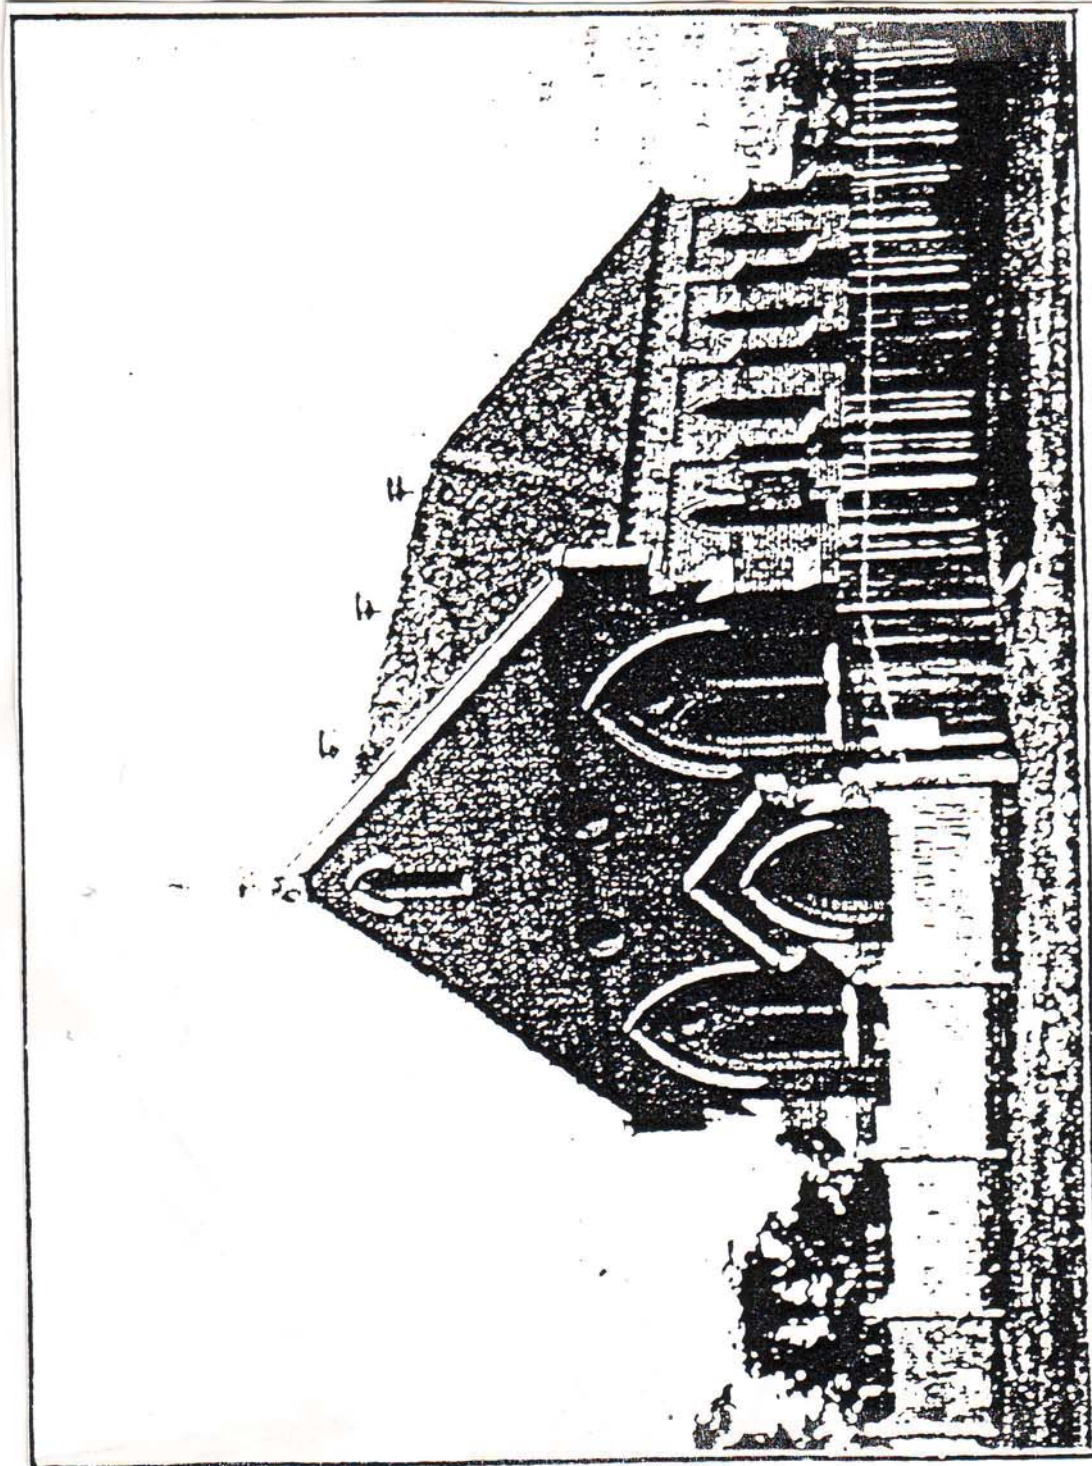
Item No. 39	Page No. 4/6	Address: 60 Dalhousie Street Name of Building: Ella Community Centre
----------------	-----------------	---

NEW METHODIST CHURCH, HABERFIELD.

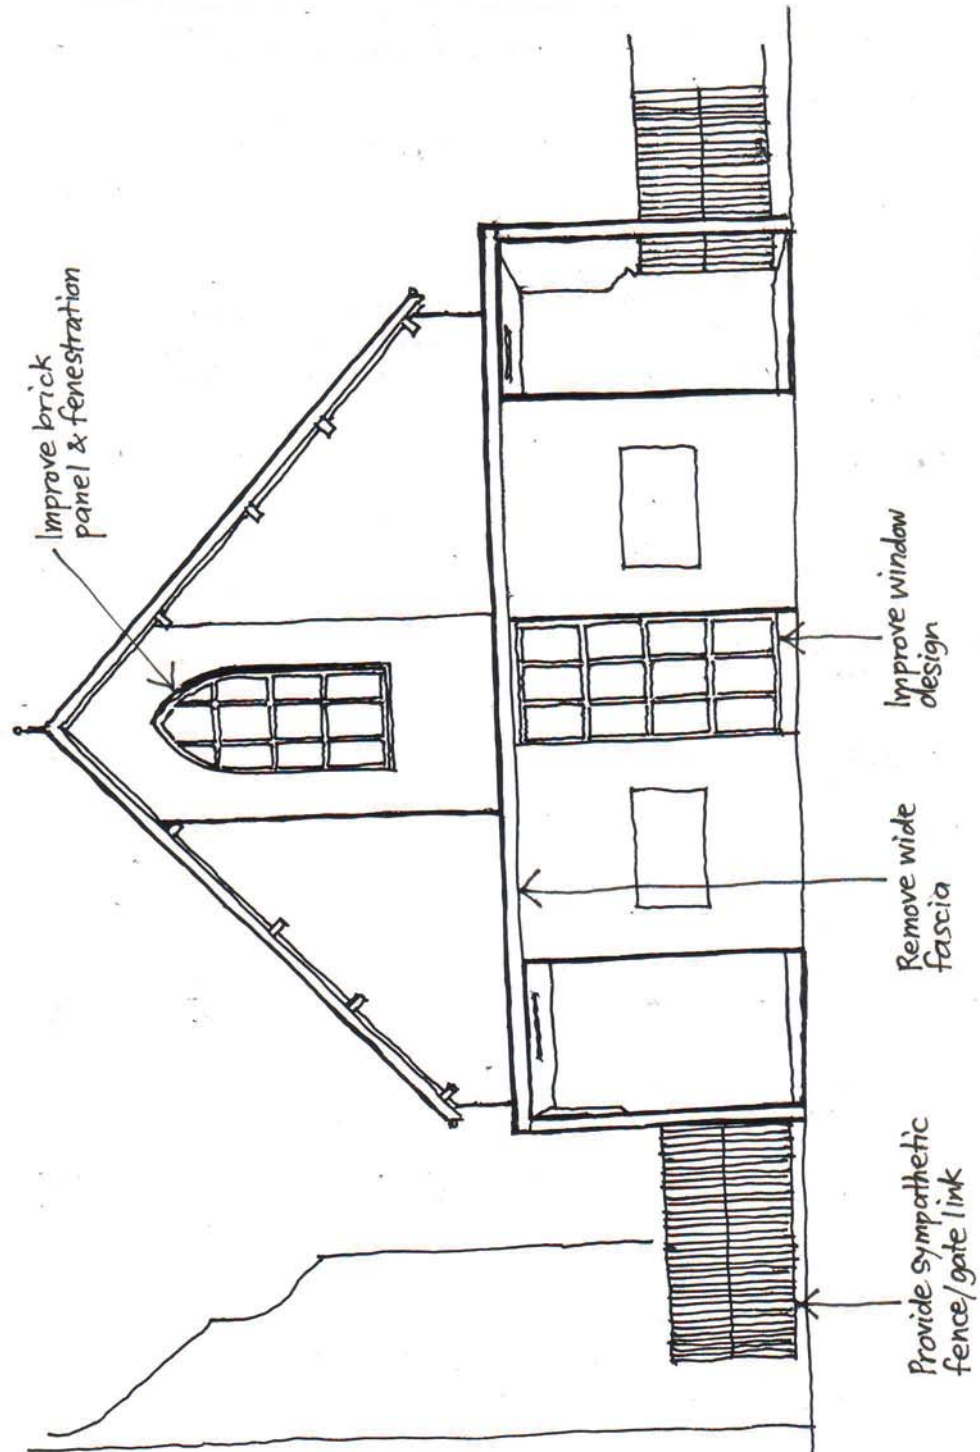
Address: 60 Dalhousie Street	Item No. 39	Page No. 5/6
Name of Building: Ella Community Centre

1. MID BRUNSWICK GREEN fascia, finish.
2. GREY GREEN. gable soffit, perlinis, verandah soffit.
3. SKY window, notice board frames.

4. FERNWOOD. porch fascia & posts.
5. existing unpainted brickwork.

Improve brick panel & fenestration

Improve window design

Remove wide fascia

Provide sympathetic fence/gate link
