# AD 2001 Ashfield Heritage Study Review of Areas Zoned 2(a)

<b>Name of Item</b> House, 'Lauthelma' <b>Other Names</b>	<b>Reference N°</b> <b>2 01 05</b>																								
<b>Address</b> 23 Alt Street <b>Locality</b> Ashfield <span style="float: right;"><b>Postcode</b></span>	<b>Land Title</b>																								
<b>Item Type</b> Building <b>Group Name</b>	<b>Owner/s</b>																								
<b>Statement of Significance</b> <p>A pleasing and authentic example of the California Bungalow style of architecture, featuring an arrangement of triple or layered gables. It typifies the kind of residential activity in Ashfield in the 1920s.</p>	<b>Condition as observed from street</b> — <input type="checkbox"/> Intact <b>Minor alteration</b> — <input type="checkbox"/> Sympathetic <input checked="" type="checkbox"/> Unsympathetic <b>Major alteration</b> — <input type="checkbox"/> Sympathetic <input type="checkbox"/> Unsympathetic																								
<b>Summary of Significance</b>

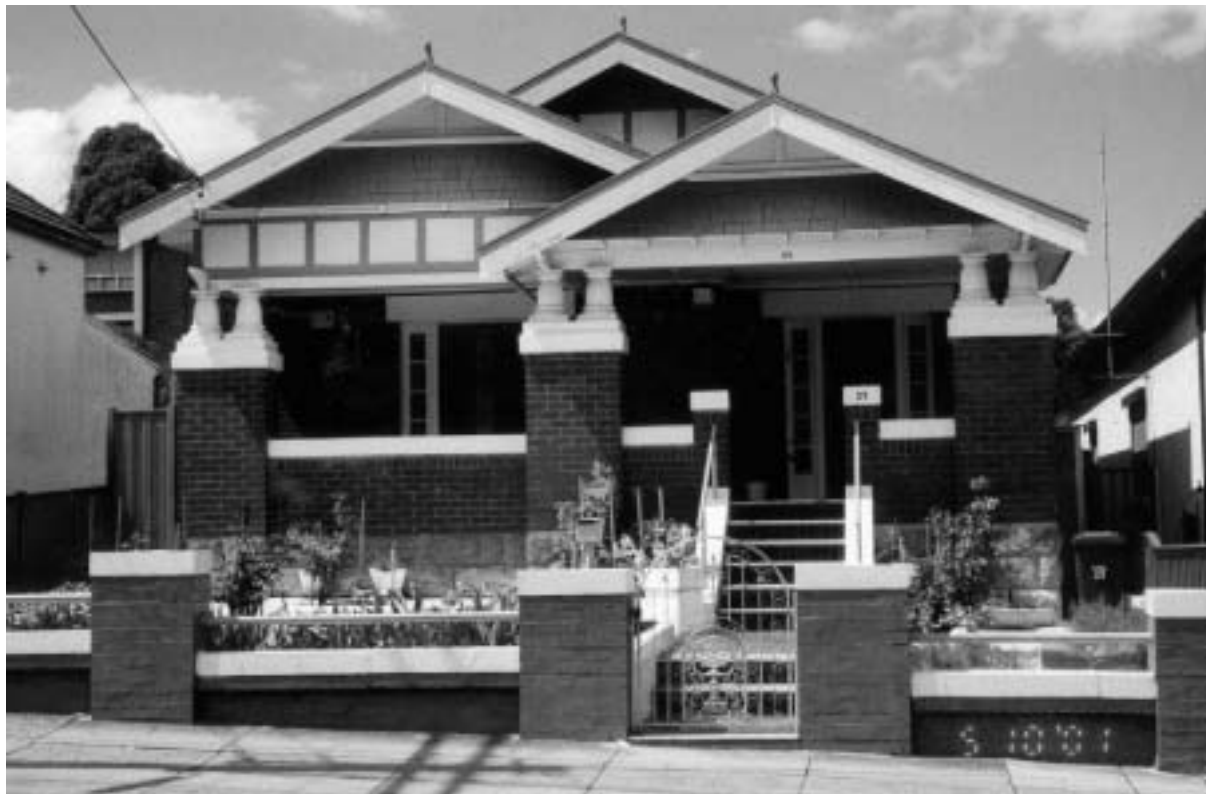
<b>Photo Roll N°</b> 13	<b>Frame N°</b> 16A	<b>Survey Date</b> 5/10/2001	<b>Surveyed by</b> RI
-------------------------	---------------------	---------------------------------	--------------------------

<p><b>Physical Description</b></p> <p>A single-storey California Bungalow with a triple-gable street front. It is built on a sandstone base, with a facade of brown tuckpointed brickwork, and characteristically low-pitched terra cotta tiled roof components with small ridge terminals. The layered gables project over a full-width verandah which has brick piers with rendered caps supporting paired stumpy colonettes. Bargeboards are plumb-cut. In the centre of the entrance bay are the steps ascending from the front path, which have tiled risers and low brick balustrades. The front door has sidelights and there is another French doorway with sidelights also opening from the side room on to the verandah. Lintels are of concrete. Two of the gables have the panel-and-batten motif and all three have panels of shingles as well. The rafters have exposed feet. The front fence consists of piers, plinths and pipe rails complementing the design of the house, though the gate is not authentic. The front garden has been largely concreted over, with well-kept perimeter flower beds. The paint colours are unsympathetic and somewhat garish but the property is well cared for.</p>
