ASHFIELD HERITAGE STUDY

1991-1992

AOIII ILLD IILIIII AOL O I OD I					1001-1006
NAME	Semi-detached pai	r of houses			REFERENCE NO. 042
OTHER NAMES					REAL PROPERTY DESCRIPTION
LOCALITY / SUBURB STREET ADDRESS	Ashfield 25-27 Bland Street	POSTCODE 21331			ZONING 2 (c)
MAP		REFERENCE			OWNER (25) Heaney MF.
PHYSICIAL CHARACTERISTICS/HISTORICAL NOTES - SEE OVER					(27) Clomen Pty Ltd.
CATEGORY		SUB CATEGORY			
EVALUATION OF SIGNIF Historic: Rare Aesthetic: Rare Social: Rare Scientific: Rare	FICANCE	Associative Associative Associative Associative	Representative Representative Representative	x x x	BOUNDARY / IDENTIFICATION The property boundary
Other: Rare		Associative	Representative		SITE CONDITION
* A mirror image parties this handsome m	air of houses which,	despite much modification,	still display some o	characteristics of	Intact Minor Alteration Major Alteration - Sympathetic - Unsympathetic Removed (site only)

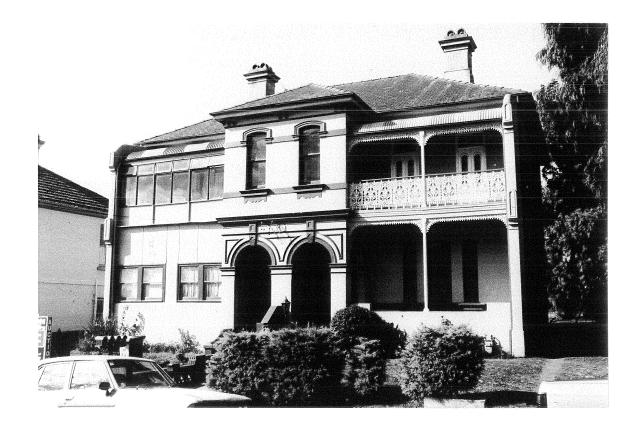
PHOTOGRAPHS		DATE OF SURVEY
BandW ROLL 91-052013	NEG NO. 14a	4/6/92
COLOUR SLIDES ROLL	FRAME NO.	SURVEYOR
STUDY TEAM: Richard Mackay, Robert Irvin	RI/CHP

•	Victorian Italianate/Filigree.					
DESCRIPTIO						
A two storey brick pair presenting a stucco facade to Bland Street. The basic roof is hipped and in the centre there is a projecting hipped						
bay which incorporates the twin arched entrance porches below and annexe rooms above, with windows having stilted segmental-arched						
heads, impost band and sill band. The round arches of the proches have mouldings, prominent keys and a prominent cornice above, at						
first floor level. The two end walls project forward as firewalls embracing the verandah, but there is no party wall parapet. The verandahs						
have bullnosed corrugated iron roofs and decorative iron comprising centre columns and bracket/frieze/fringe elements, with an upstairs						
balustrade. French doors open to top verandahs, three light windows to lower verandah. There are traces of ruby glass in the doorcases.						
Front steps have slate treads and stucco balustrade.

Verandahs of No. 27 have been filled in, ironwork removed. Modern low taperstry brick fence. Decorative iron of No. 25 has been replaced with aluminium. Fence removed.						
The same and the following.
