Ashfield Heritage Study Review of Areas Zoned 2b & 2c

Name of Item Cottage				Reference No	
Other Names	5				18
Address	042 Liverpo	ool Road			Land Title
Audiess	042 Liverpo	or Koau			Lot 2 DP 12981
Locality	Summer Hill		Postcode (2130

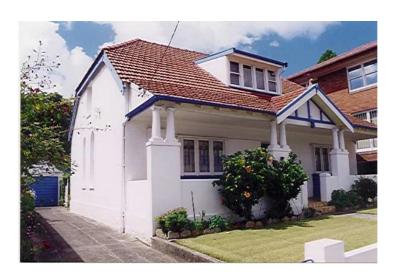
Photograph

Single storey brick cottage now clad with stucco. This is an earlier cottage which was extensively remodelled probably in the 1920s. The main roof is jerkin-head in form and is likely to have been the original form of the roof form. It is now clad with Marseilles terra cotta tiles. An attic storey has been incorporated in the roof and a bank of attic windows facing west lets light into this space. Another window at the side provides light to this storey and suggests that the attic was part of the original layout of the cottage. At the side, below this rectangular window there is a pair of round headed windows which also appear to date from the earlier form of this building. A verandah runs across the front of this cottage. A break front gable has been added to this verandah possibly when the cottage was remodelled. This gable is clad with fibro with timber cover strips. The verandah roof is supported by four sets of twin round masonry pillars set upon a high stuccoed brick base which rises from the balustrade. Triple casement windows with leadlight glass are on either side of the main entrance.
