AD 2001 Ashfield Heritage Study Review of Areas Zoned 2(a)

Current UseReference N° House, 68 Holden Street, Ashfield, part of a group of six similar houses1.08.30

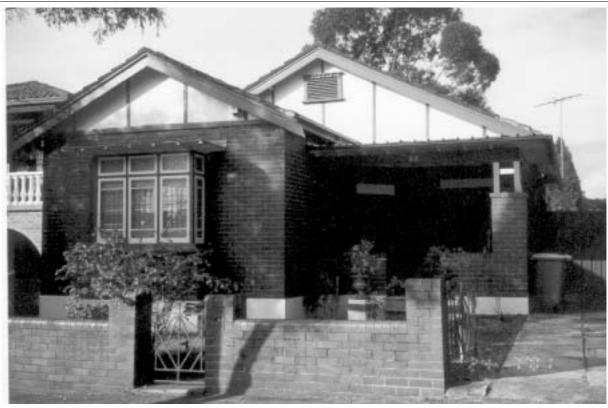
Photo Roll N° 7 Frame N° 12A Survey Date Surveyed by RI RI

These six almost identical California Bungalows, all substantially intact, are built with brown face brick fronts and common brick sides. Each has a broad full-width gable facing the street, with a projecting gabled wing at one side in which is a five-light window. The gables have panel-and-batten treatment and the main gable has a decorative vent. There is a deep verandah beside the projecting bay, floored with tessellated tiles, with brick balustrading and a singe corner pier surmounted by triple short posts supporting the verandah roof. An unusual feature is that each front entrance is located at the inner corner of the verandah, in a canted wall, and a room with French doors opens on to the verandah. All houses have side driveways and curved front paths. The door and window lintels appear to be concrete.
