AD 2001 Ashfield Heritage Study Review of Areas Zoned 2(a)

| Name of Item House, one of a group of six Other Names | Reference N° 1 08 40 | | | | | | | | | | | | | | | | | | | | | | | | |
|--|--|---|---|---|---|---|---|---|---|---|---|---|---|---|---|---|---|---|---|---|---|---|---|---|--|
| Address 72 Holden Street Locality Ashfield Postcode | Land Title | | | | | | | | | | | | | | | | | | | | | | | | |
| Item Type Building Group Name | Owner/s | | | | | | | | | | | | | | | | | | | | | | | | |
| Statement of Significance One of an extremely unusual ensemble of six adjacent houses of the same period and architectural style, of high quality and in remarkably intact order. The subtle variations of design appear to indicate individual requirements without sacrificing the harmony of the group. The suite is a potent demonstration of residential development in Ashfield in the period between the World Wars. | Condition as observed from street — <input type="checkbox"/> Intact Minor alteration — <input checked="" type="checkbox"/> Sympathetic <input type="checkbox"/> Unsympathetic Major alteration — <input type="checkbox"/> Sympathetic <input type="checkbox"/> Unsympathetic | | | | | | |

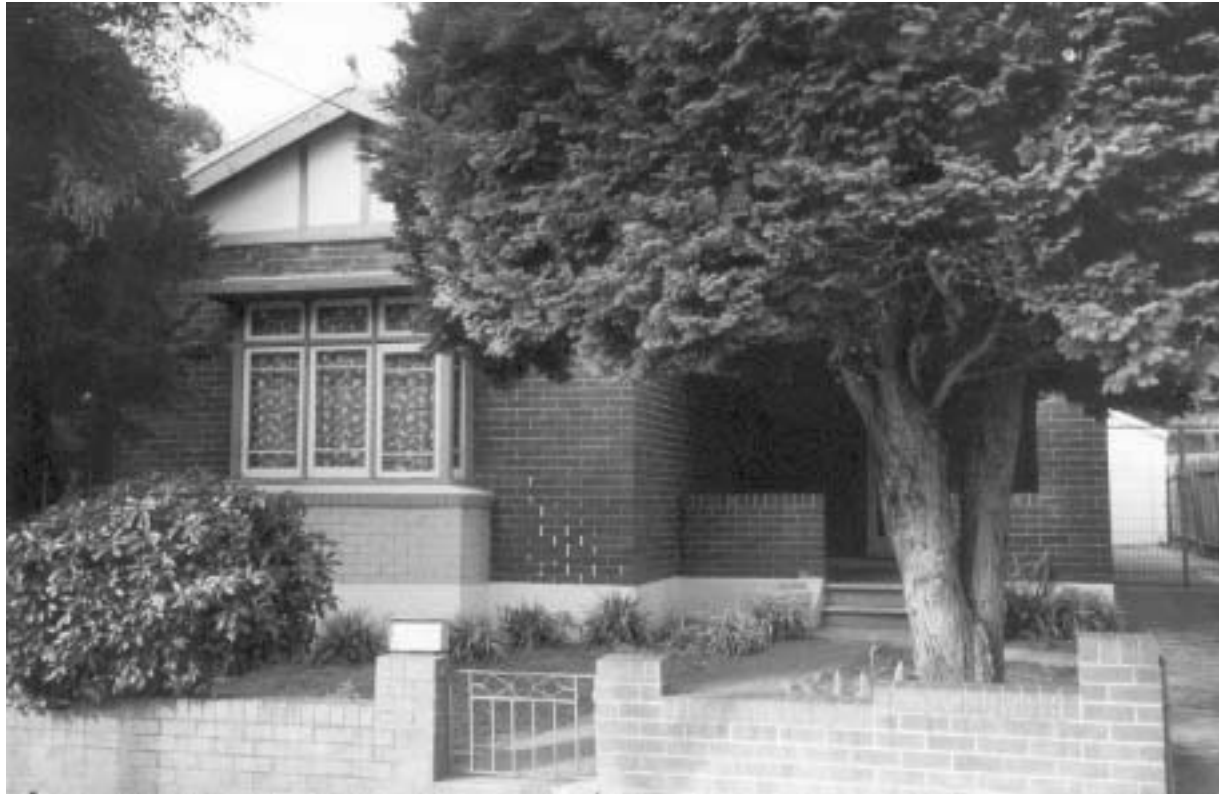
| Photo Roll N° 7 | Frame N° 14A | Survey Date | Surveyed by RI |

| <p>Physical Description</p> <p>These six almost identical California Bungalows, all substantially intact, are built with brown face brick fronts and common brick sides. Each has a broad full-width gable facing the street, with a projecting gabled wing at one side in which is a five-light window. The gables have panel-and-batten treatment and the main gable has a decorative vent. There is a deep verandah beside the projecting bay, floored with tessellated tiles, with brick balustrading and a single corner pier surmounted by triple short posts supporting the verandah roof. An unusual feature is that each front entrance is located at the inner corner of the verandah, in a canted wall, and a room with French doors opens on to the verandah. All houses have side driveways and curved front paths. Here there are two substantial conifers in the front garden. The door and window lintels appear to be concrete.</p> | |
