Ashfield Heritage Study Review of Areas Zoned 2b & 2c

Name of Item Strathmore Other Names	Reference No <div style="text-align: center; font-weight: bold; font-size: 1.2em;">49</div>																								
Address 09 Tintern Road Locality Ashfield Postcode 2131	Land Title																								
Item Type Group Group Name Tintern Road Victorian Group	Zoning 2c

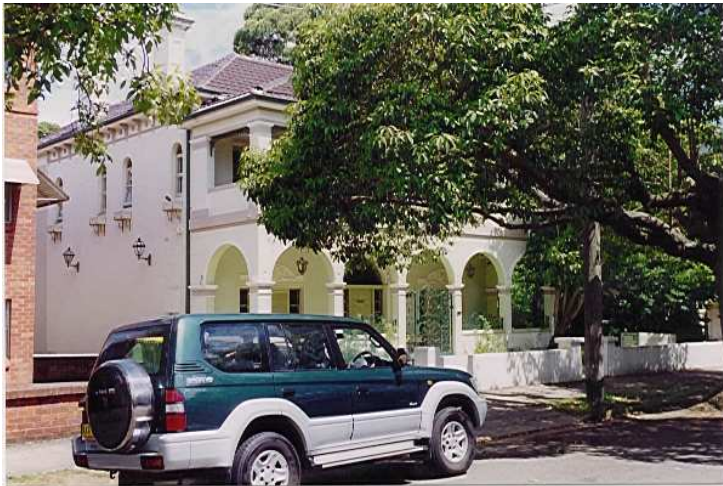
</div>																									
Photo roll 1999 - 1	Survey Date 12/23/1999 Surveyed by: TK																								
Negative 13 14

Two storey late Victorian villa of rendered and painted masonry construction. Hipped roof now clad with dark terra cotta tiles. Eaves brackets interspersed with roundels above a moulding betray the Italianate origins of this building which has now been altered. Decorative rendered chimneys remain. A colonnaded loggia at the front shields the building from the weather and adds to privacy. The lower part of the colonnade has squared rendered masonry columns supporting the upper level loggia which has squarer and thicker columns support the upper roof. A wrought iron grilled gate protects this entrance and gives a faintly Moorish air to what was once an Italianate villa. A moulded multi-panelled door is set within a wide central doorway with side lights and circular fanlight leading into the villa. The front windows are protected with shutters. Above the two sets of front windows is an elaborate plaster ?? . The upper windows on the sides are narrow round arches with double hung sashes. A low modern rendered brick fence is at street level.
