ASHFIELD HERITAGE STUDY

1991-1992

NAME Three Commercial Premises with Dwellings above.				REFERENCE NO. 083	
OTHER NAMES	Formerly Shops an	d Dwellings.			REAL PROPERTY DESCRIPTION
LOCALITY / SUBURB STREET ADDRESS MAP PHYSICIAL CHARACTER CATEGORY EVALUATION OF SIGNIF Historic: Rare	Croydon 125, 127 and 129 E RISTICS/HISTORICA FICANCE x TICANCE ng ensemble of shop th ensemble.	POSTCODE Edwin Street North. REFERENCE AL NOTES - SEE OVER SUB CATEGORY Associative			ZONING 2(a) OWNER (125) Jaytel Pty Ltd (127) AA Purposes Pty Ltd (129) JE Beckman & Assoc. Pty Ltd BOUNDARY / IDENTIFICATION The property boundary SITE CONDITION Intact Minor Alteration Major Alteration
* Representative of	of late 19th century n	etail trade in proximity to Cr	oydon Railway Sta	tion.	- Sympathetic - Unsympathetic X Removed (site only)

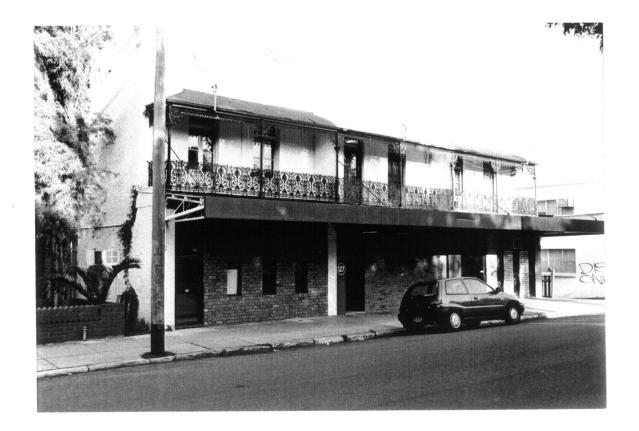
Written: Oral: Graphic: PHYSICAL CI Materials: Exterior:	HARACTERISTICS: Brick/stucco walls, roofs not visible, decorative cast iron balcony Two storey attached trio of former shops with dwellings above, n	verandahs with	corrugated premises.	iron roofs.
Written: Oral: Graphic: PHYSICAL CH Materials: Exterior: Interior:	HARACTERISTICS: Brick/stucco walls, roofs not visible, decorative cast iron balcony Two storey attached trio of former shops with dwellings above, n Not inspected. Victorian Regency.	verandahs with	corrugated premises.	iron roofs.
Written: Oral: Graphic: PHYSICAL CH Materials: Exterior: Interior: Styles: DESCRIPTION	HARACTERISTICS: Brick/stucco walls, roofs not visible, decorative cast iron balcony Two storey attached trio of former shops with dwellings above, n Not inspected. Victorian Regency.	ow commercial	premises.	
Written: Oral: Graphic: PHYSICAL CI Materials: Exterior: Interior: Styles: DESCRIPTION A group	HARACTERISTICS: Brick/stucco walls, roofs not visible, decorative cast iron balcony Two storey attached trio of former shops with dwellings above, n Not inspected. Victorian Regency. N:	ow commercial	premises.	y slender cast iron columns.
