ASHFIELD HERITAGE STUDY

1991-1992

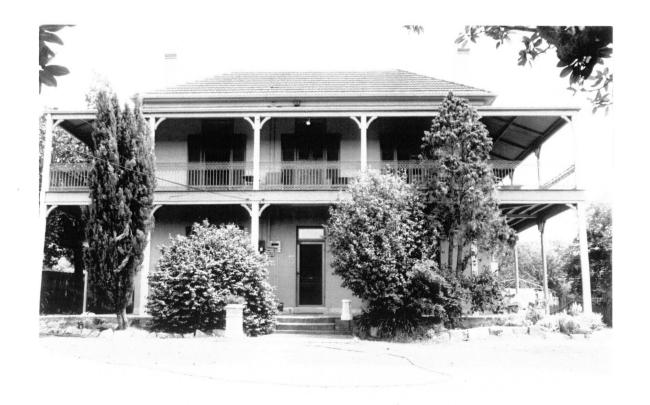
NAME		House					REFERENCE NO. 117	
OTHER NAMI	ES	Formerly GADS HI	LL VILLA				REAL PROPERTY D	ESCRIPTION
LOCALITY / S		Croydon 8 Highbury Street	POSTCODE	2132			ZONING 2(a)	
	TILOU	o riigiibary oucot					OWNER	
MAP			REFERENCE					onald College
PHYSICIAL C	HARACTE	RISTICS/HISTORICA	AL NOTES - SI	EE OVER			of Dance	oriala college
FIITOIDIAL	TIATIAOTE						BOUNDARY / IDEN	TIFICATION
CATEGORY			SUB CATEGO	ORY				
EVALUATION	OF SIGNI	FICANCE						
Historic:	Rare	(Associative	Х	Representative			
Aesthetic:	Rare	C	Associative	X	Representative			
Social:	Rare	K	Associative	X	Representative			
Scientific:	Rare		Associative		Representative			
Other:	Rare		Associative		Representative		SITE CONDITION	
STATEMENT	OF SIGNIE	ICANCE					Intact

* A house of historic significance			because of its	associations	with Lawrence Be	rain.	Minor Alteration	
		borow and Gads Hill				-31	Major Alteration	X

- Sympathetic	
							- Unsympathetic	X
							Removed (site only)

Written: Oral: Graphic: PHYSICAL CI Materials:	Triangle of Land. N. Peek, historical searches. HARACTERISTICS: Brick/stucco walls. Concrete tile roof. Verandah with timber pos Two storey house with symmetrical front and encircling verandal	ts and brackets	and first flo	or balcony panels of cast iron.
Written: Oral: Graphic: PHYSICAL CH Materials: Exterior: Interior:	Triangle of Land. N. Peek, historical searches. HARACTERISTICS: Brick/stucco walls. Concrete tile roof. Verandah with timber pos Two storey house with symmetrical front and encircling verandal Not inspected.	ts and brackets	and first flo	or balcony panels of cast iron.
Written: Oral: Graphic: PHYSICAL CI Materials: Exterior: Interior: Styles:	Triangle of Land. N. Peek, historical searches. HARACTERISTICS: Brick/stucco walls. Concrete tile roof. Verandah with timber pos Two storey house with symmetrical front and encircling verandal Not inspected. Victorian filigree.	ts and brackets	and first flo	or balcony panels of cast iron.
