# Ashfield Heritage Study Review of Areas Zoned 2b & 2c

<b>Name of Item</b> Flats <b>Other Names</b>	<b>Reference No</b> <p style="text-align: center;"><b>47</b></p>																								
<b>Address</b> 06 Sunning Place <b>Locality</b> Summer Hill <span style="float: right;"><b>Postcode</b> 2130</span>	<b>Land Title</b> Lot 8 DP 18093																								
<b>Item Type</b> Group <b>Group Name</b> Sunning Place Flat Group	<b>Zoning</b> 2c

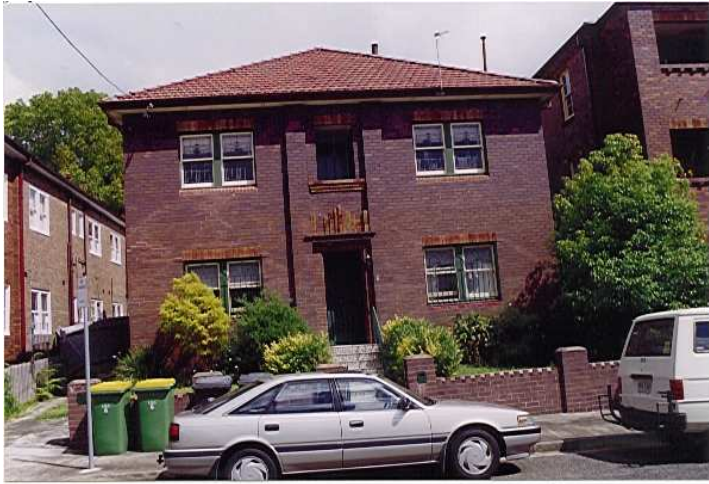
</div>																									
<b>Photo roll</b> 2000-3 <span style="margin-left: 100px;"><b>Negative</b> 27</span>	<b>Survey Date</b> 1/13/2000 <span style="float: right;"><b>Surveyed by:</b> TK</span>

Two storey brick block of flats with some elements of Inter war Art Deco style. A hipped roof clad with Marseilles terra cotta tiles covers the building. The walls are of dark face bricks. Lighter brown texture bricks are used for contrast on the entrance, around the stairwell window and as soldier courses above windows. Double hung sash windows with leadlights are used on the front facade. The front fence consists of a low wall decorated top row of bricks and short piers all built of bricks identical to the building.
