## AD 2001 Ashfield Heritage Study Review of Areas Zoned 2(a)

<b>Name of Item</b> Block of flats, 'Wilton' <b>Other Names</b>	<b>Reference N°</b> <b>3 19 09</b>																								
<b>Address</b> 168 Smith Street <b>Locality</b> Summer Hill <span style="float: right;"><b>Postcode</b> 2130</span>	<b>Land Title</b>																								
<b>Item Type</b> Building <b>Group Name</b>	<b>Owner/s</b>																								
<b>Statement of Significance</b> <p>An impressive and unusual example of late Inter-War architecture displaying interesting Functionalist and Art Deco motifs. It makes a positive streetscape statement and complements the scale of St Andrew's church next door.</p>	<b>Condition as observed from street</b> — <input checked="" type="checkbox"/> Intact <b>Minor alteration</b> — <input type="checkbox"/> Sympathetic <input type="checkbox"/> Unsympathetic <b>Major alteration</b> — <input type="checkbox"/> Sympathetic <input type="checkbox"/> Unsympathetic <b>Modifications</b> —

## Ashfield Heritage Study Review of Areas Zoned 2(a)

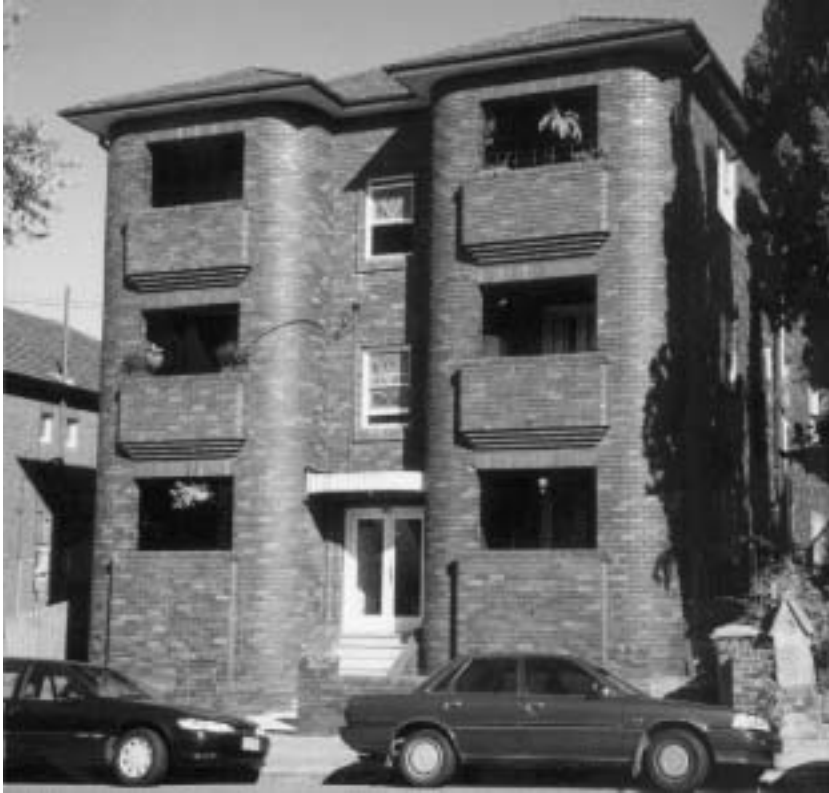
<b>Photo Roll N°</b> 44	<b>Frame N°</b> 21	<b>Survey Date</b> 15/8/2002	<b>Surveyed by</b> RI

<p><b>Physical Description</b></p> <p>A three-storey block of flats which exploits its site to the utmost. It has a facade of variegated brown brick and a hipped roof of terra cotta tiles with boxed eaves. It is a symmetrical three-bay composition, with two projecting bays embracing a narrower central bay containing the entrance and staircases. The flanking bays contain an open balcony on each level. The entrance is at the top of a flight of terrazzo steps which rise from the short terrazzo front path to glazed double doors bearing the name of the building, and above them there is a flat concrete hood with a reeded fascia. The doorway has a surround of bullnose and scotia moulded bricks. The balcony bays have rounded corners laid in curved stretchers, projecting balustrade motifs, also with quadrant corners, corbelled at the two highest levels, and soldier-brick lintel motifs. The two stair windows, enframed in moulded bricks, are timber and have double-hung sashes with vigorous Art Deco leaded designs in uncoloured glass. The windows in the side walls have squinch brick sills.</p> <p>A side drive leads to a service yard and garaging at the rear. The front fence, of bricks matching the facade work, has bullnose capping, with piers marking the entrance path.</p>
