## AD 2001 Ashfield Heritage Study Review of Areas Zoned 2(a)

<b>Name of Item</b> Block of four flats, 'Ruthven' <b>Other Names</b>	<b>Reference N°</b> <b>3 13 05</b>																								
<b>Address</b> 17 Morris Street <b>Locality</b> Summer Hill <span style="float: right;"><b>Postcode</b> 2130</span>	<b>Land Title</b>																								
<b>Item Type</b> Building <b>Group Name</b>	<b>Owner/s</b>																								
<b>Statement of Significance</b> <p>An interesting manifestation of the changes in residential development that have occurred in Ashfield since the Victorian period when the original 'Ruthven' was built. Erected during World War II, this block of flats is a simple though stylish building with echoes of the Functionalist style of architecture.</p>	<b>Condition as observed from street</b> — <input checked="" type="checkbox"/> Intact <b>Minor alteration</b> — <input type="checkbox"/> Sympathetic <input type="checkbox"/> Unsympathetic <b>Major alteration</b> — <input type="checkbox"/> Sympathetic <input type="checkbox"/> Unsympathetic																								
<b>Summary of Significance</b>

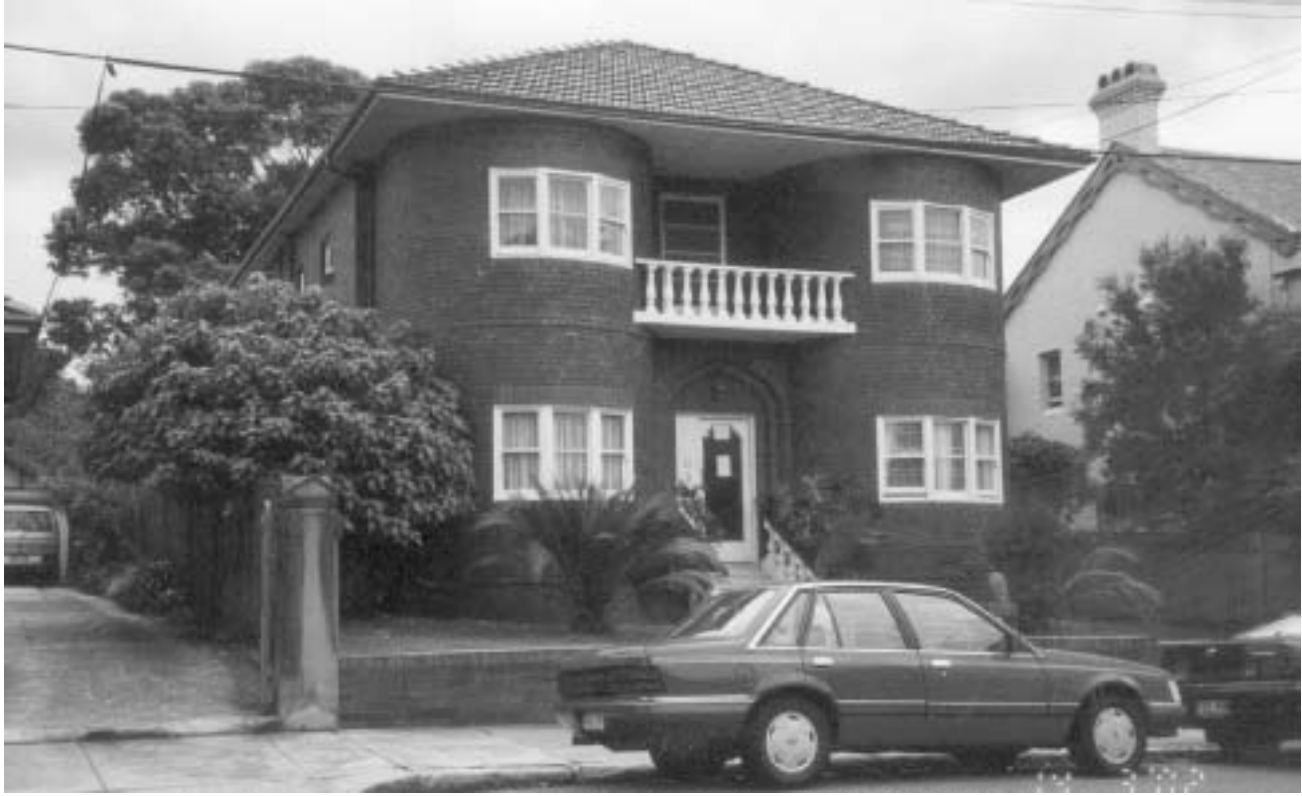
<b>Photo Roll N°</b> 20	<b>Frame N°</b> 17																								
<b>Survey Date</b> 14/3/02 <span style="margin-left: 50px;"><b>Surveyed by</b> RI</span>

<p><b>Physical Description</b></p> <p>This is a stylishly simple two-storey building of loadbearing face brickwork, with an amply-eaved hipped roof of terra cotta tiles. Its symmetrical facade comprises two full-height semicircular bays, laid in header bond, flanking the recessed central entrance and stair hall. A two-course band projects slightly at first floor level. The entrance doorcase has a four-centred Tudor-motif arch of brick, while above it, offering some protection from the worst of the weather, there is a balustraded concrete balcony (it is not likely that the balustrading is original). The bays have three-light faceted timber windows at each level, with double-hung sashes. The openings are headed with soldier-course brick lintel motifs.</p> <p>Terrazzo steps rise from the small front garden to the entrance. The low front fence of brick retains the lawn. One stone pier survives from the original residence 'Ruthven'.</p>
