Ashfield Heritage Study Review of Areas Zoned 2b & 2c

<p>Name of Item Navua Other Names</p>	<p>Reference No 11</p>																								
<p>Address 22 Gower Street Locality Summer Hill Postcode 2130</p>	<p>Land Title Lot 1 DP 18093</p>																								
<p>Item Type Group Group Name Sunning Place Flat Group</p>	<p>Zoning 2c</p>

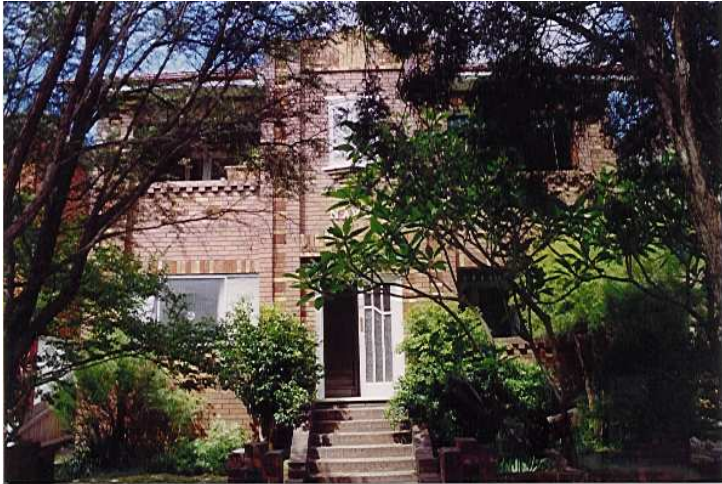
</div>																									
<p>Photo roll 2000-3</p>	<p>Negative 21</p>																								
<p>Survey Date 1/13/2000</p>	<p>Surveyed by: TK</p>

Two storey brick block of flats in Inter war Art Deco style. A hipped roof clad with Marseilles terra cotta tiles covers the building. The central stair has been used to create a feature with its strong verticality. Fluted pilasters are on each side of this main stairway and at the ends of the building. The main building is built of brown face bricks with darker texture bricks used for decorative features. The side walls are constructed of common bricks. Multi-paned glass double doors lead into the central stairway. The stairway window is used as a feature of the building and is composed of diagonal glazing bars supporting frosted glass. Recessed porches face the street from all the front flats. These porches usually highlighted with dentilated brickwork and bricks laid as soldier courses. One of these porches has been enclosed.
