Ashfield Heritage Study Review of Areas Zoned 2b & 2c

<p>Name of Item Hillcrest Other Names</p>	<p>Reference No 46</p>																								
<p>Address 05 Sunning Place Locality Summer Hill Postcode 2130</p>	<p>Land Title Lot 7 DP 18093</p>																								
<p>Item Type Group Group Name Sunning Place Flat Group</p>	<p>Zoning 2c</p>

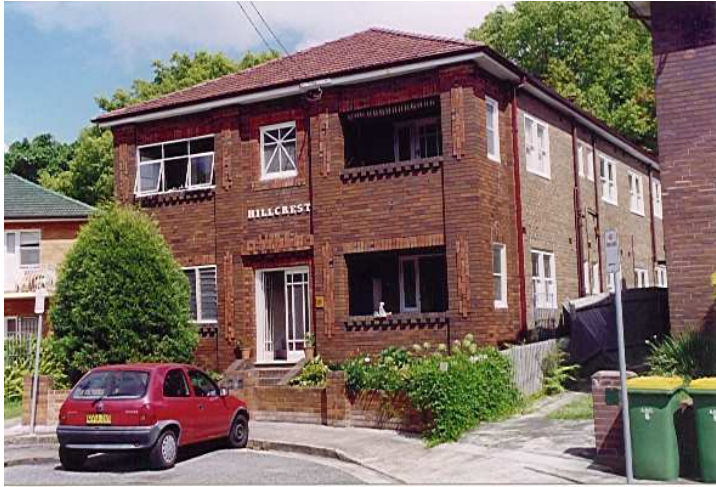
</div>																									
<p>Photo roll 2000-3</p>	<p>Negative 26</p>																								
<p>Survey Date 1/13/2000</p>	<p>Surveyed by: TK</p>

Two storey brick block of flats with some elements of Inter war Art Deco style. A hipped roof clad with Marseilles terra cotta tiles covers the building. The walls are of dark brown face bricks with lighter brown texture bricks used for contrast around the entrance doorway, as soldier courses above windows and as vertical panels on the facade. The side walls are built of lighter common bricks. The stairwell window features a star burst pattern in the glazing bars. Glass doors with glass sidelights lead into recessed porches on the front flats. Two of these have been enclosed. Double hung sash windows are used around the building. A low fence with short piers built of bricks identical to the building is at the front.
