ZONE 7 BROUGHTON HALL INVENTORY OF INDIVIDUAL ITEMS

ZONE 7 - BROUGHTON HALL

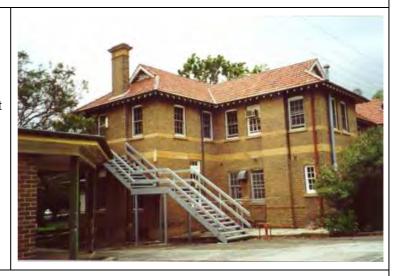
BUILDING: B121- WARD 24

CONDITION: Fair to good, intact with minor additions including enclosed verandah.

Two storey building with Federation era aesthetic. Brick walls with stone string course and sills, complex terracotta tiled roof with gablet vents and rafters exposed in eaves. Arched opening to entrance. Multi-paned double hung windows and extensive verandah on garden side with fine turned timber columns.

HISTORY:	Built c. 1920. Drawing signed by G. M. Blair 1908 and passed by G. M. Blair 13 September 1918. 1908 is well prior to government use of site, so the building may have been intended for elsewhere.
REFERENCES:	Leong (67). MHI/628-9, JTCW
SIGNIFICANCE:	High. One of most important elements of the Broughton Hall group, enclosing garden and consistent in materials, design and scale. Finely crafted and designed building. Accomplished example of type. Note that external metal stairs are intrusive.
GUIDELINES:	Retain and conserve according to Burra Charter principles (including adaptive reuse). Respect group values in any work. If practicable, remove unsympathetic verandah enclosure. General maintenance required, including rainwater goods. Remove redundant services from external walls. The design of the external fire stairs should be integrated with the building as appropriate for intended use.

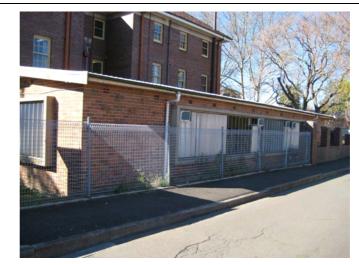
BUILDING: B124

Single storey brick and concrete building linked to building B125. Wide metal louvres present over windows. Shallow pitched gabled roof covered with steel decking.

CONDITION:	Average
HISTORY:	Built c. 1960
REFERENCES:	JTCW
SIGNIFICANCE:	Intrusive
GUIDELINES:	Retain, recycle, replace or preferably remove. Record prior to removal.

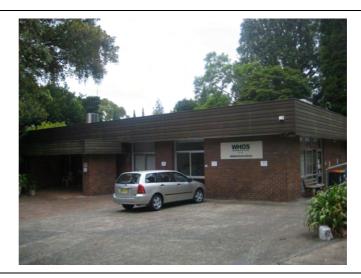
BUILDING: B128 - WHOS Administration

Single storey modern brick building with flat metal deck roof and aluminium windows and doors. Siting disregards garden design. Materials and design are inconsistent with Broughton Hall Group.

CONDITION:	Good
HISTORY:	Built 1971. Tennis court appears in early photos of Broughton Hall gardens, see Powell.
REFERENCES:	Leong (74), MH1/181-196, JTCW, Powell.
SIGNIFICANCE:	Intrusive - building is not significant. Site significant as Broughton Hall tennis court, allowing location of early garden photographs which show court.
GUIDELINES:	Retain, recycle, or preferably remove and if practicable return site to garden retaining its tennis court form. Record prior to removal.

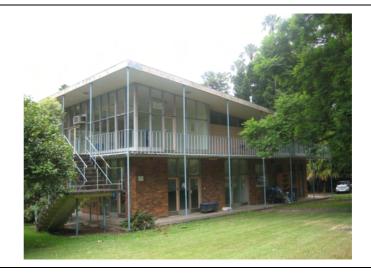
BUILDING: B129 DAINTREE LODGE

Two storey brick building with extensive areas of glazing and low pitched "butterfly" profile roof. Siting disregards garden design and building inconsistent with group.

CONDITION:	Good
HISTORY:	Built c. 1960
REFERENCES:	Leong (75), MH1/62-63, JTCW
SIGNIFICANCE:	Low - characteristic post-World War II building showing Modernist architectural influence. Intrusive on original garden setting.
GUIDELINES:	Retain, recycle or remove. If retained, conserve according to Burra Charter principles. If removed, return site to garden and record prior to removal.

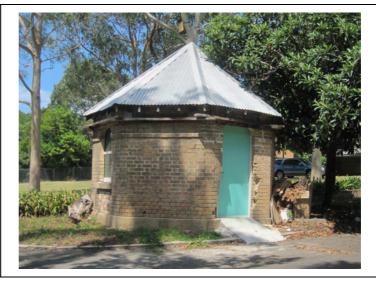
BUILDING: B137 SUMMER HOUSE

Octagonal summer house of finely detailed brick construction with corrugated iron roof - formerly slate or shingled (from spacing of battens). Single doorway opposite niche (false window). Two window openings on opposite sides. Boarded ceiling. Construction consistent with nineteenth century date.

CONDITION:	Fair.
HISTORY:	Built as garden pavilion as part of early garden design. Extant before 1890. Inappropriately adapted as w.c. at beginning of 2011.
REFERENCES:	Dept of Lands Metropolitan Detail Series Leichhardt Sheet 57, 1890. Site inspection, MH1/9, and site plans 1931-51. Leong thesis (referred to as gate lodge).
SIGNIFICANCE:	High. Only surviving built element of estate gardens.
GUIDELINES:	Retain and conserve as landscape element according to Burra Charter principles. Enhance heritage significance by initiating sympathetic adaptive reuse and removing inappropriate w.c. installation. Reconstruct / install appropriate window and door fabric.

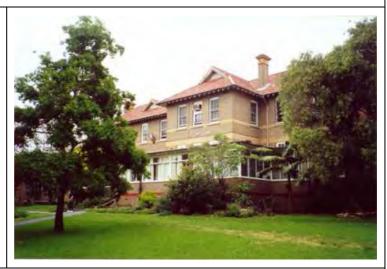
BUILDING: B193 WARD 25

CONDITION: Fair to good, intact (minor additions)

Two storey Federation period building. Brick walls with stone string course and sills, complex terracotta tiled roof with gablet vents and rafters exposed in eaves, arched opening to entrance. Multipaned double hung windows and extensive verandah on garden side with fine turned timber columns. Verandah has been enclosed.

HISTORY:	May have been built c. 1920. Drawing signed drawn by G. M. Blair 1908 and passed by G. M. Blair 13.9.18. 1908 is well prior to government use of site, the building may have been intended for elsewhere.
REFERENCES:	Leong (65), MH1/628-9, JTCW
SIGNIFICANCE:	High. One of the most important elements of Broughton Hall Group enclosing garden and consistent in materials, design and scale. Finely crafted and designed building. Accomplished example of type.
GUIDELINES:	Conserve according to Burra Charter principles. Stormwater disposal requires attention. Reinstate verandahs, reconstruct original windows where these have been removed or modified as appropriate. Initiate regular maintenance program.

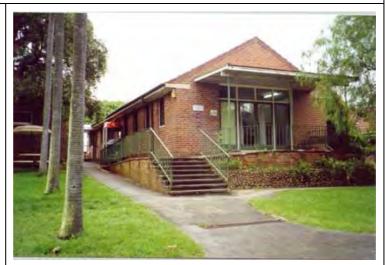
BUILDING: B194

Single storey brick building with gabled tiled roof. Thin concrete canopy sheltering terraced area and extensively glazed opening at eastern end

oons	G000
HISTORY:	Built c. 1958
REFERENCES:	Leong (63)
SIGNIFICANCE:	Low. Minimal heritage significance in demonstrating change to use of electro therapy in psychiatric care.
GUIDELINES:	Retain, recycle, replace or remove as practicable. If removed record prior to demolition. Investigate further historical/social significance of introduction of electro therapy. If modified, works should respect buildings of higher significance nearby.

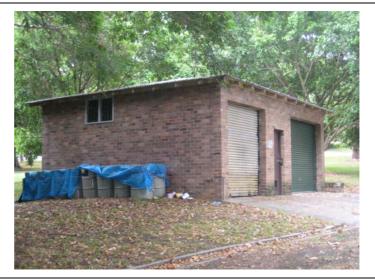
BUILDING: B196 GARAGE, STORAGE

Small brick shed with corrugated steel roof and two steel roller doors on the north elevation in Broughton Hall gardens. Exposed rafter ends.

CONDITION:	Poor
HISTORY:	Unknown; c. 1931
REFERENCES:	Inspection JTCW
SIGNIFICANCE:	Intrusive in landscaped setting.
GUIDELINES:	The building should be removed and the Broughton Hall garden restored. Record prior to removal.

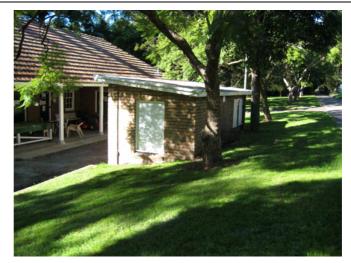
BUILDING: B197 GARDENER'S STORE AND WC.

Small brick structure with mono-pitch roof covered by corrugated steel. Relatively large window openings have been boarded over.

CONDITION:	Good.
HISTORY:	Unknown, circa 1960.
REFERENCES:	Inspection JTCW
SIGNIFICANCE:	Intrusive in landscaped setting.
GUIDELINES:	Retain or remove. Record prior to removal.

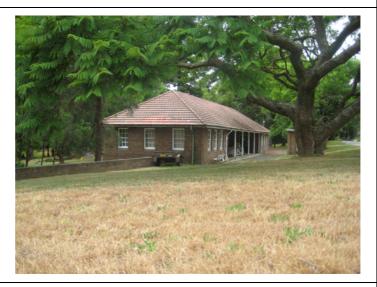
B198 WORKSHOP

Small single storey brick building in Broughton Hall Gardens. Terracotta tiled hipped roof and recessed verandah on west façade. Isolated from other buildings.

CONDITION:	Average. Roof and windows in need of maintenance.
HISTORY:	c. 1937
REFERENCES:	Leong (60) JTCW
SIGNIFICANCE:	Low. Minimal heritage significance.
GUIDELINES:	Retain, recycle, or remove as practicable. If replaced have regard to setting in Broughton Hall Gardens. General maintenance required if retained. If removed record prior to demolition.
