# Birchgrove Park Masterplan

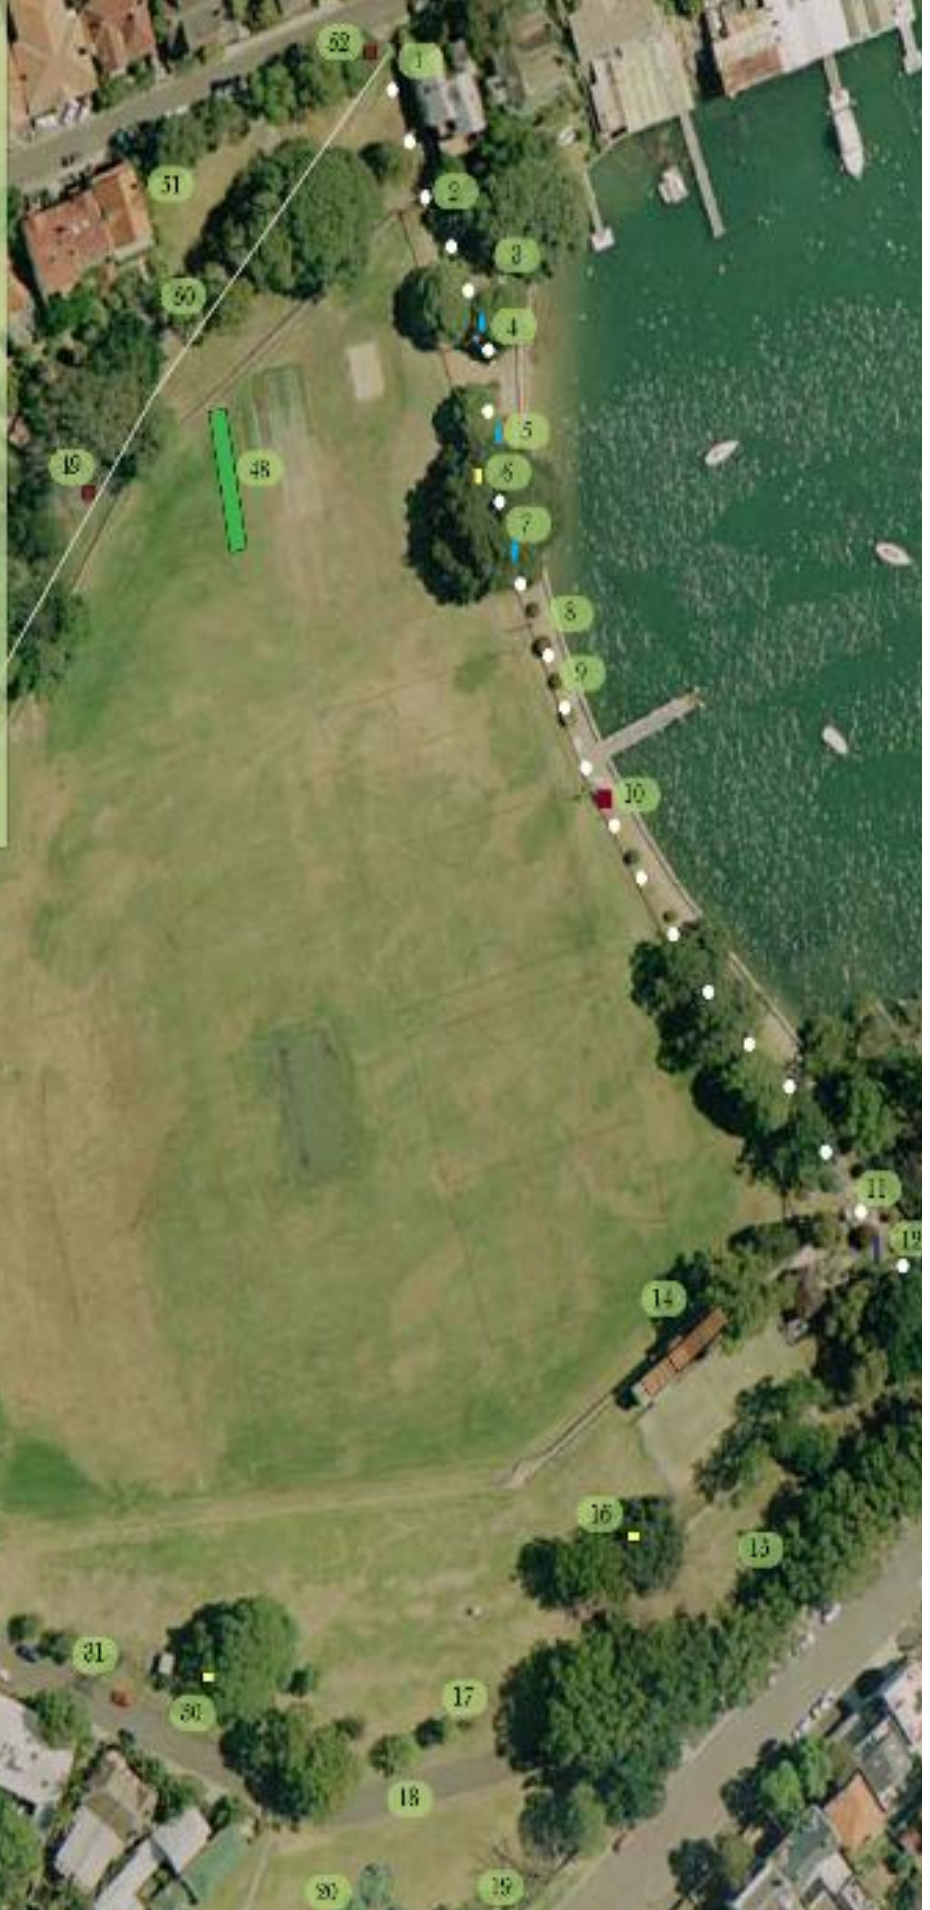
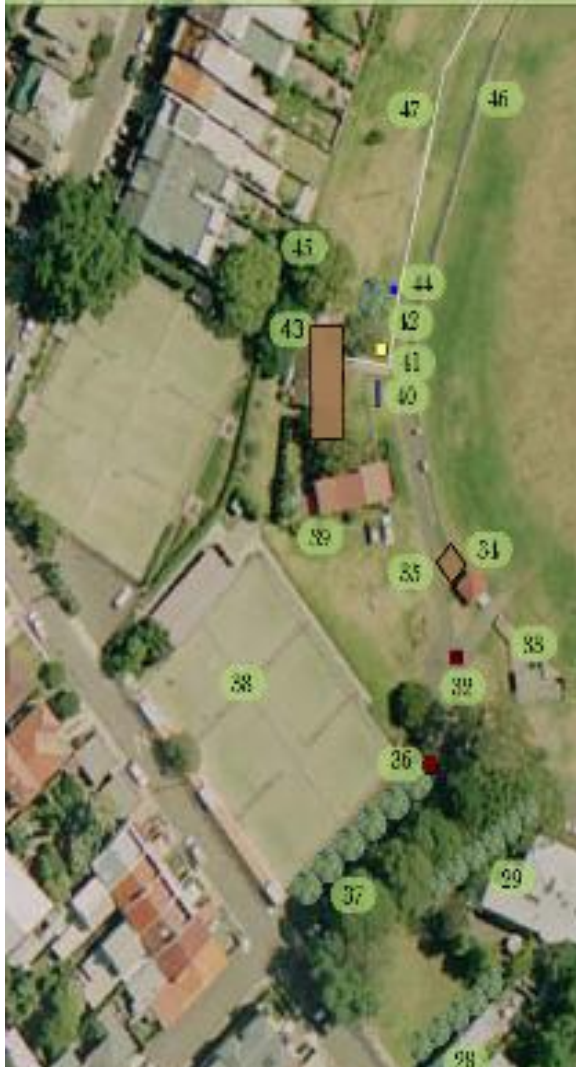
# LEGEND

- 1 Existing Cross slope pathway alignment to be retained & bitumenised with suspended timber sections over the tree roots.
- 2 Remove 4 x oleander shrubs encroaching on pathway.

- 3 Existing graded bitumen pathway from Deloitte Avenue to remain unchanged.
- 4 Retain seating.
- 5 Retain seating.
- 6 Retain garbage bin.
- 7 Retain seating.

- 8 Proposed undergrounding of powerlines along eastern side of park.
- 9 Proposed bollard lighting along Deloitte Ave. (Indicated by white dots).
- 10 Proposed location for heritage sign. To contain historical information and images.

- 11 Remove & replace pumping station fence with a more aesthetically pleasing style fence.
- 12 Proposed cycle rack.
- 13 Proposed location for heritage sign. To contain historical information & images.

- 14 Remove existing concrete terracing. Proposed new pavillion with viewing deck & changing room (to future design). Possible incorporation with tennis pavillion (shown attached).

- 15 Retain stone 'play' house.
- 16 Relocate garbage bins.
- 17 Fig Plantings
- 18 The Terrace & Grove tree will be subject to a detailed Traffic Management Study to assess traffic movement with possible solutions to car parking & pedestrian safety.

- 19 Fig Planting (Replace dead Camphor Laurel)
- 20 Proposed shade trees
- 21 Proposed BBQ area (to future design).
- 22 Proposed drinking fountain.
- 23 Playground's eastern fence line to be removed & playground extended to Grove Street boundary wall.

- 24 Proposed temporary shade sails over the playground until adequate natural shade from newly planted tree specimens is sufficient.
- 25 Proposed shade tree.

- 26 Proposed location for heritage sign. To contain historical information & images.
- 27 Retain garbage bins.
- 28 Screen planting.
- 29 Screen planting.

- 30 Retain garbage bins.
- 31 Irrigation facility to be located underground.
- 32 Proposed heritage sign. To contain historical information & images.
- 33 Remove shed. Fence to match surrounds.

- 34 Retain timber shed & add new maintenance shed.
- 35 Replace metal gate with timber picket gate. Fence to match existing oval fence.
- 36 Retain former Ticket Box.

- 37 Install avenue of small trees (e.g. Blueberry Ash) along base of tennis court retaining wall to define view corridor.
- 38 Lighting upgrade to Australian Standards. Court surface improvements to be undertaken over a 3 - 5 year period.

- 39 Retain existing Caretakers residence.
- 40 Proposed cycle rack.
- 41 Relocate garbage bins (from Caretakers residence).
- 42 Proposed Podocarpus tree (Native Plum Pine).

- 43 Proposed expanded toilets/changeroom facility (low profile to future design). Renovate existing structure.
- 44 Proposed drinking fountain.
- 45 Remove Camphor Laurel (Refer to T6 in the Draft Birchgrove Plan of Management)

- 46 Retain timber seat around fence.
- 47 Proposed new bitumen pathway.
- 48 Proposed additional practice cricket wicket.
- 49 Proposed location for heritage sign. To contain historical information & images (near former Birchgrove House steps).

- 50 Retain existing path.
- 51 Retain the existing lawn character of Louisa Road frontage.
- 52 Proposed location for heritage sign. To contain historical information & images.
